**Re: Texas Custodial Trust
Former ASARCO Smelter Site, El Paso, Texas**

**Subject: East Category I Landfill Confirmation Sampling Results
Former ASARCO Smelter Site, El Paso, Texas**

**FORMER ASARCO SMELTER
 EAST CATEGORY I LANDFILL**

TEST PIT LOCATIONS

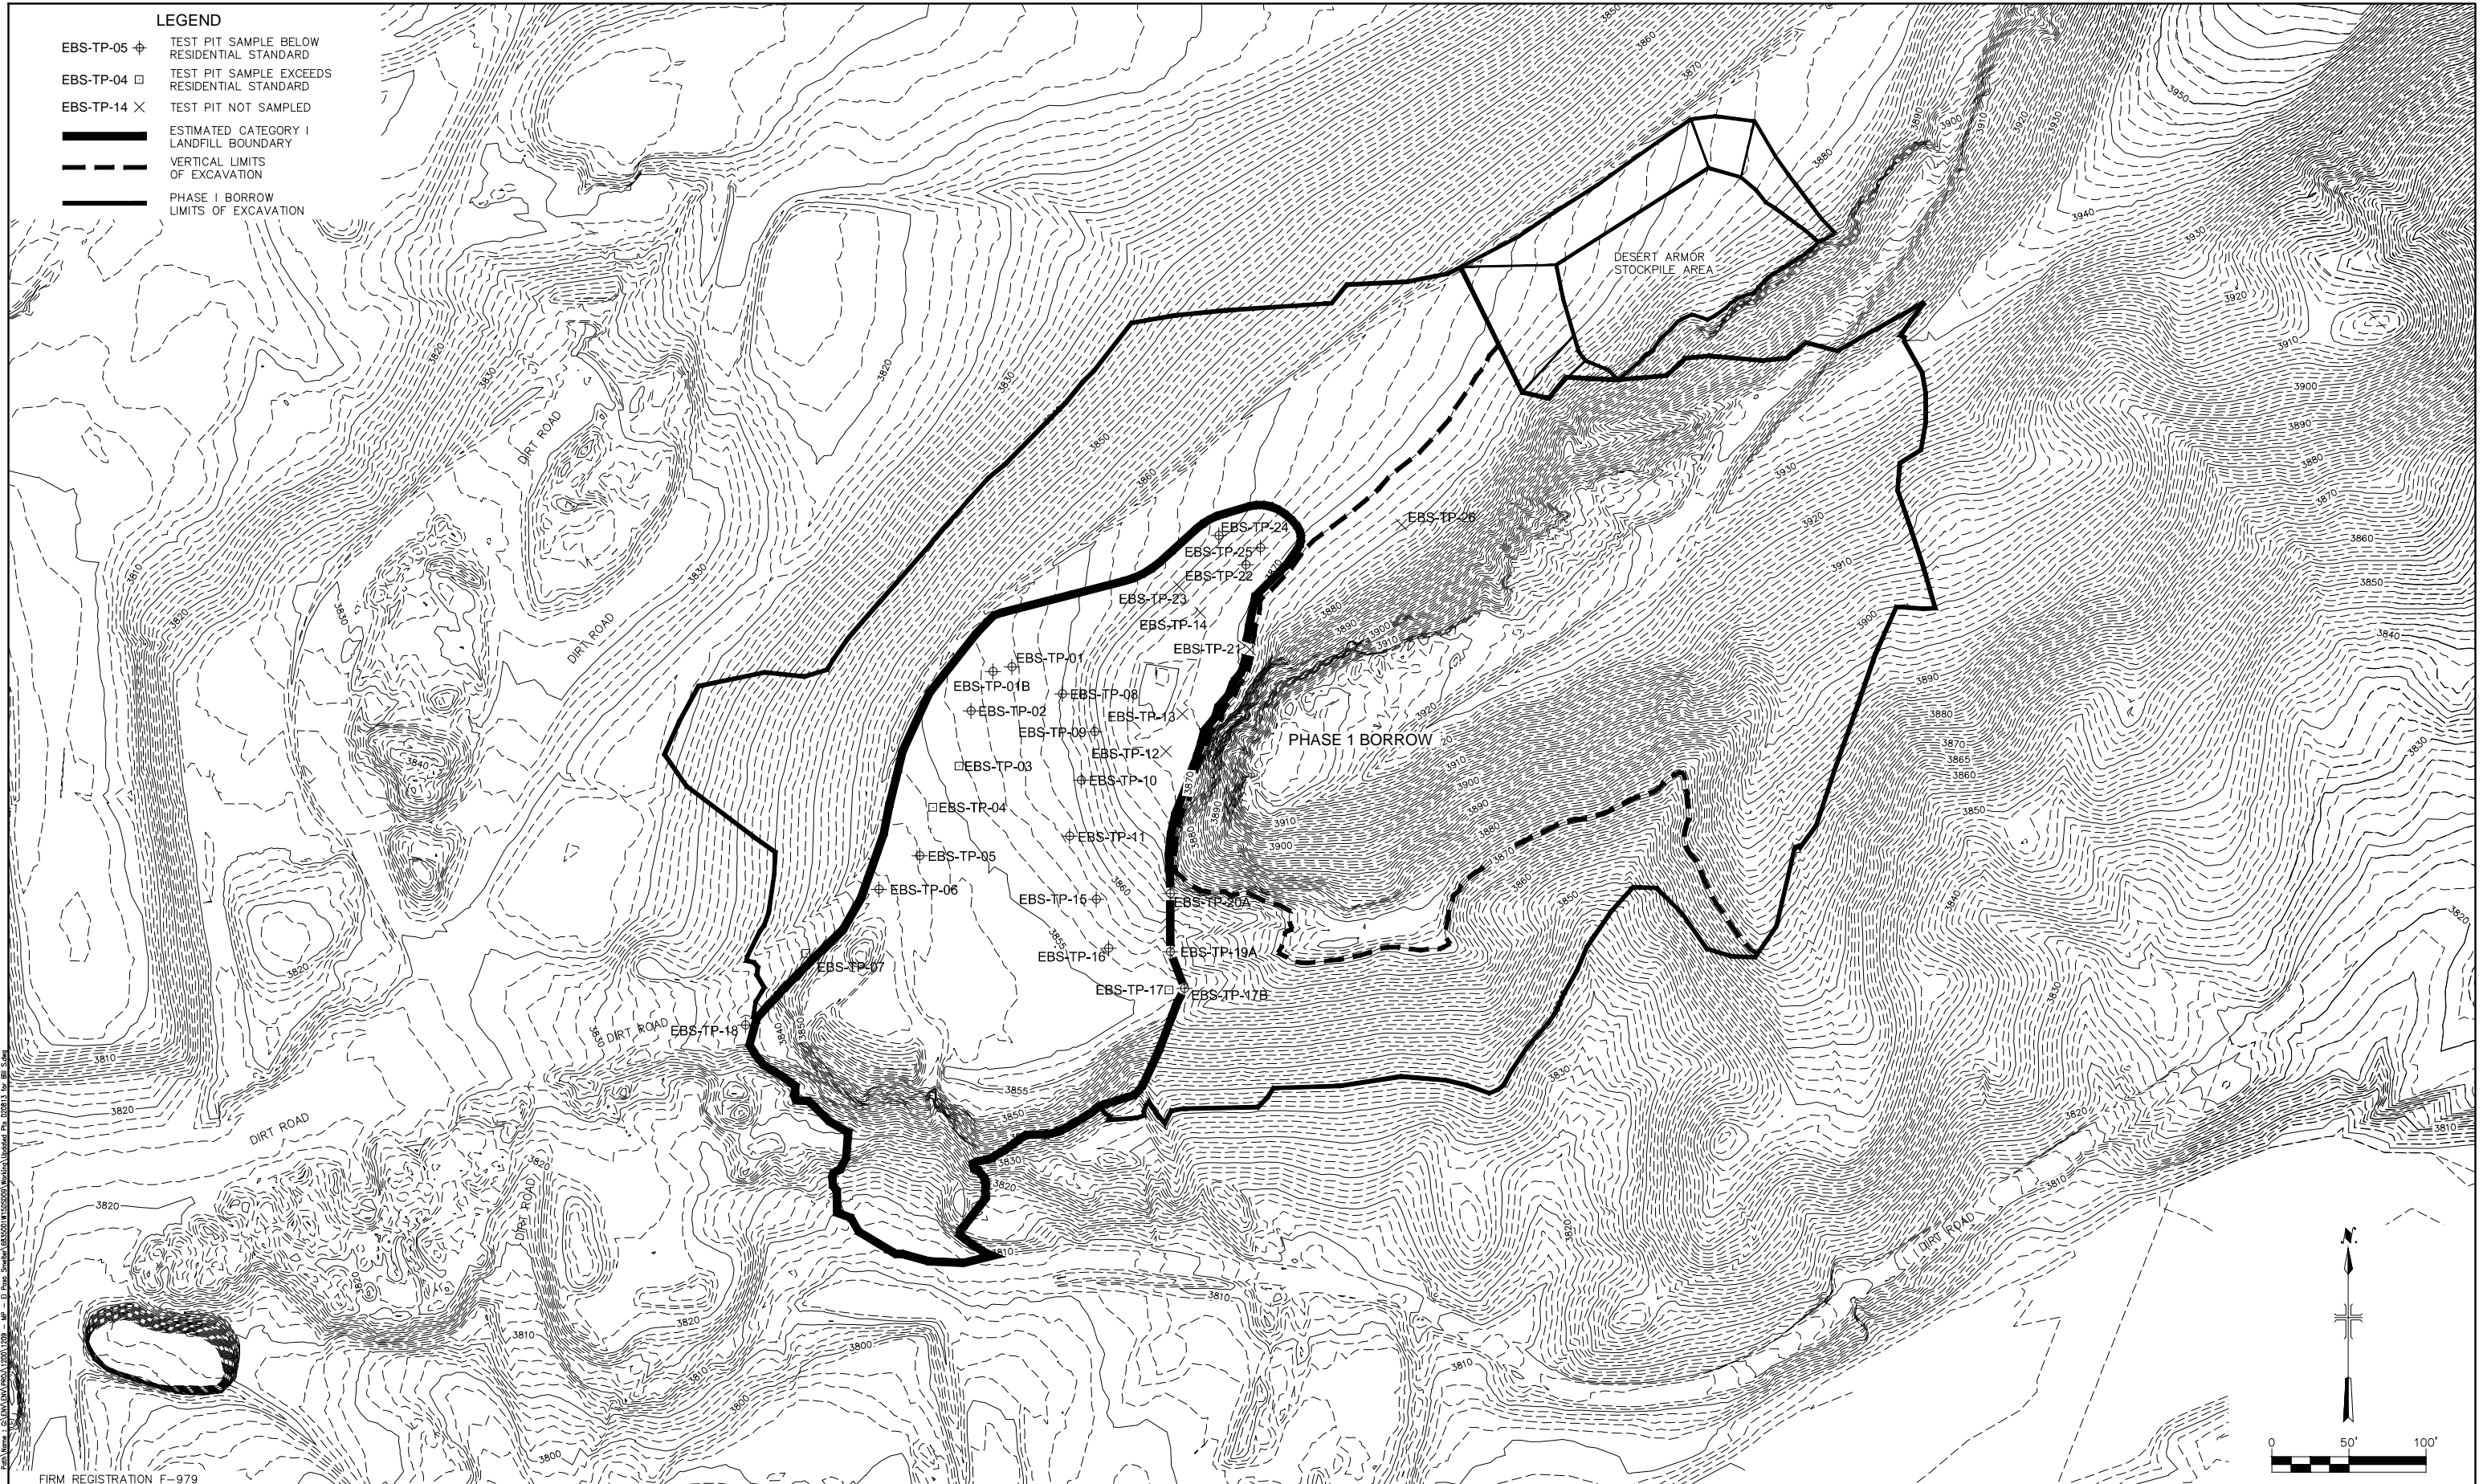
The limits of the East Category I landfill were first located using historical survey data. Subsequently, a total of 26 test pits were located and excavated to identify the interface of Category I and native material. The locations of the test pits are provided in Figure 1. Test pit observations, including depth to Category I material are summarized in Table 1.

The western and southeastern samples of the former landfill cover soils (i.e., TP-01-2-3, TP-01B-2-3, TP-03-1-2, TP-04-1.5-2.5, TP-11-2-3, TP-17-2-3) indicated exceedances of the residential standards; therefore, additional environmental samples were collected in the southeastern section which is adjacent to the East Borrow Source (EBS) area. Step-out samples were taken at TP-17B, TP-19A and TP-20A to locate clean soils and better define the eastern boundary. The western interface of the landfill was not fully delineated since this area will be excavated, and confirmation samples will be collected in that location at a later date.

The sample results indicated a clean soil boundary could be established to facilitate excavation of clean material from the EBS. The landfill interface (plus a 5-foot buffer) was then delineated in the field to keep construction equipment from inadvertently excavating the material using highly-visible markers. The markers include 7-foot-tall flags and construction fencing along the eastern boundary of the landfill. These markers can be seen from large equipment and indicate the horizontal locations of the boundary of the landfill. As discovered from the test pits, the thickness of the soil cover over the waste material varies, and a vertical limit was established to prevent excavation into the soil cover or the Category I material. This vertical limit was established 2 feet above the toe of the ridge on the eastern side of the landfill at an elevation of 3,871 feet. A paint mark has been added to the cut face indicating this limit, as well as a construction stake (referencing a GPS survey point) listing the elevation in the event the paint mark is not visible. This vertical elevation will act as a visual stopping point for excavation activities to assure that the waste material is not exposed in that area, and will be in effect until the Category I material removal process begins at a later date. Finally, all equipment operators were briefed on the material-handling procedures for EBS material. The material handling procedures (see Attachment 1) provide necessary information required to identify the difference between the native and waste material as well as instructions if waste material is encountered. A copy of these procedures is required to be in all excavation equipment operating in the area.
