October 17, 2012

Project No. 0118148

Subject: Former ASARCO Smelter Powerhouse Building, Limited
Structural Assessment

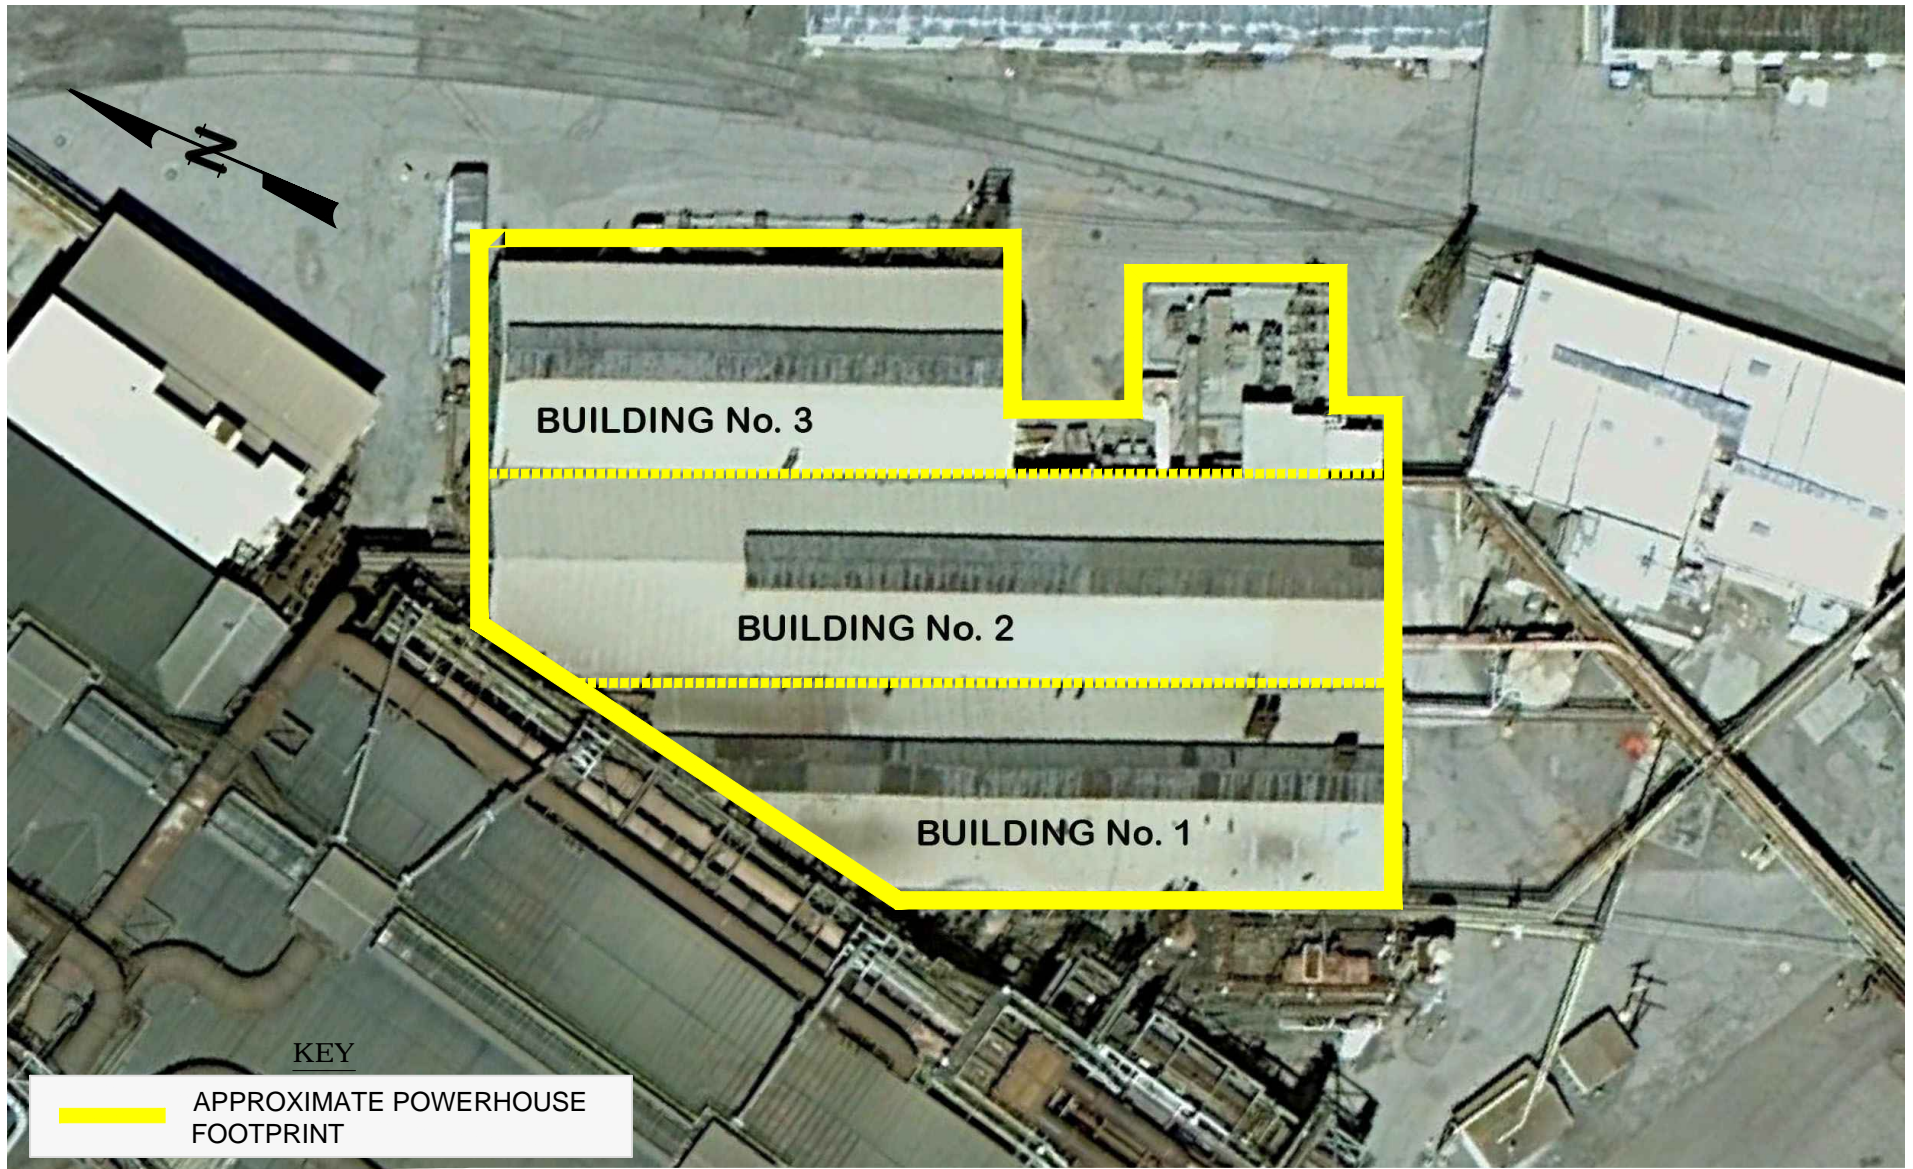
FIGURE 1
 STRUCTURAL ASSESSMENT
 POWERHOUSE BUILDING
 AREA PLAN
 Asarco
 El Paso, Texas

The building consists of three, 46-foot wide bays (Buildings 1, 2 and 3) joined together (see aerial view, Figure 1). The three bays are open to one another forming a single building with a clear open width of 138 feet (Figure 2) and an overall length of a little over 169 feet in Buildings 1 and 2 and about 116 feet in Building 3. Buildings 1 and 2 were constructed around 1917 to 1925; Building 3 was constructed in the late 1930s. Building 3 is offset along its north-south axis from Buildings 1 and 2. Plan dimensions and a typical section are shown in Figure 2.

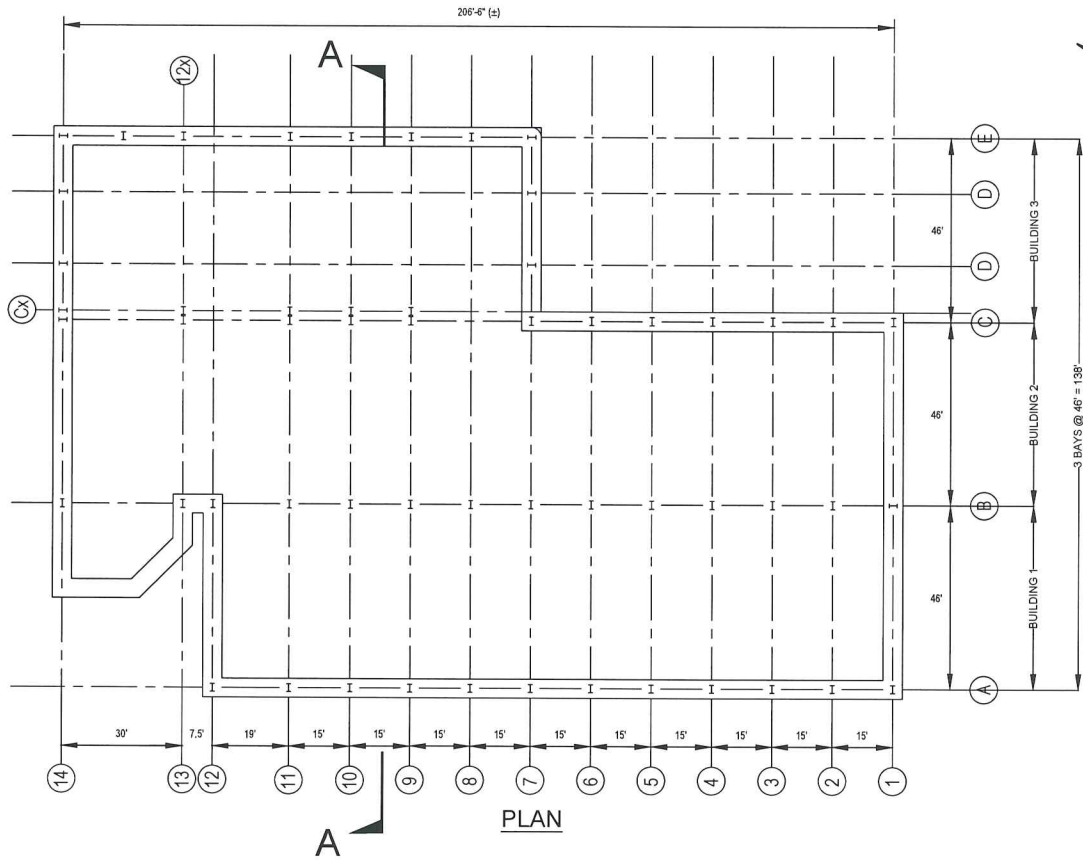
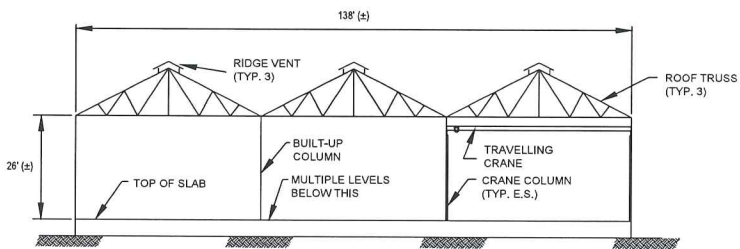
FIGURE 2
STRUCTURAL ASSESSMENT
POWERHOUSE BUILDING
PLAN AND SECTION
Asarco
El Paso, Texas

The three building superstructures are steel frames with brick shear walls between each exterior bay wall (see Figure 2). The roof structure is a double-fink truss with chords constructed of double angles and webs constructed of single angles.

Transverse wind loading appears to be carried by the steel frame with fabricated moment connections at the top and base of the columns. The base connections are formed either by embedding the steel column into concrete or by providing anchor plates and bolts. Typical column section dimensions are shown in Figure 2.
