Re: Closeout Report for American Canal Clean-up
Former ASARCO Smelter Site, El Paso, Texas

RE: Clean-up and removal of sloughed soils and rock from the American Canal, repairs to the slope between the rail road tracks and the canal, and repairs to canal fencing.

Appendix A - Photolog

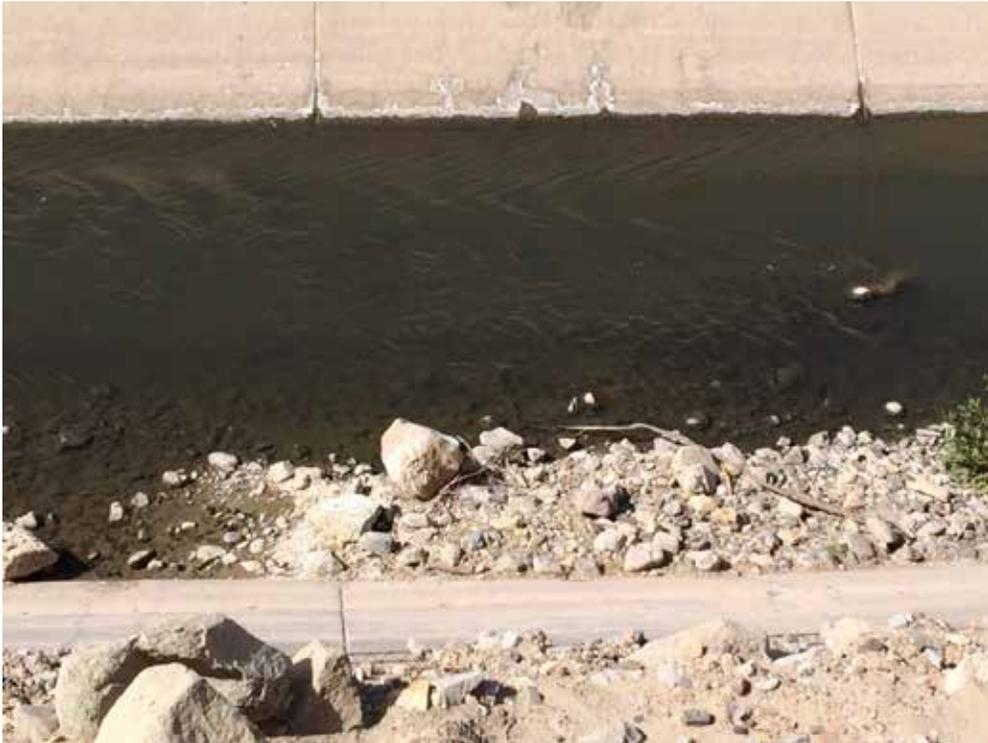
2-1) Sloughed rock and soil material (debris).

The removal operation began on Monday, May 5. Crew members initially set up safety lines from north to south parallel to the canal by anchoring two poles. Another set of poles were anchored adjacent to railroad track to carry oversized material. After the safety lines were established, crew members began dislodging the loose debris on the slope between the track and canal. Throughout the duration of the operation, crew members built the slope between the rail road track and the canal back to form, matching the surrounding conditions of the slope.

The mucking and scooping of debris was performed by a skid steer and an excavator along with manual labor. Every morning the skid steer was hoisted into the canal with the excavator and hoisted out at the end of the day. The skid steer would muck the debris/sediments and place the material in the bucket of the excavator that was staged outside of the canal. The excavator would then place the material into a dump truck waiting in the staging area. Technicians also scooped the materials manually with buckets and shovels to aid in the cleanup operation. Once the dump truck was loaded, it was hauled to the Former ASARCO Smelter site for disposal. Routine monitoring of the operation was performed by Malcom Pirnie. The clean-up and removal operation, including the slope repair was complete on May 20. A total of 13 truckloads estimated at 10 cubic yards per load were removed from the canal. Photographs documenting the

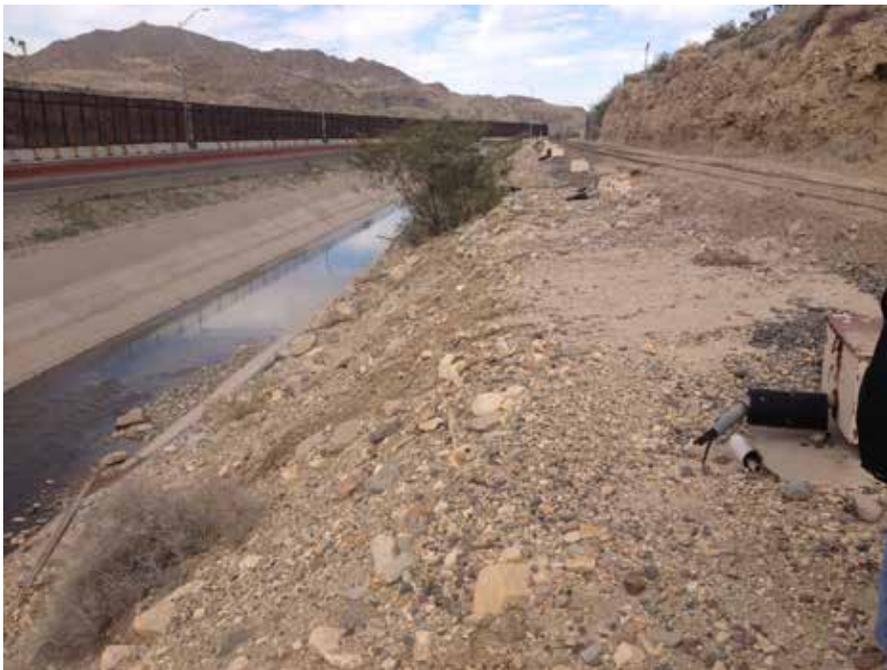
2-2) View of initial removal area, looking upstream.

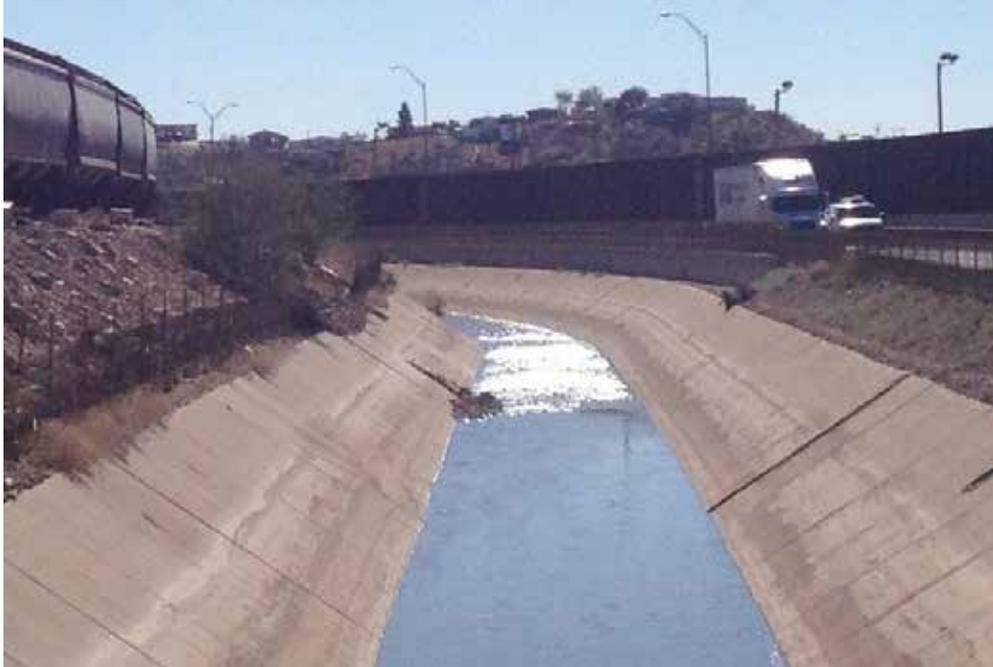
2-3) View of initial removal area, looking downstream.

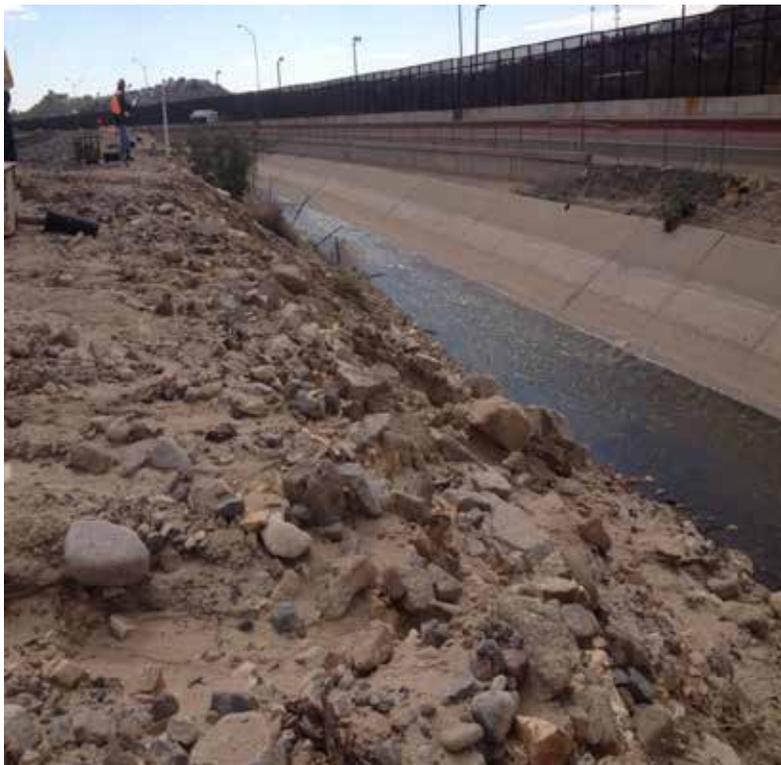
2-4) View of fence pushed over from soil and rocks.

The crew then completed installing new T-posts and installing chain-link fence with three strands of barbed-wire on May 21 completing the operation. Approximately 100 feet of fencing was installed.

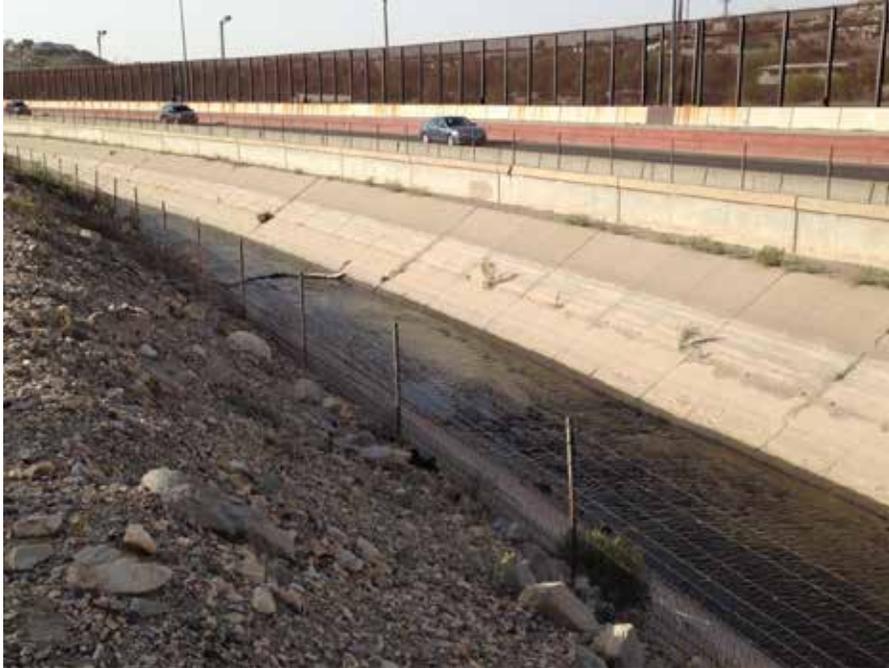
3-1) Adsorbent boom downstream of work zone.

As a precaution to mitigate any unavoidable oil spills or contamination of the water from the heavy equipment operating in the canal, VIVA set up an adsorbent/hard boom across the canal downstream. The boom remained set up throughout the duration of the heavy equipment operation. Also, decontamination of heavy equipment, ladders and tools used in the canal was conducted by using a pressure washer to wash down the equipment outside the canal prior to being placed in the water.

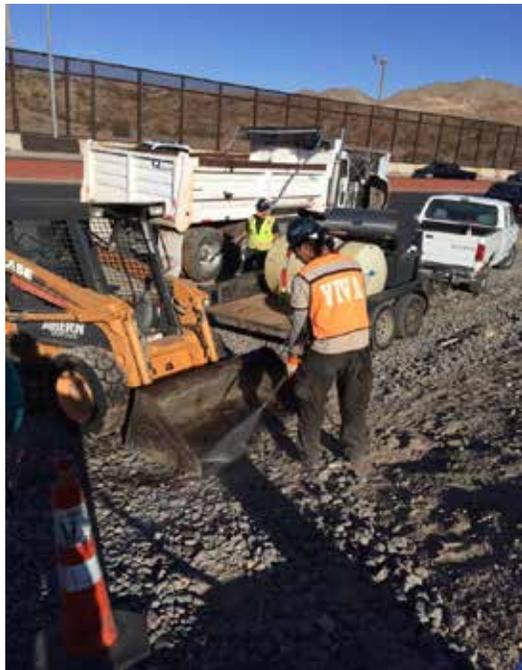
3-2) Decontamination of equipment.

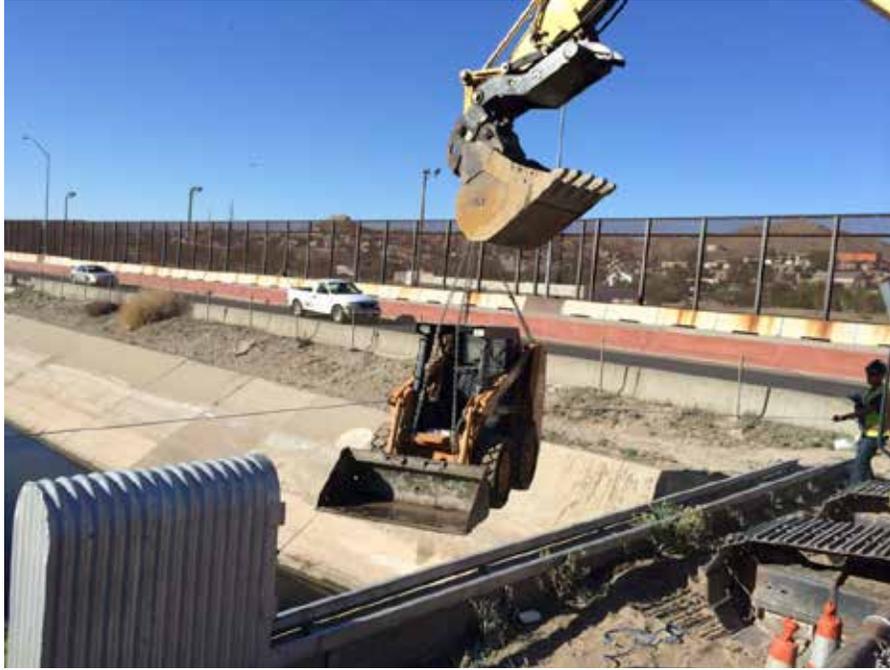
3-3) Hoisting skid steer into canal.

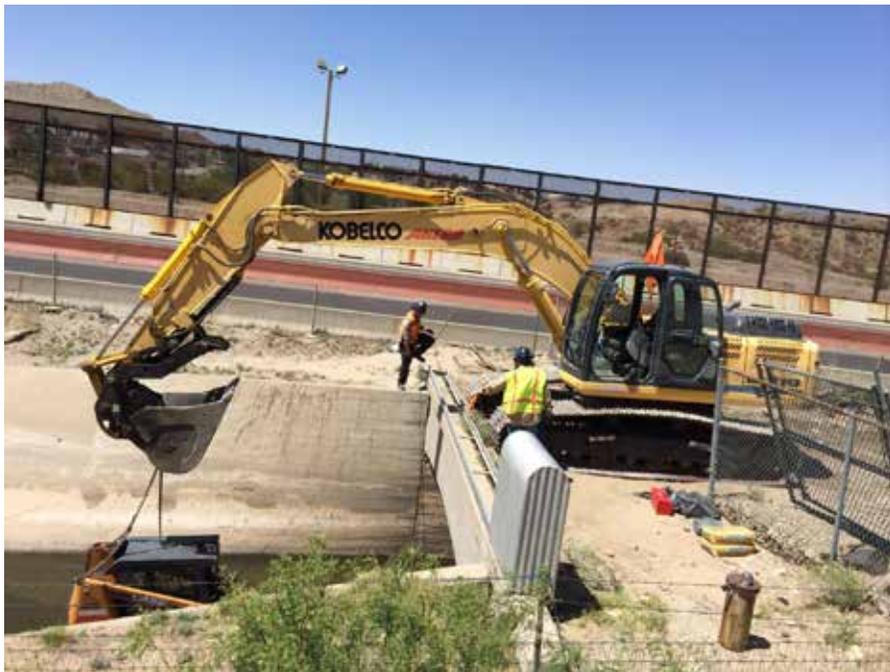
3-4) Hoisting skid steer into canal.

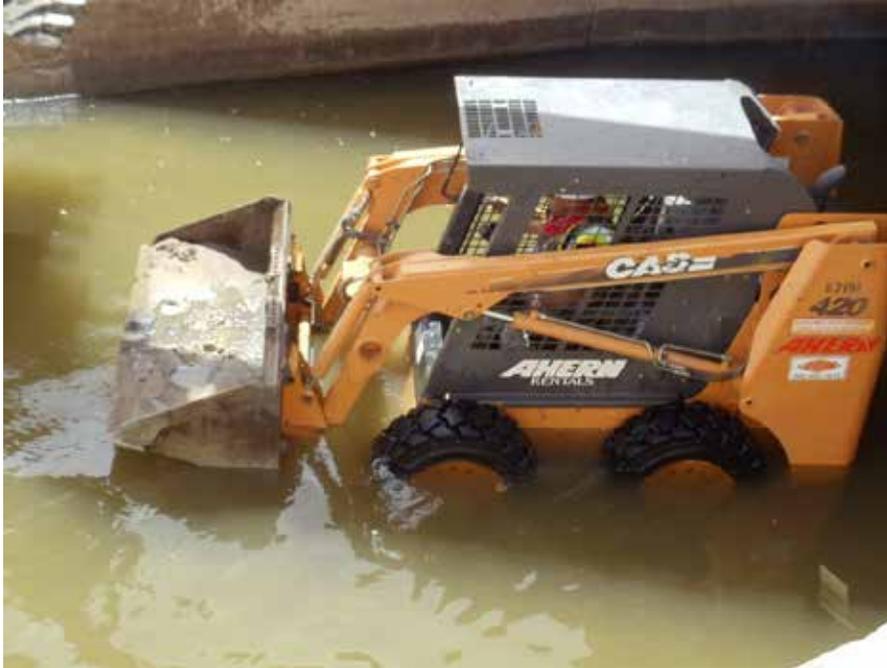
4-1) Skid steer operating in canal.

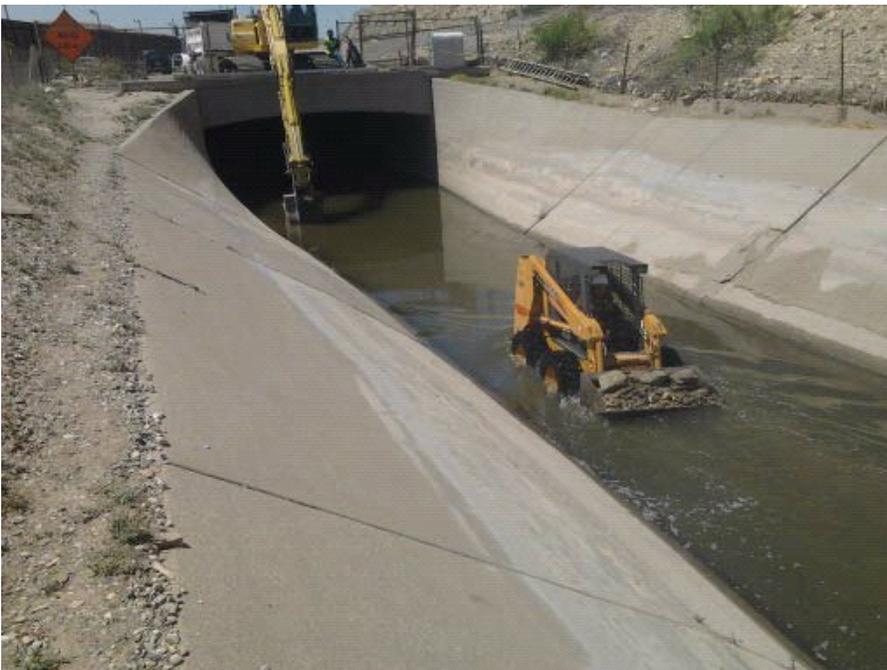
4-2) Skid steer hauling material to excavator for removal (traveling in reverse to prevent water from entering skid steer cab).

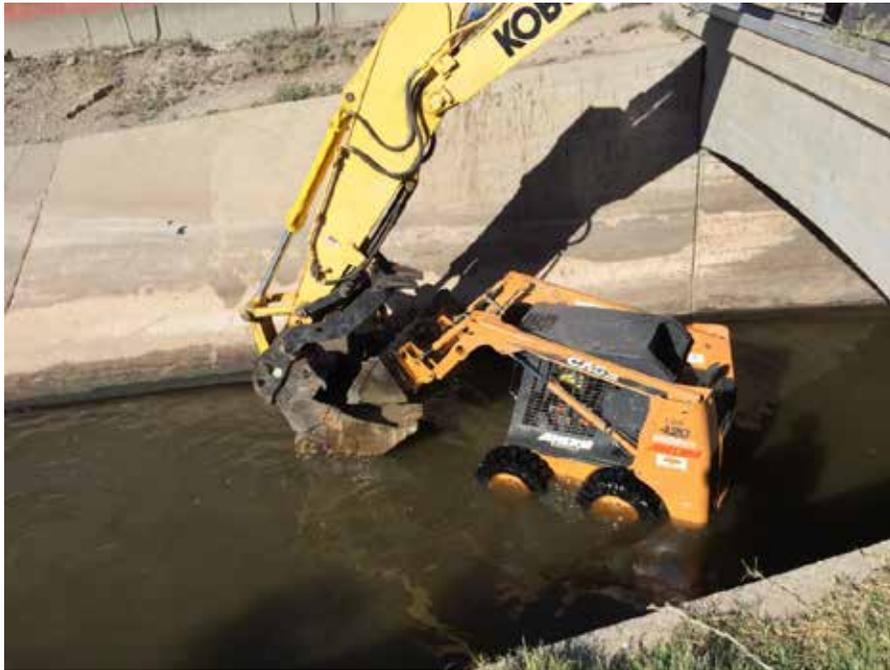
4-3) Skid steer placing debris in excavator bucket.

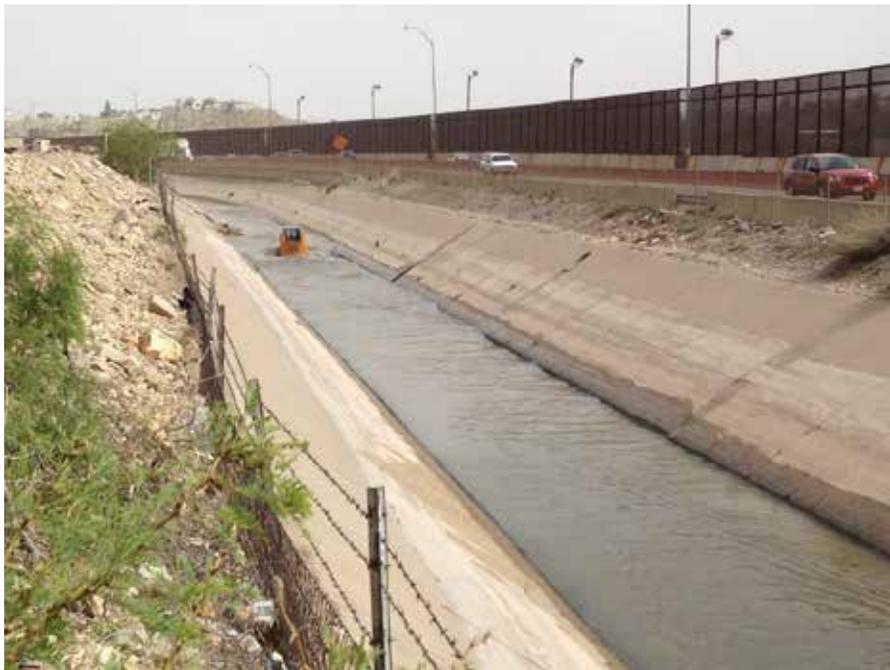
4-4) Skid steer removing debris, looking downstream.

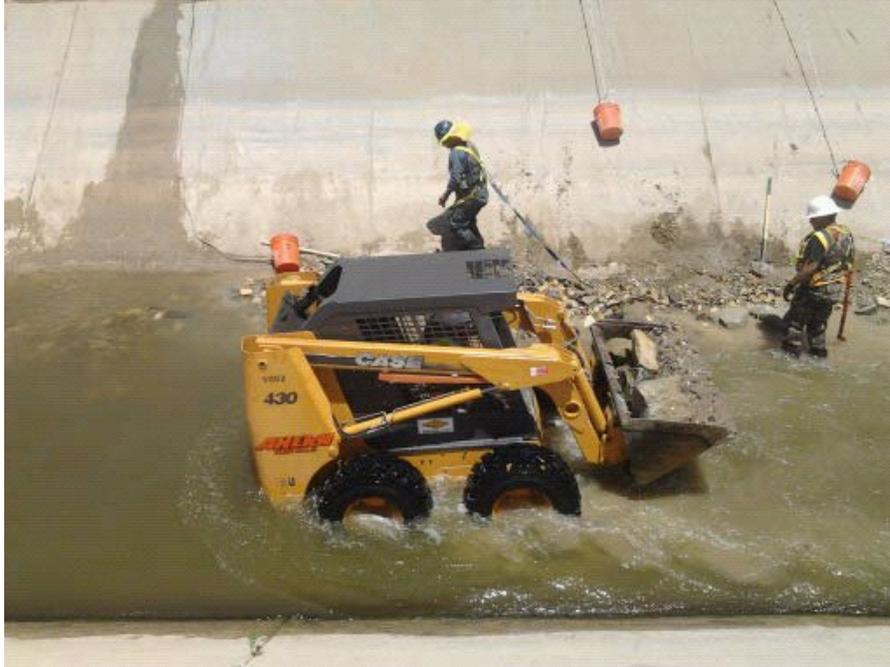
4-5) Skid steer removing and hauling away debris.

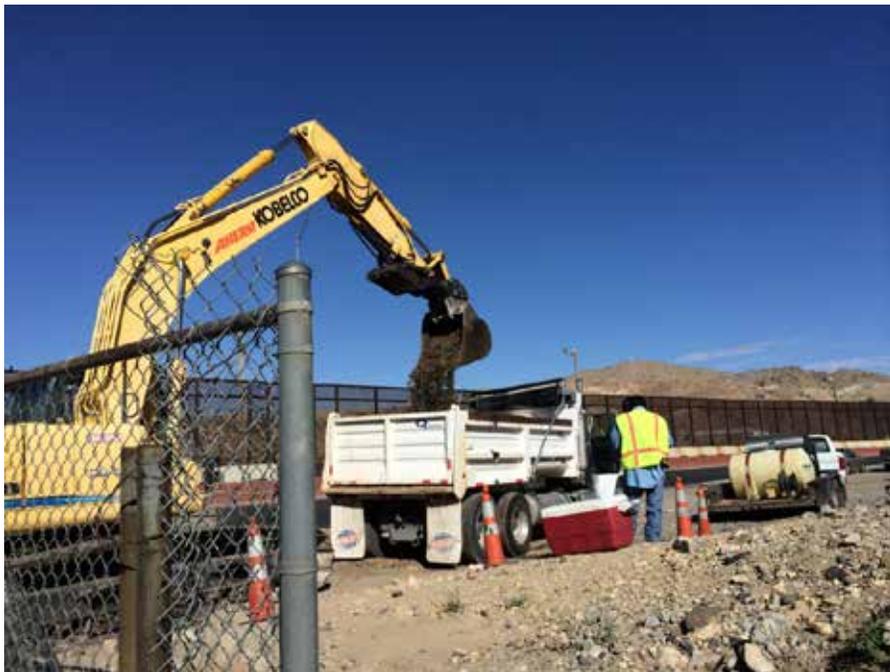
4-6) Placement of debris into dump truck.

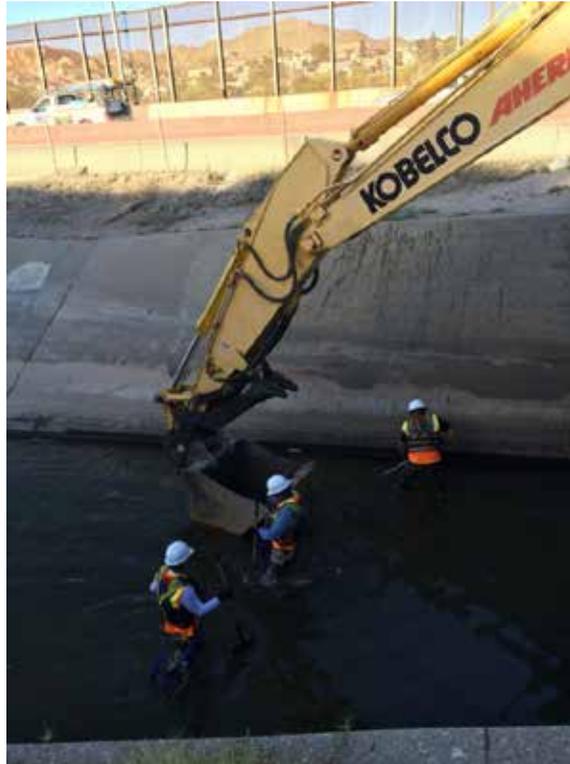
5-1) Manual removal of debris with hand labor.

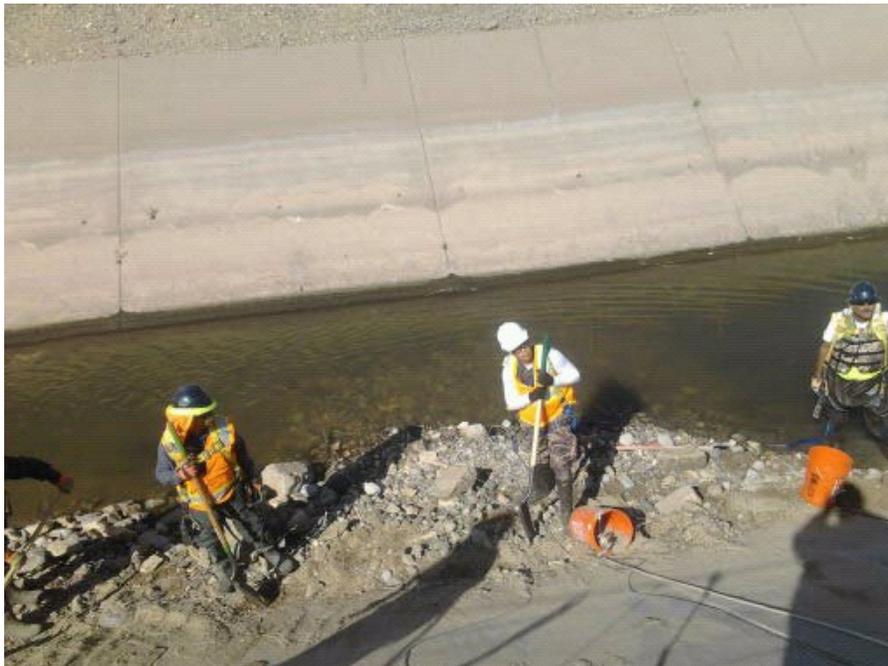
5-2) Manual removal of debris with hand labor.

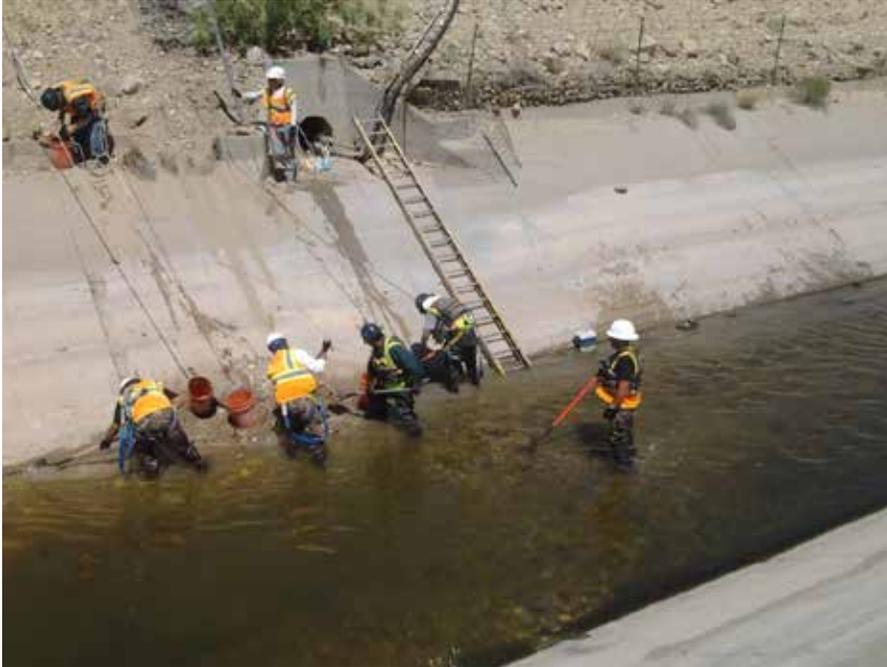
5-3) Manual removal of debris and placement back onto slope.

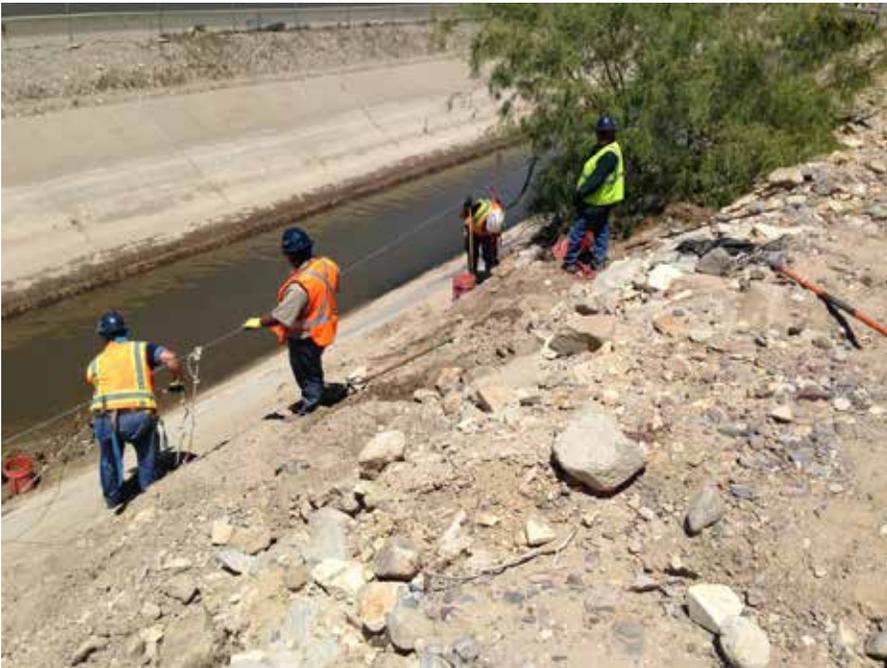
5-4) Manual removal of debris and placement back onto slope.

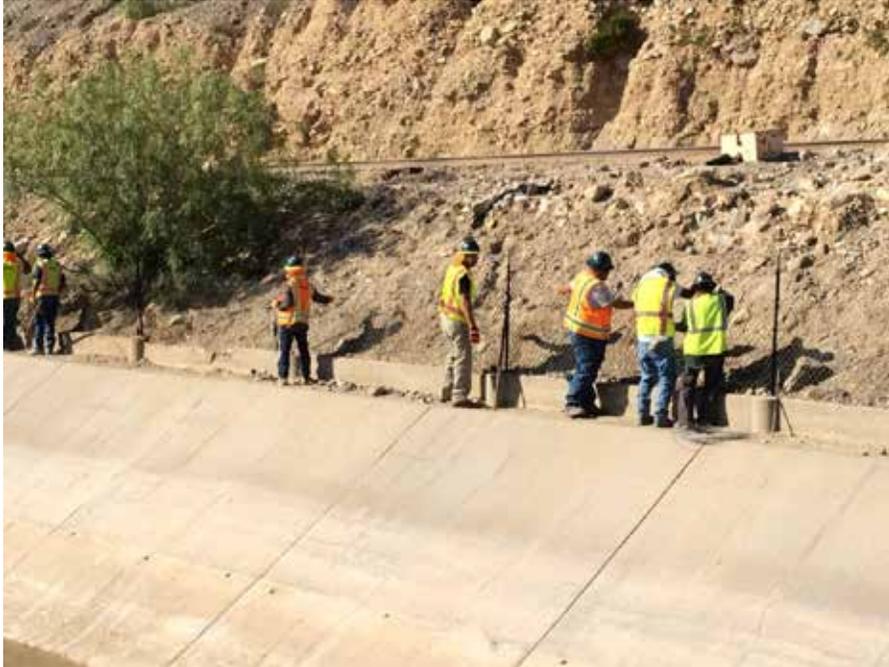
6-1) Fence installation.

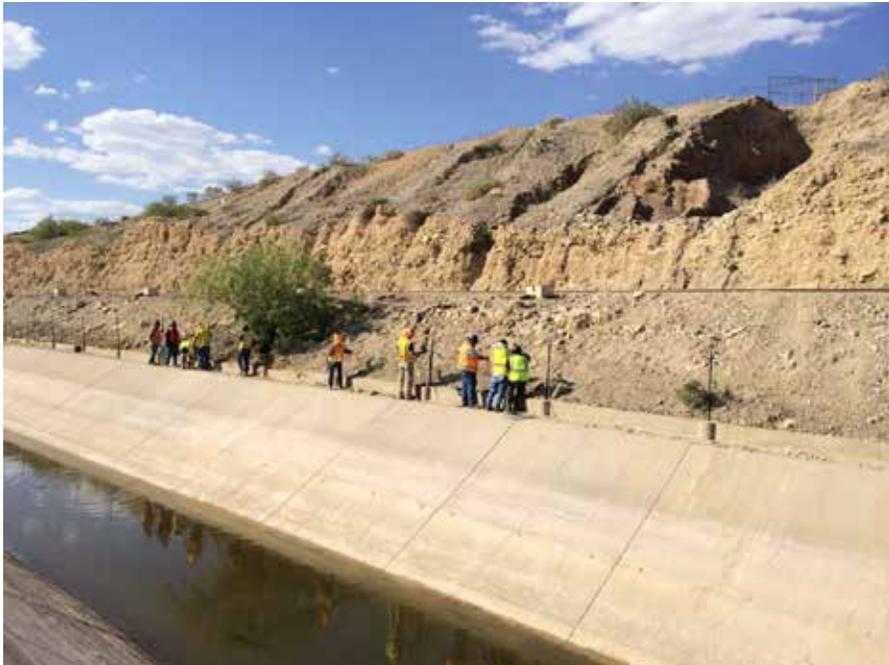
6-2) Fence installation.

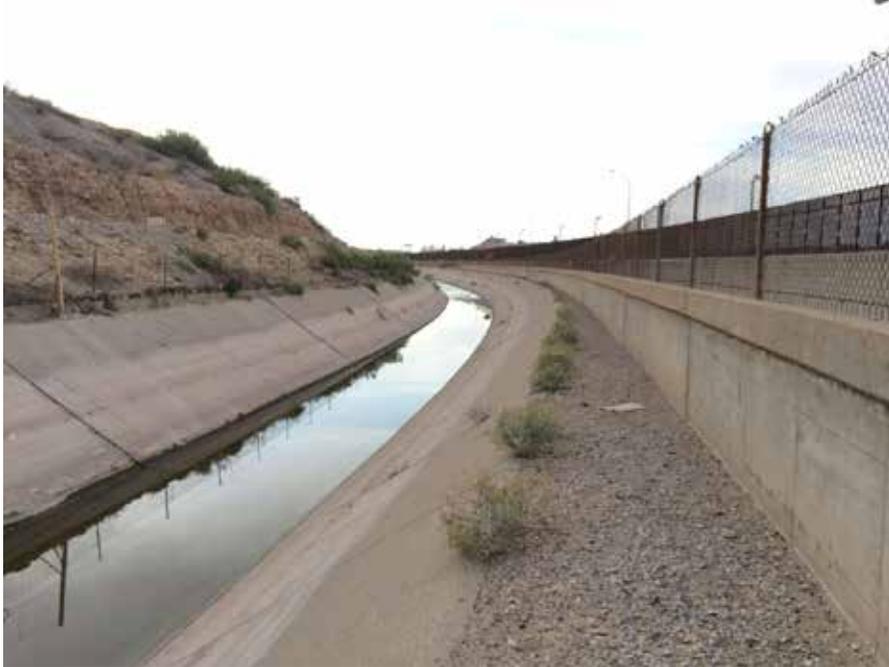
7-1) Conditions after debris removal. Note: smooth water surface, no ripples.

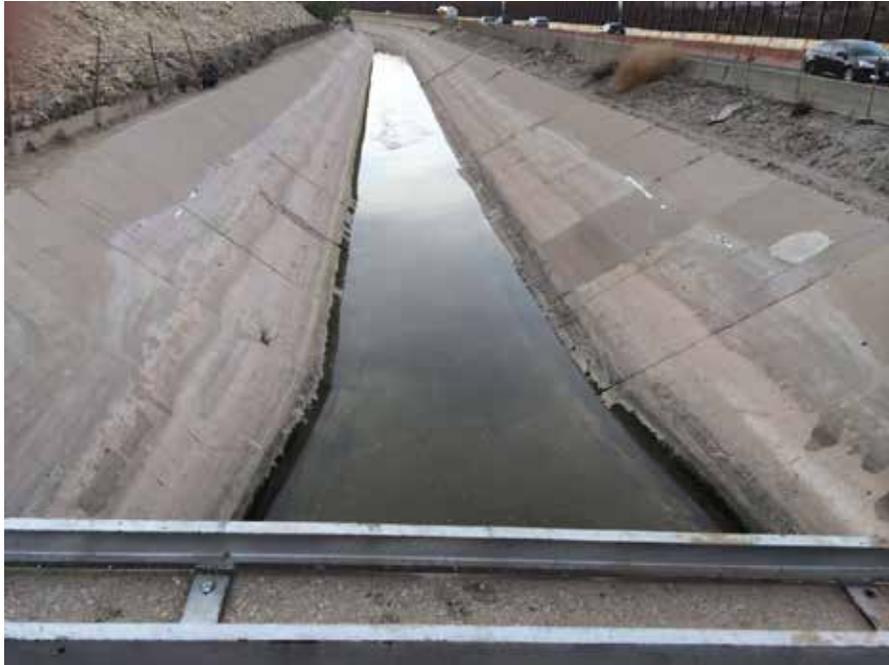
7-2) Conditions after debris removal as seen from the staging area looking downstream.

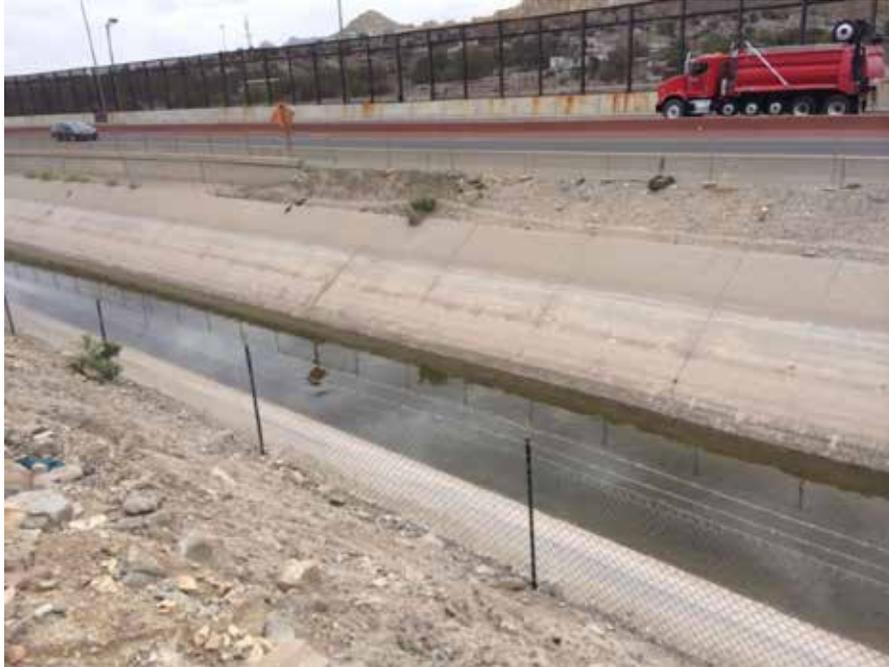
7-3) Repaired fence and slope.

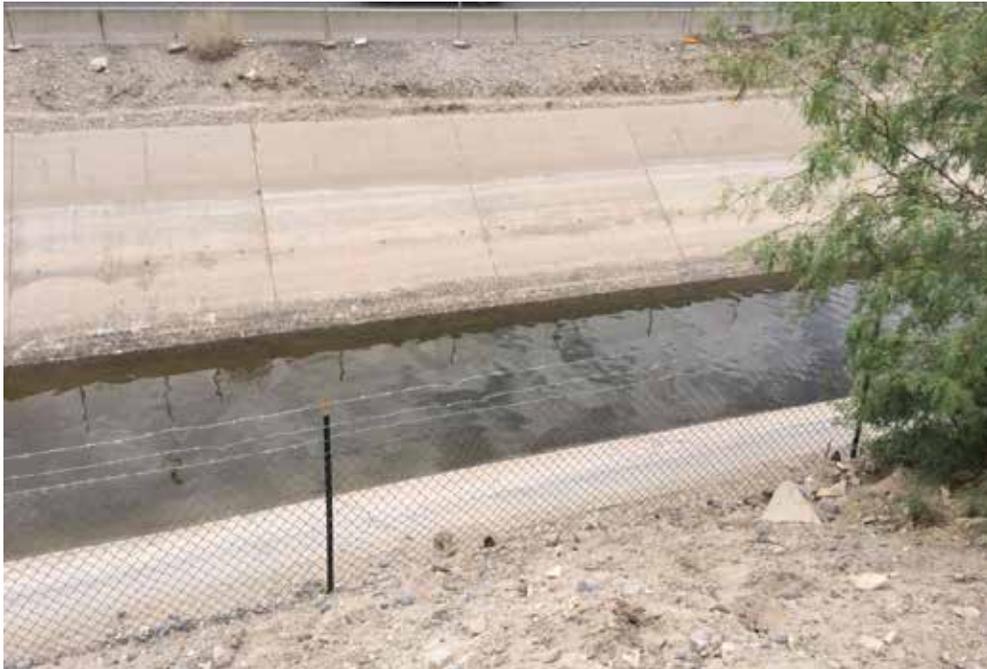
7-4) Repaired fence.
