FORMER EL PASO SMELTER SITE
EL PASO, TEXAS

**ANTIMONY DISTRIBUTION IN SOIL
EAST MOUNTAIN**

**FIGURE
4-2**

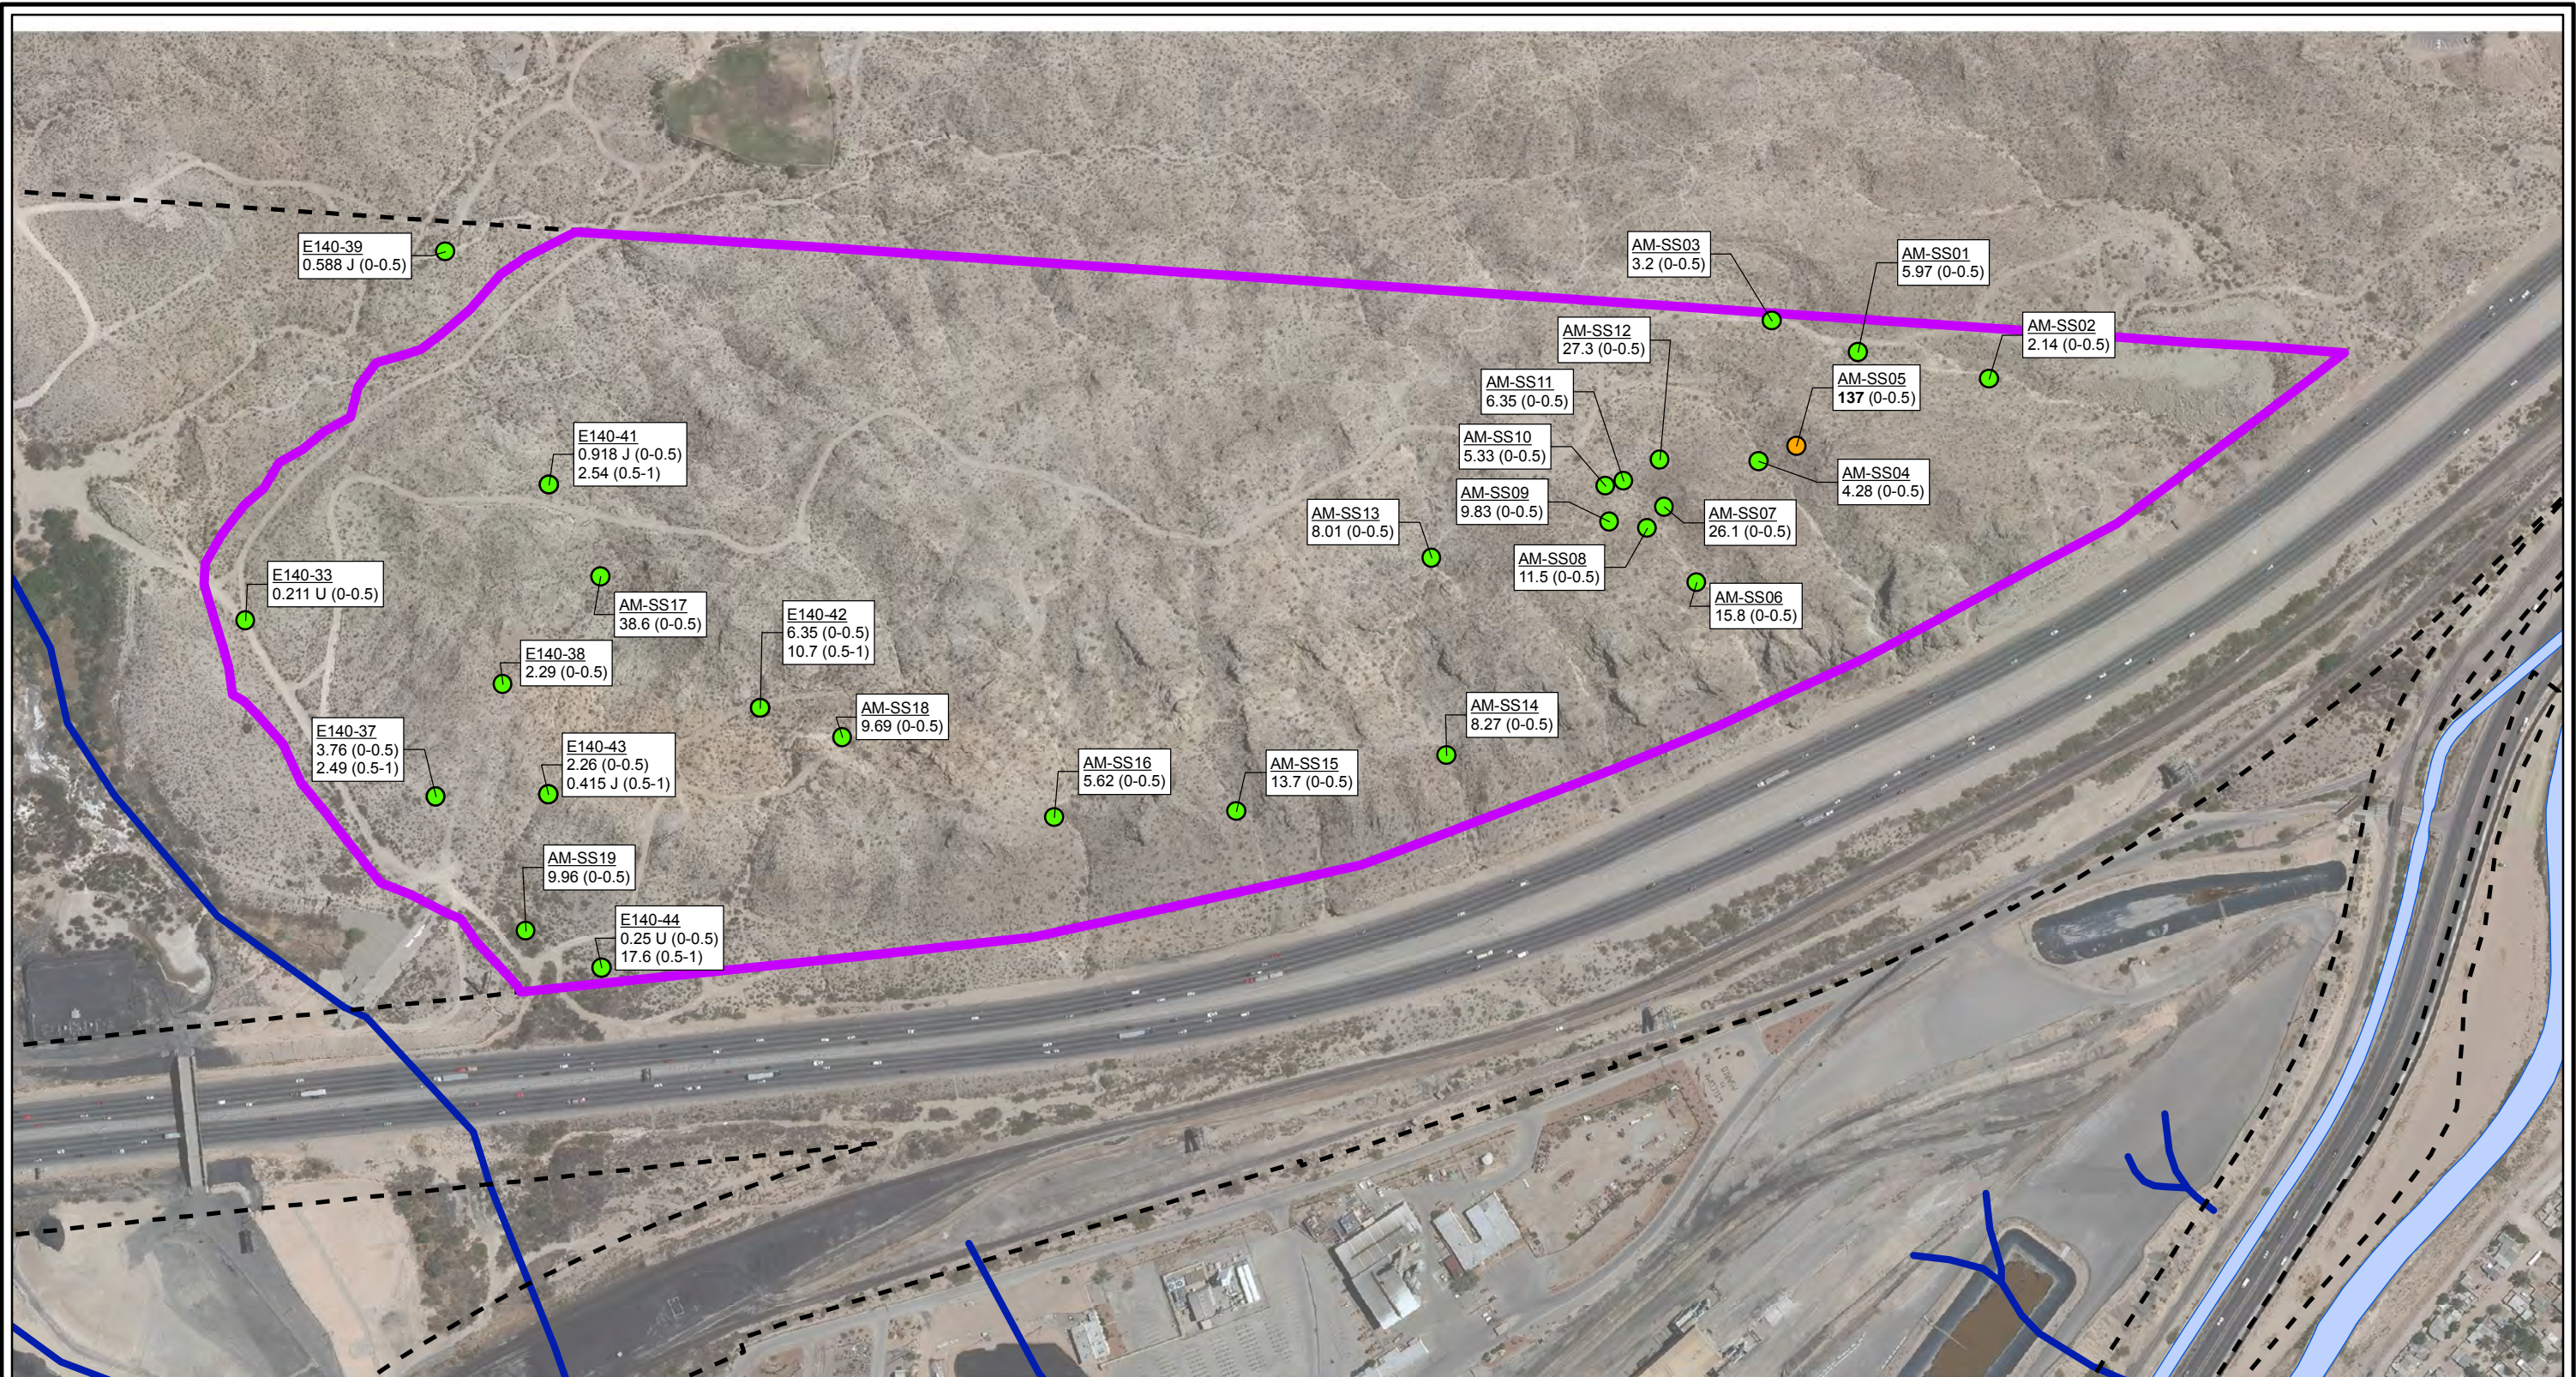
NOTE:
 Screening Level (RRR SAI-Res = 72 mg/kg)
Bolded Value exceeds screening level
Italics indicate below the water table
 J = Estimated Value
 U = Not detected at or above reporting limit
 Date of Aerial Photo: 2009
