FORMER EL PASO SMELTER SITE
EL PASO, TEXAS

**COPPER DISTRIBUTION IN SOIL
PARKER BROTHERS ARROYO/FINES PILE**

**FIGURE
4-23**

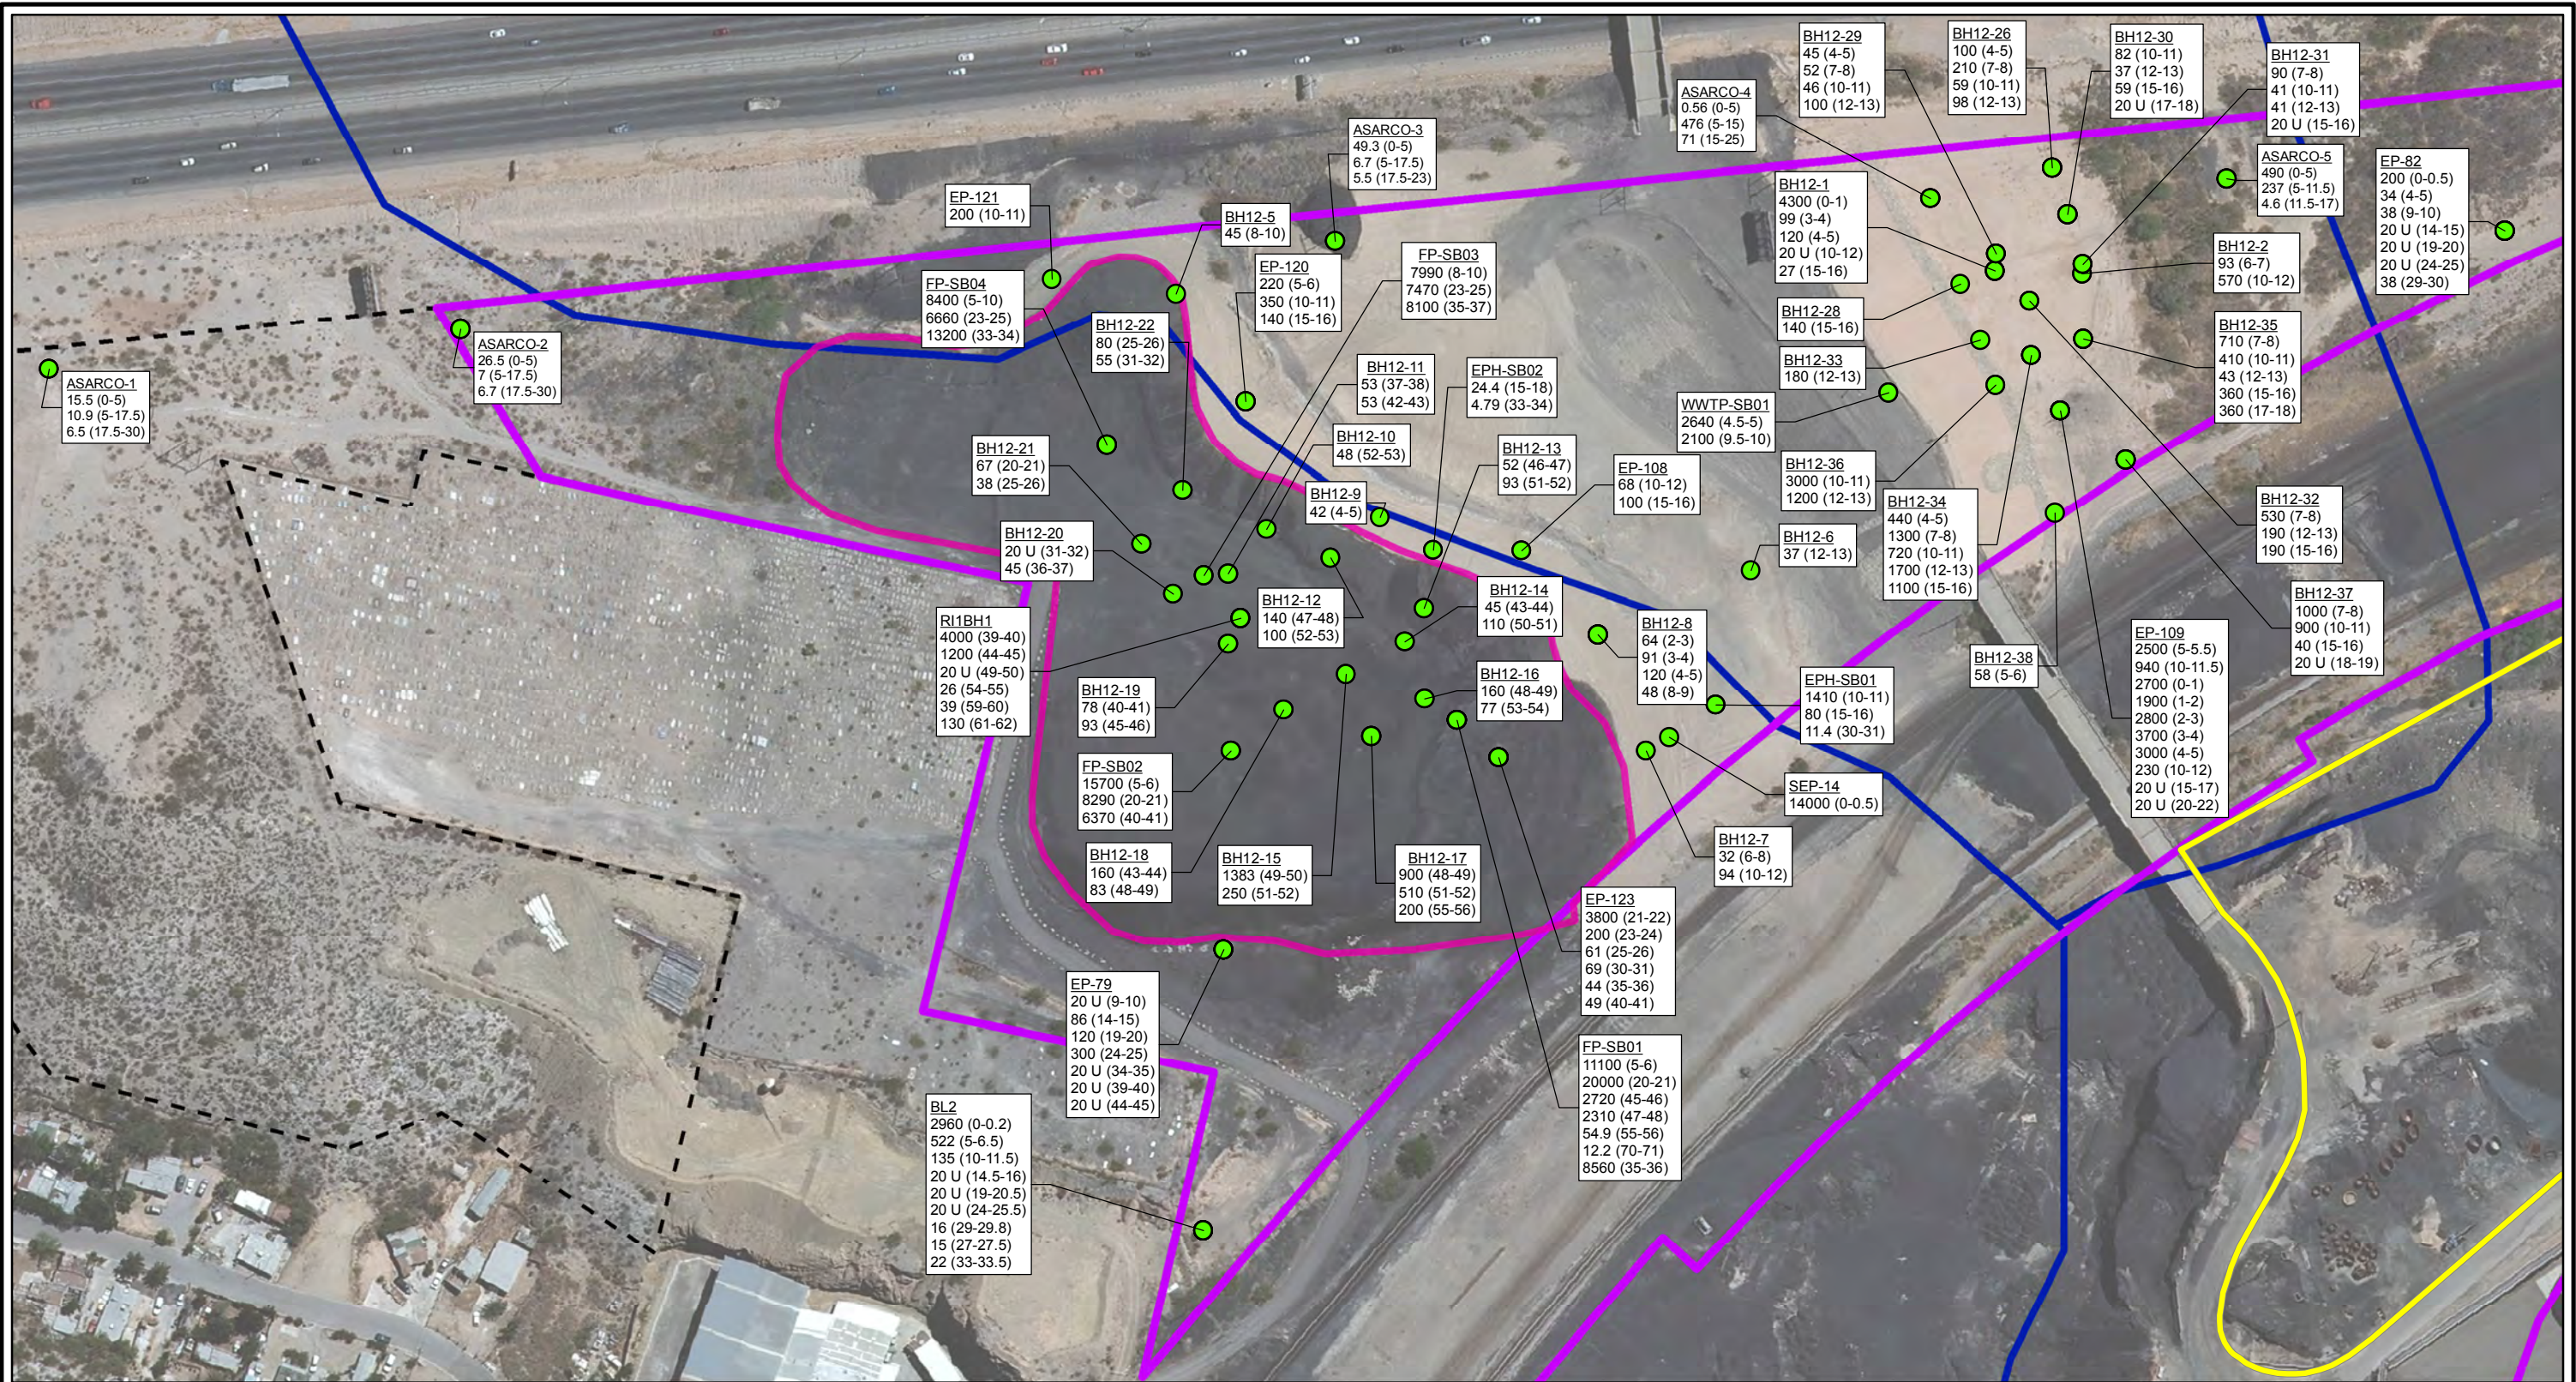
NOTE:
 Screening Level (RRR SAI-Ind = 74000 mg/kg)
Bolded Value exceeds screening level
Italics indicate below the water table
 J = Estimated Value
 U = Not detected at or above reporting limit
 Date of Aerial Photo: 2009
