FORMER EL PASO SMELTER SITE
EL PASO, TEXAS

**LEAD DISTRIBUTION IN SOIL
PARKER BROTHERS ARROYO/FINES PILE**

**FIGURE
4-25**

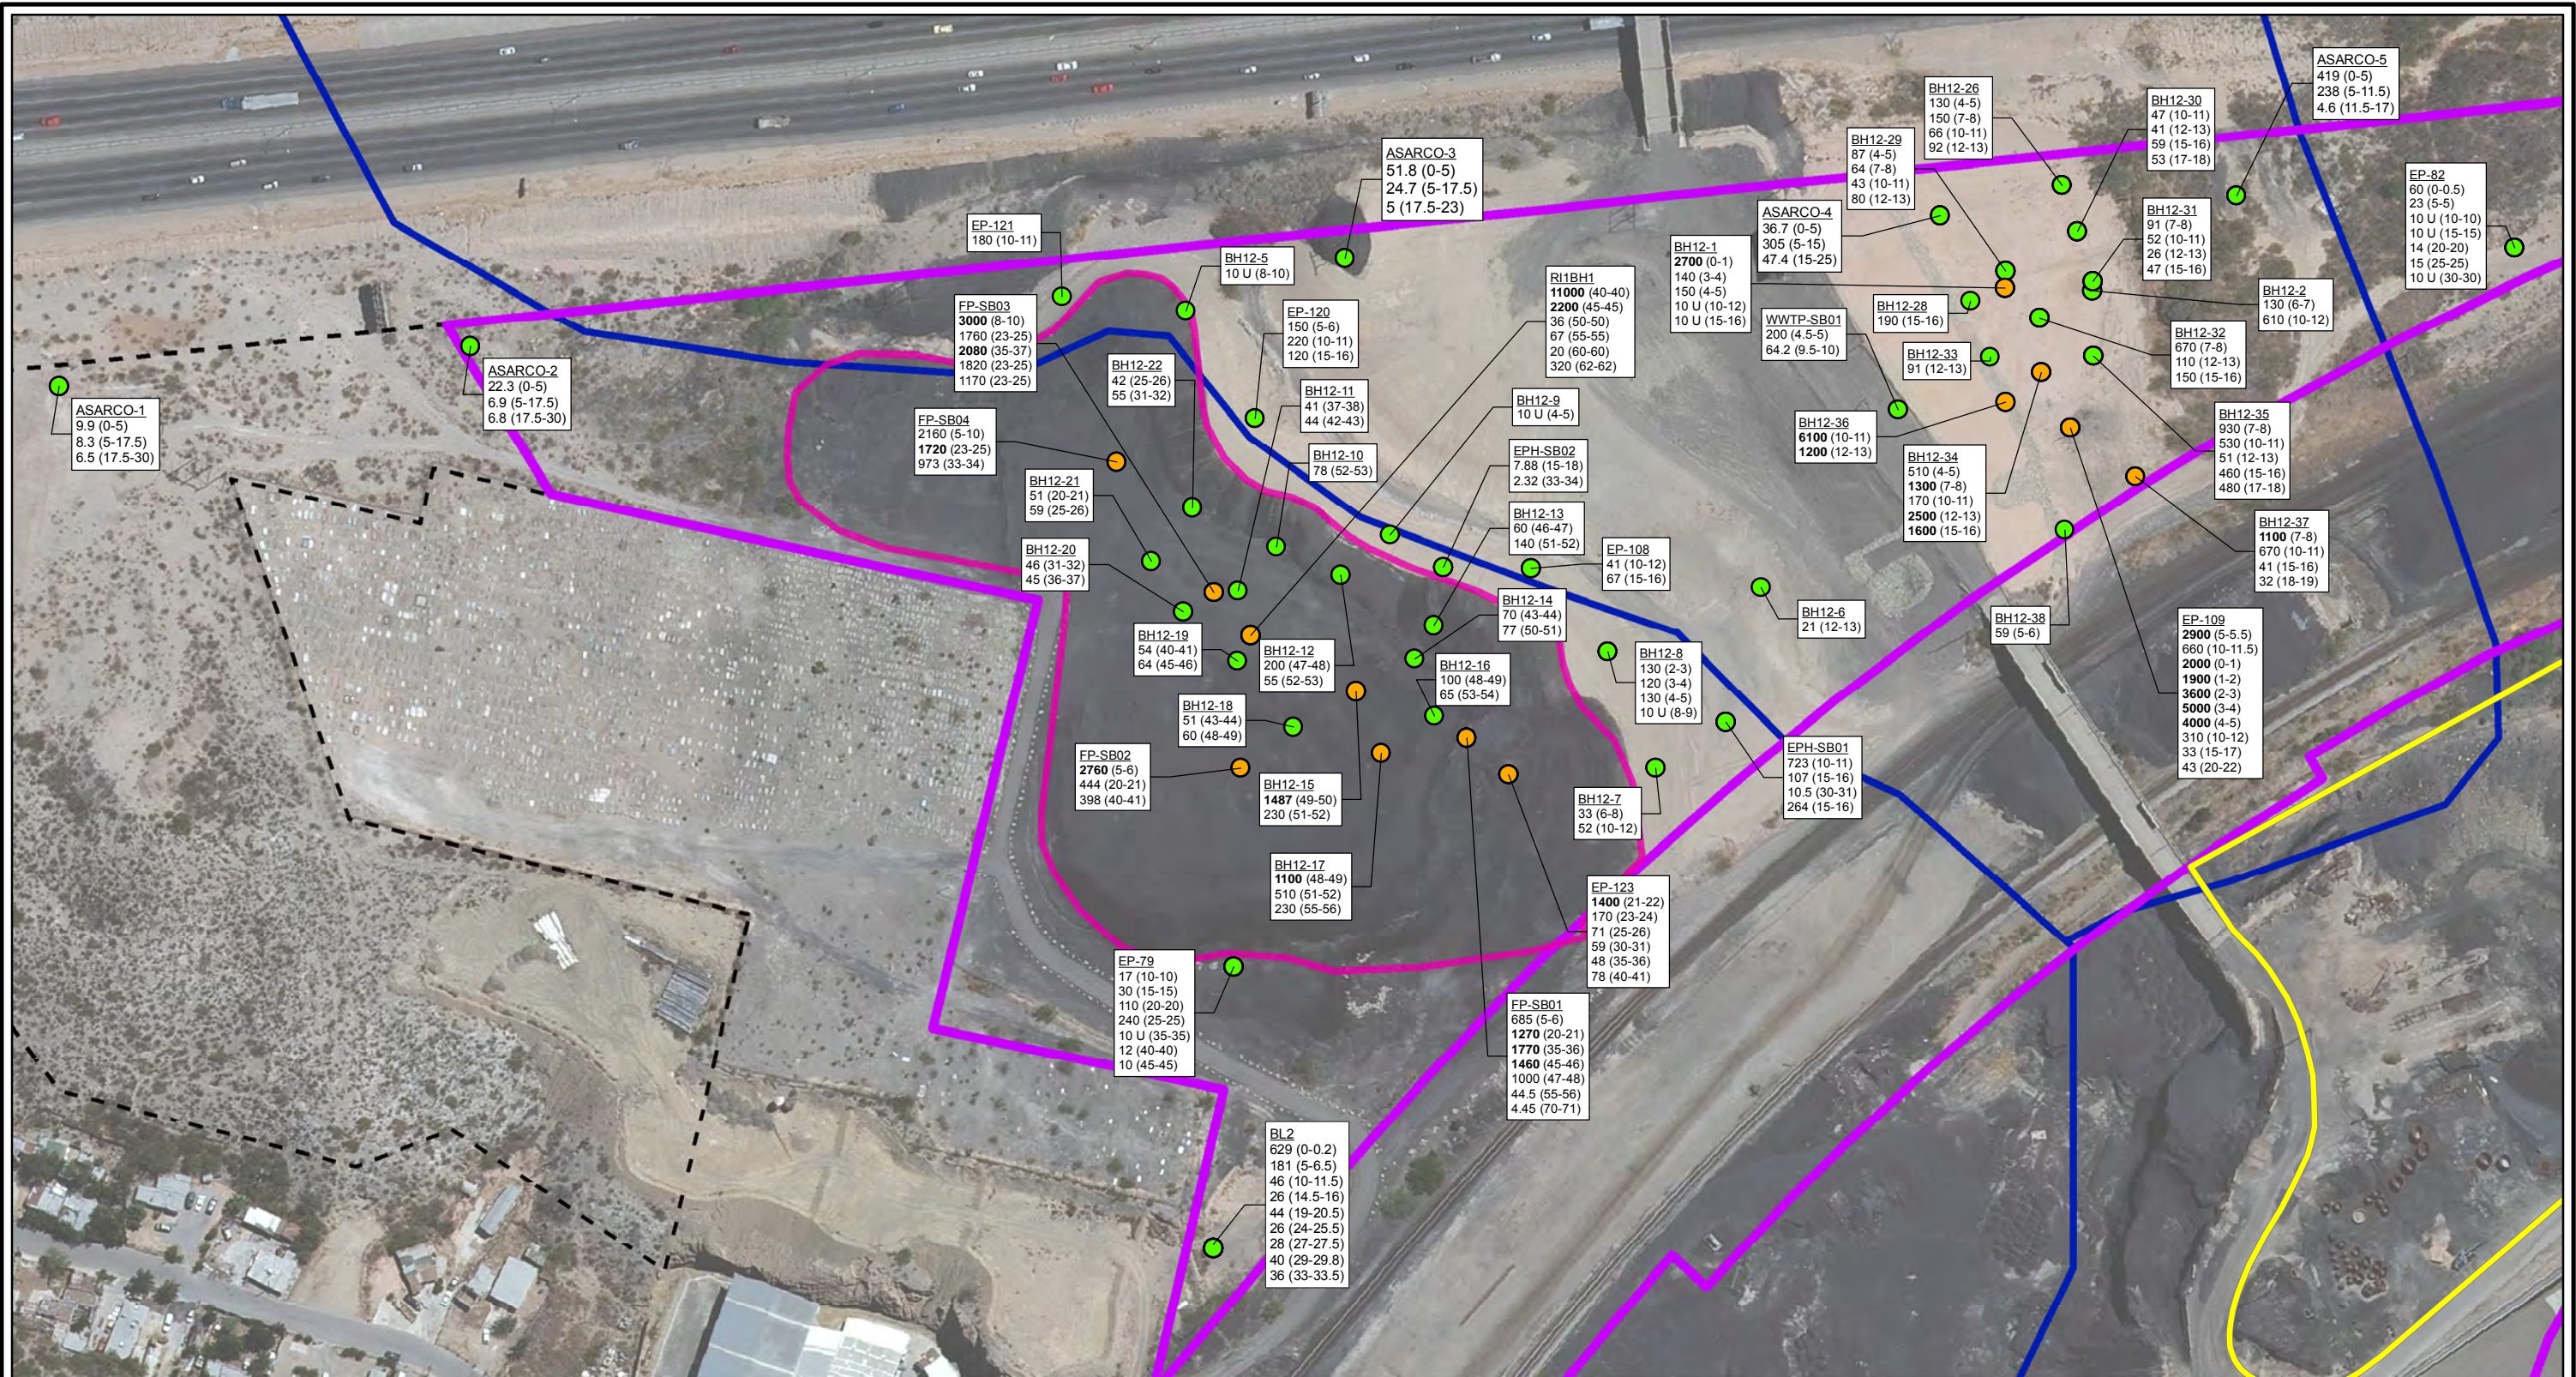
NOTE:
 Screening Level (RRR SAI-Ind = 1000 mg/kg)
