FORMER EL PASO SMELTER SITE
EL PASO, TEXAS

**ARSENIC DISTRIBUTION IN SOIL
SOUTH TERRACE ARROYO**

**FIGURE
4-30**

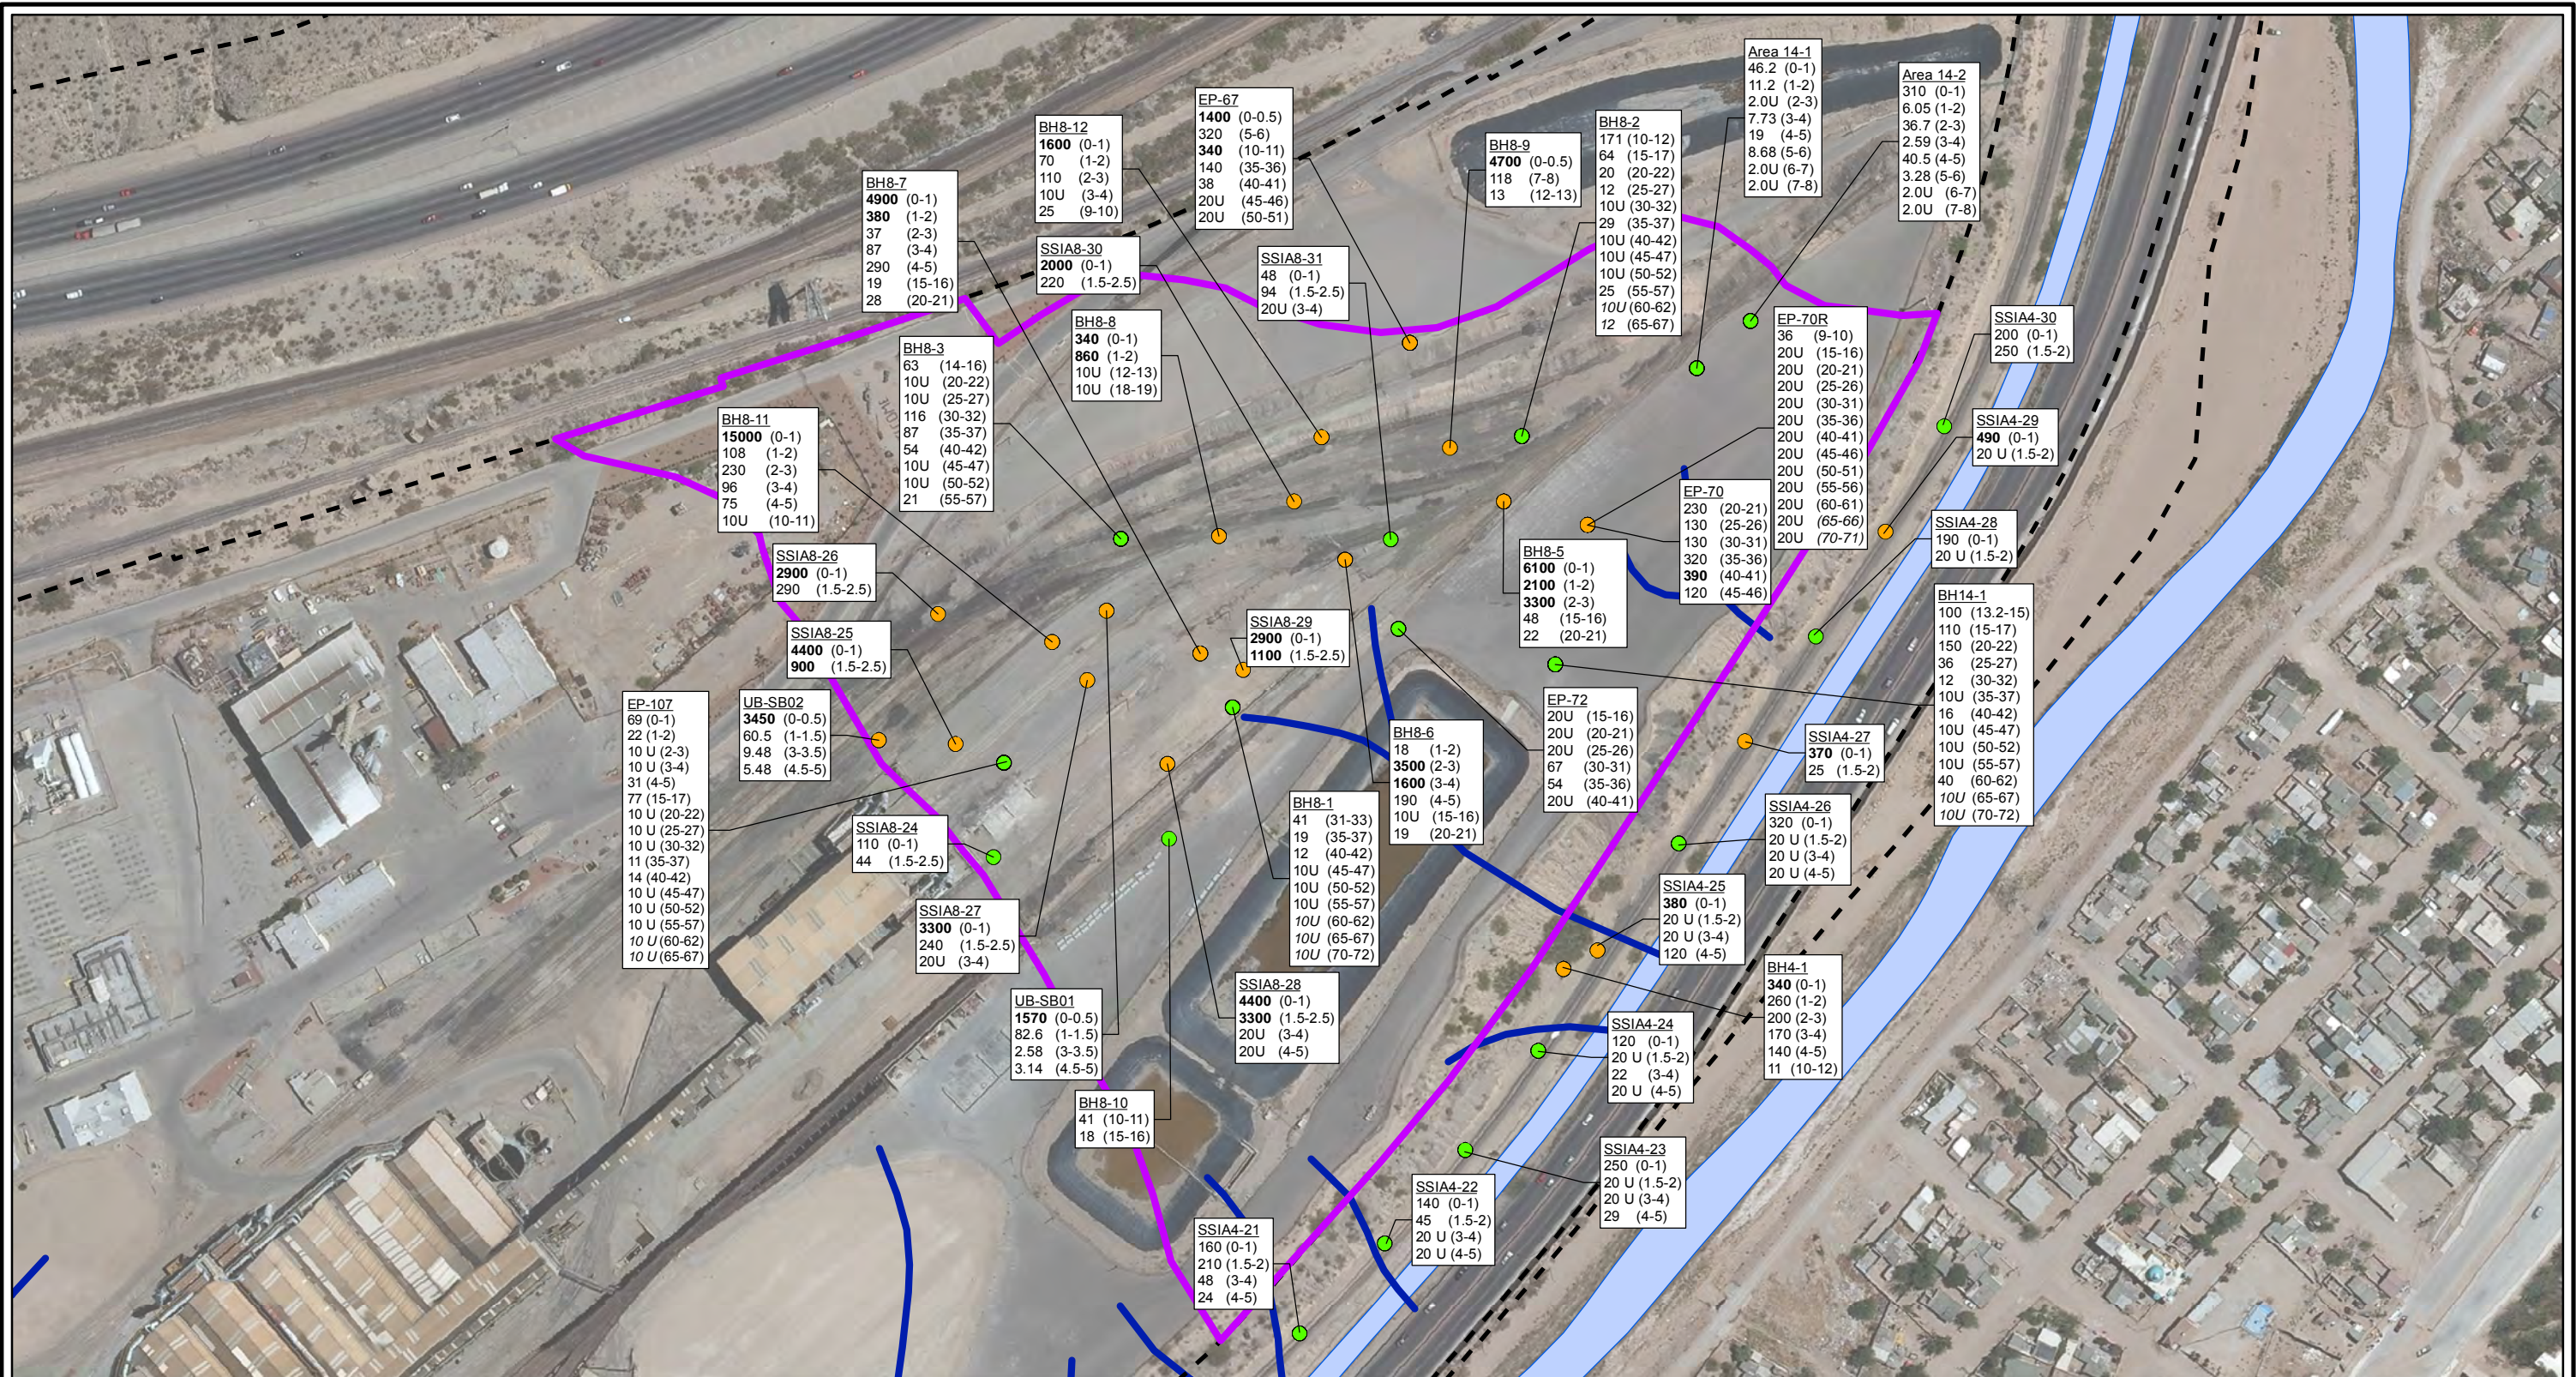
NOTE:
 Screening Level (RRR SAI-Ind = 320 mg/kg)
Bolded Value exceeds screening level
Italics indicate below the water table
 J = Estimated Value
 U = Not detected at or above reporting limit
