FORMER EL PASO SMELTER SITE
EL PASO, TEXAS

**COPPER DISTRIBUTION IN SOIL
SOUTH TERRACE ARROYO**

**FIGURE
4-32**

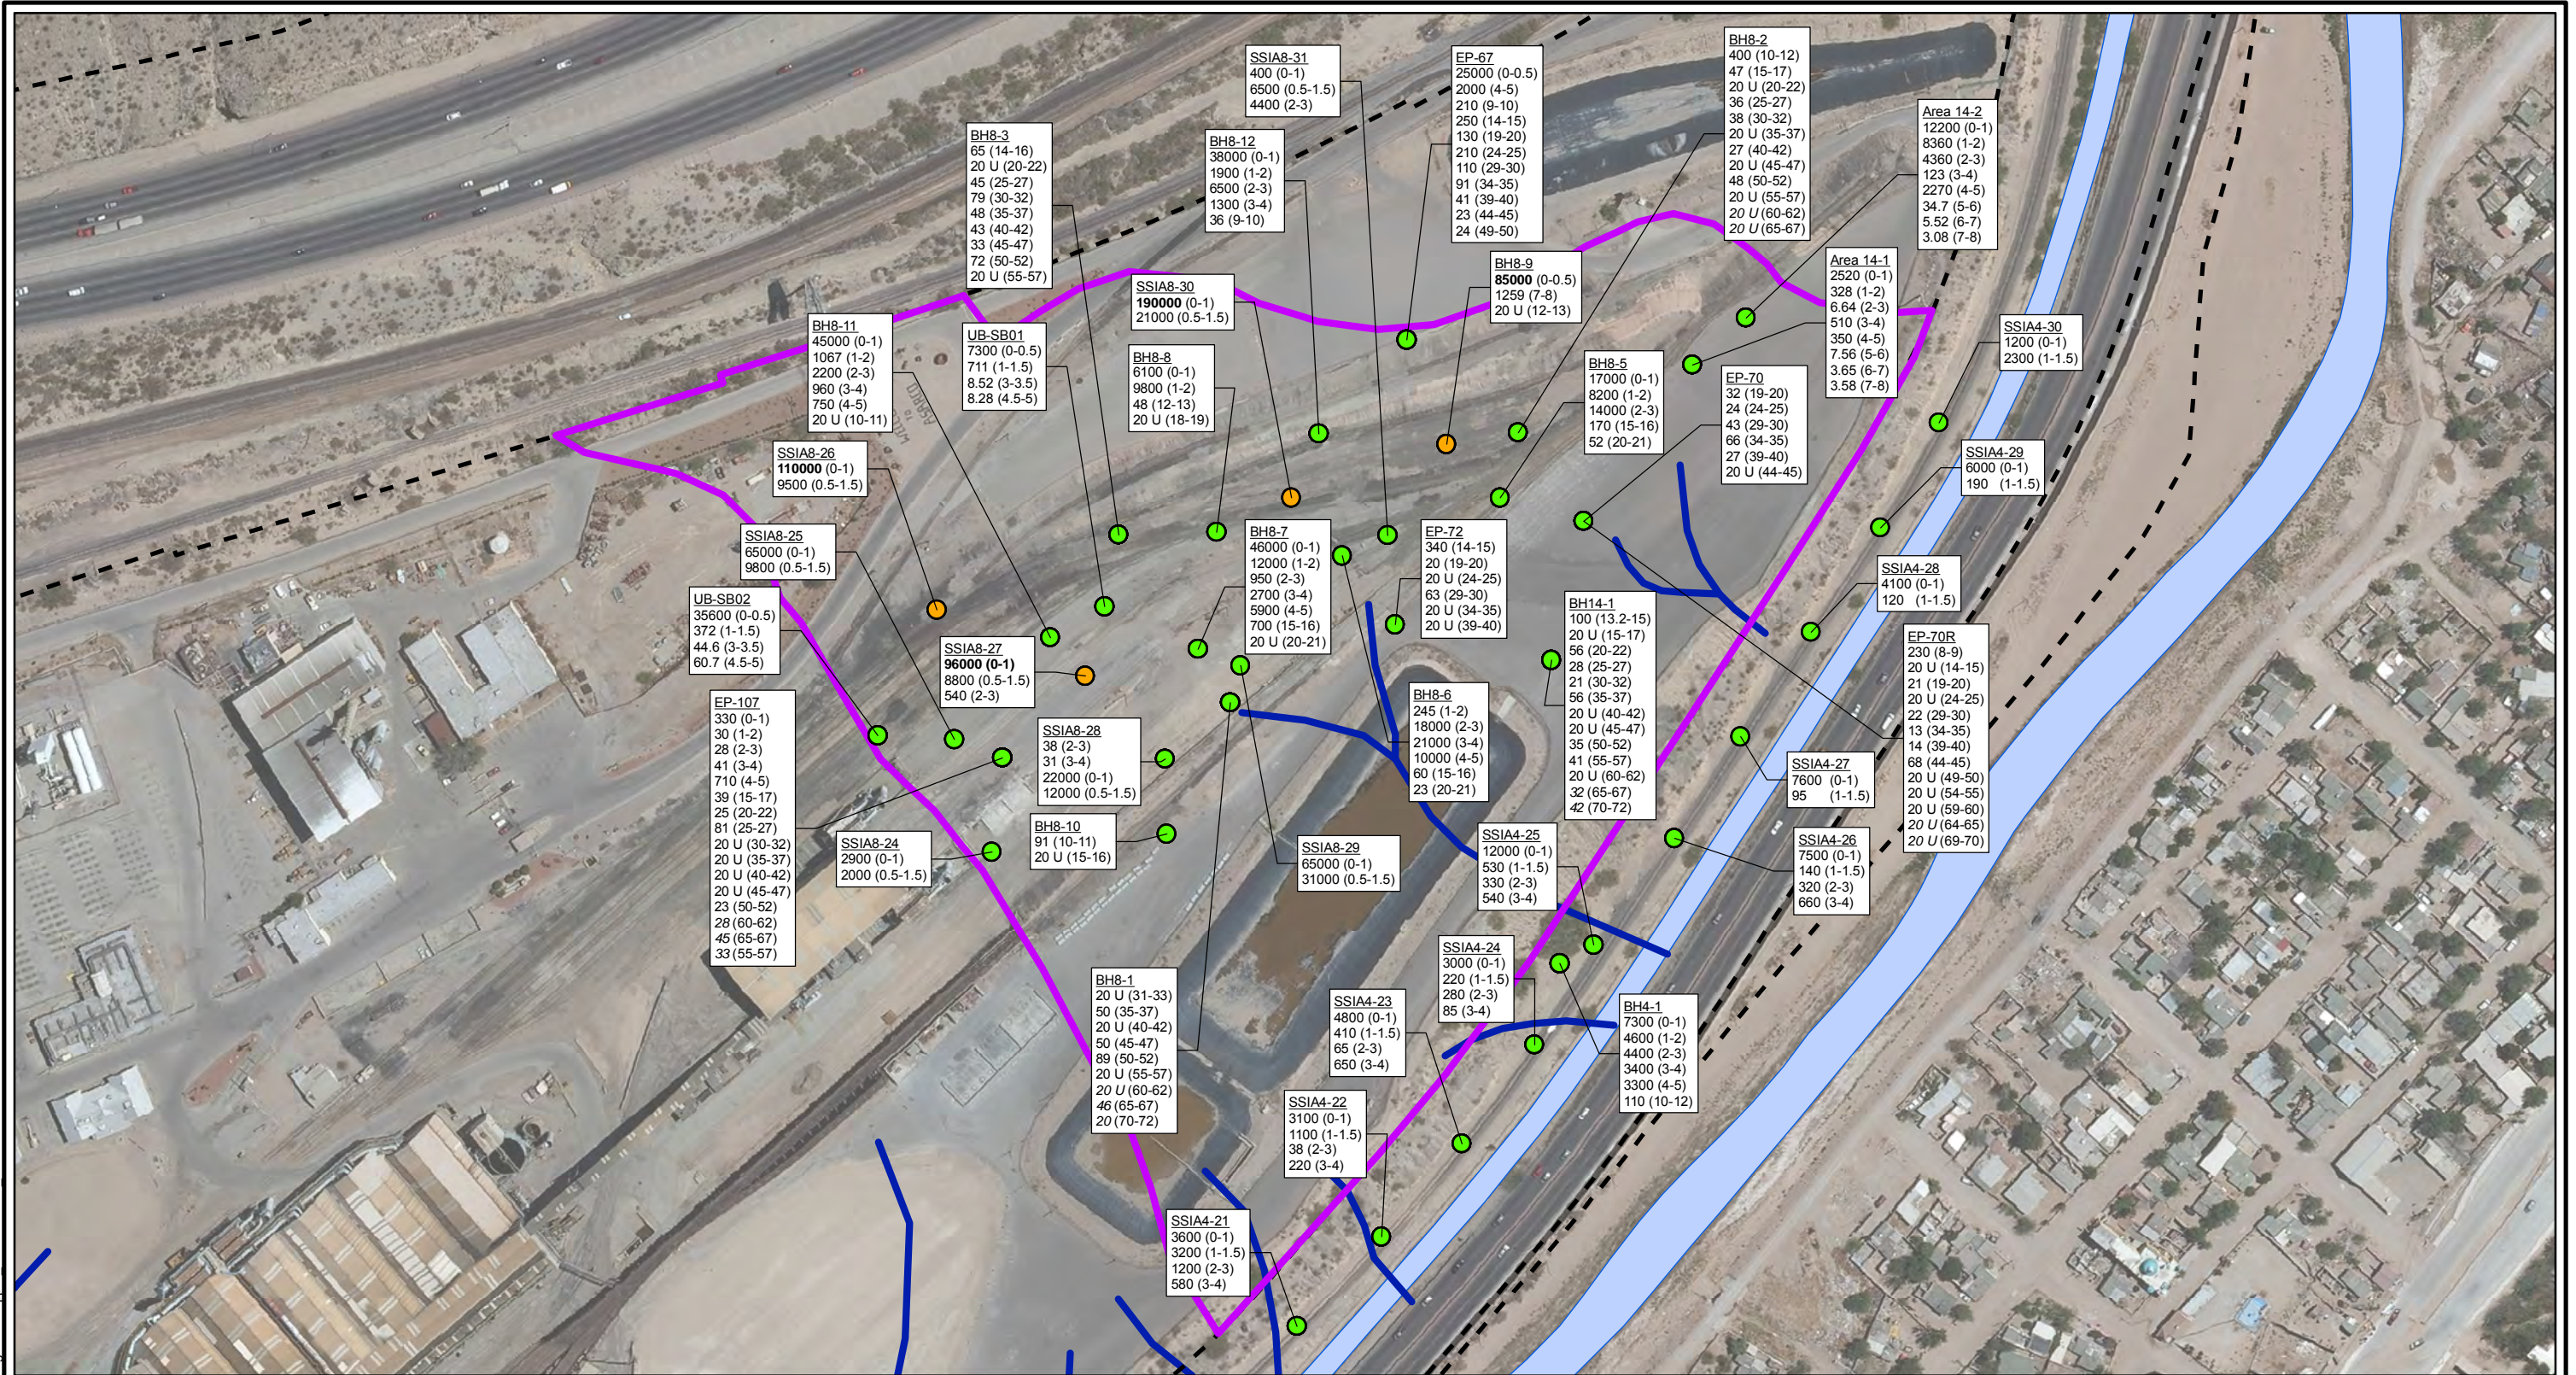
NOTE:
 Screening Level (RRR SAI-Ind = 74000 mg/kg)
Bolded Value exceeds screening level
Italics indicate below the water table
 J = Estimated Value
 U = Not detected at or above reporting limit
 Date of Aerial Photo: 2009
