FORMER EL PASO SMELTER SITE  
EL PASO, TEXAS

**MERCURY DISTRIBUTION IN SOIL  
POND 1 ARROYO**

**FIGURE  
4-38**

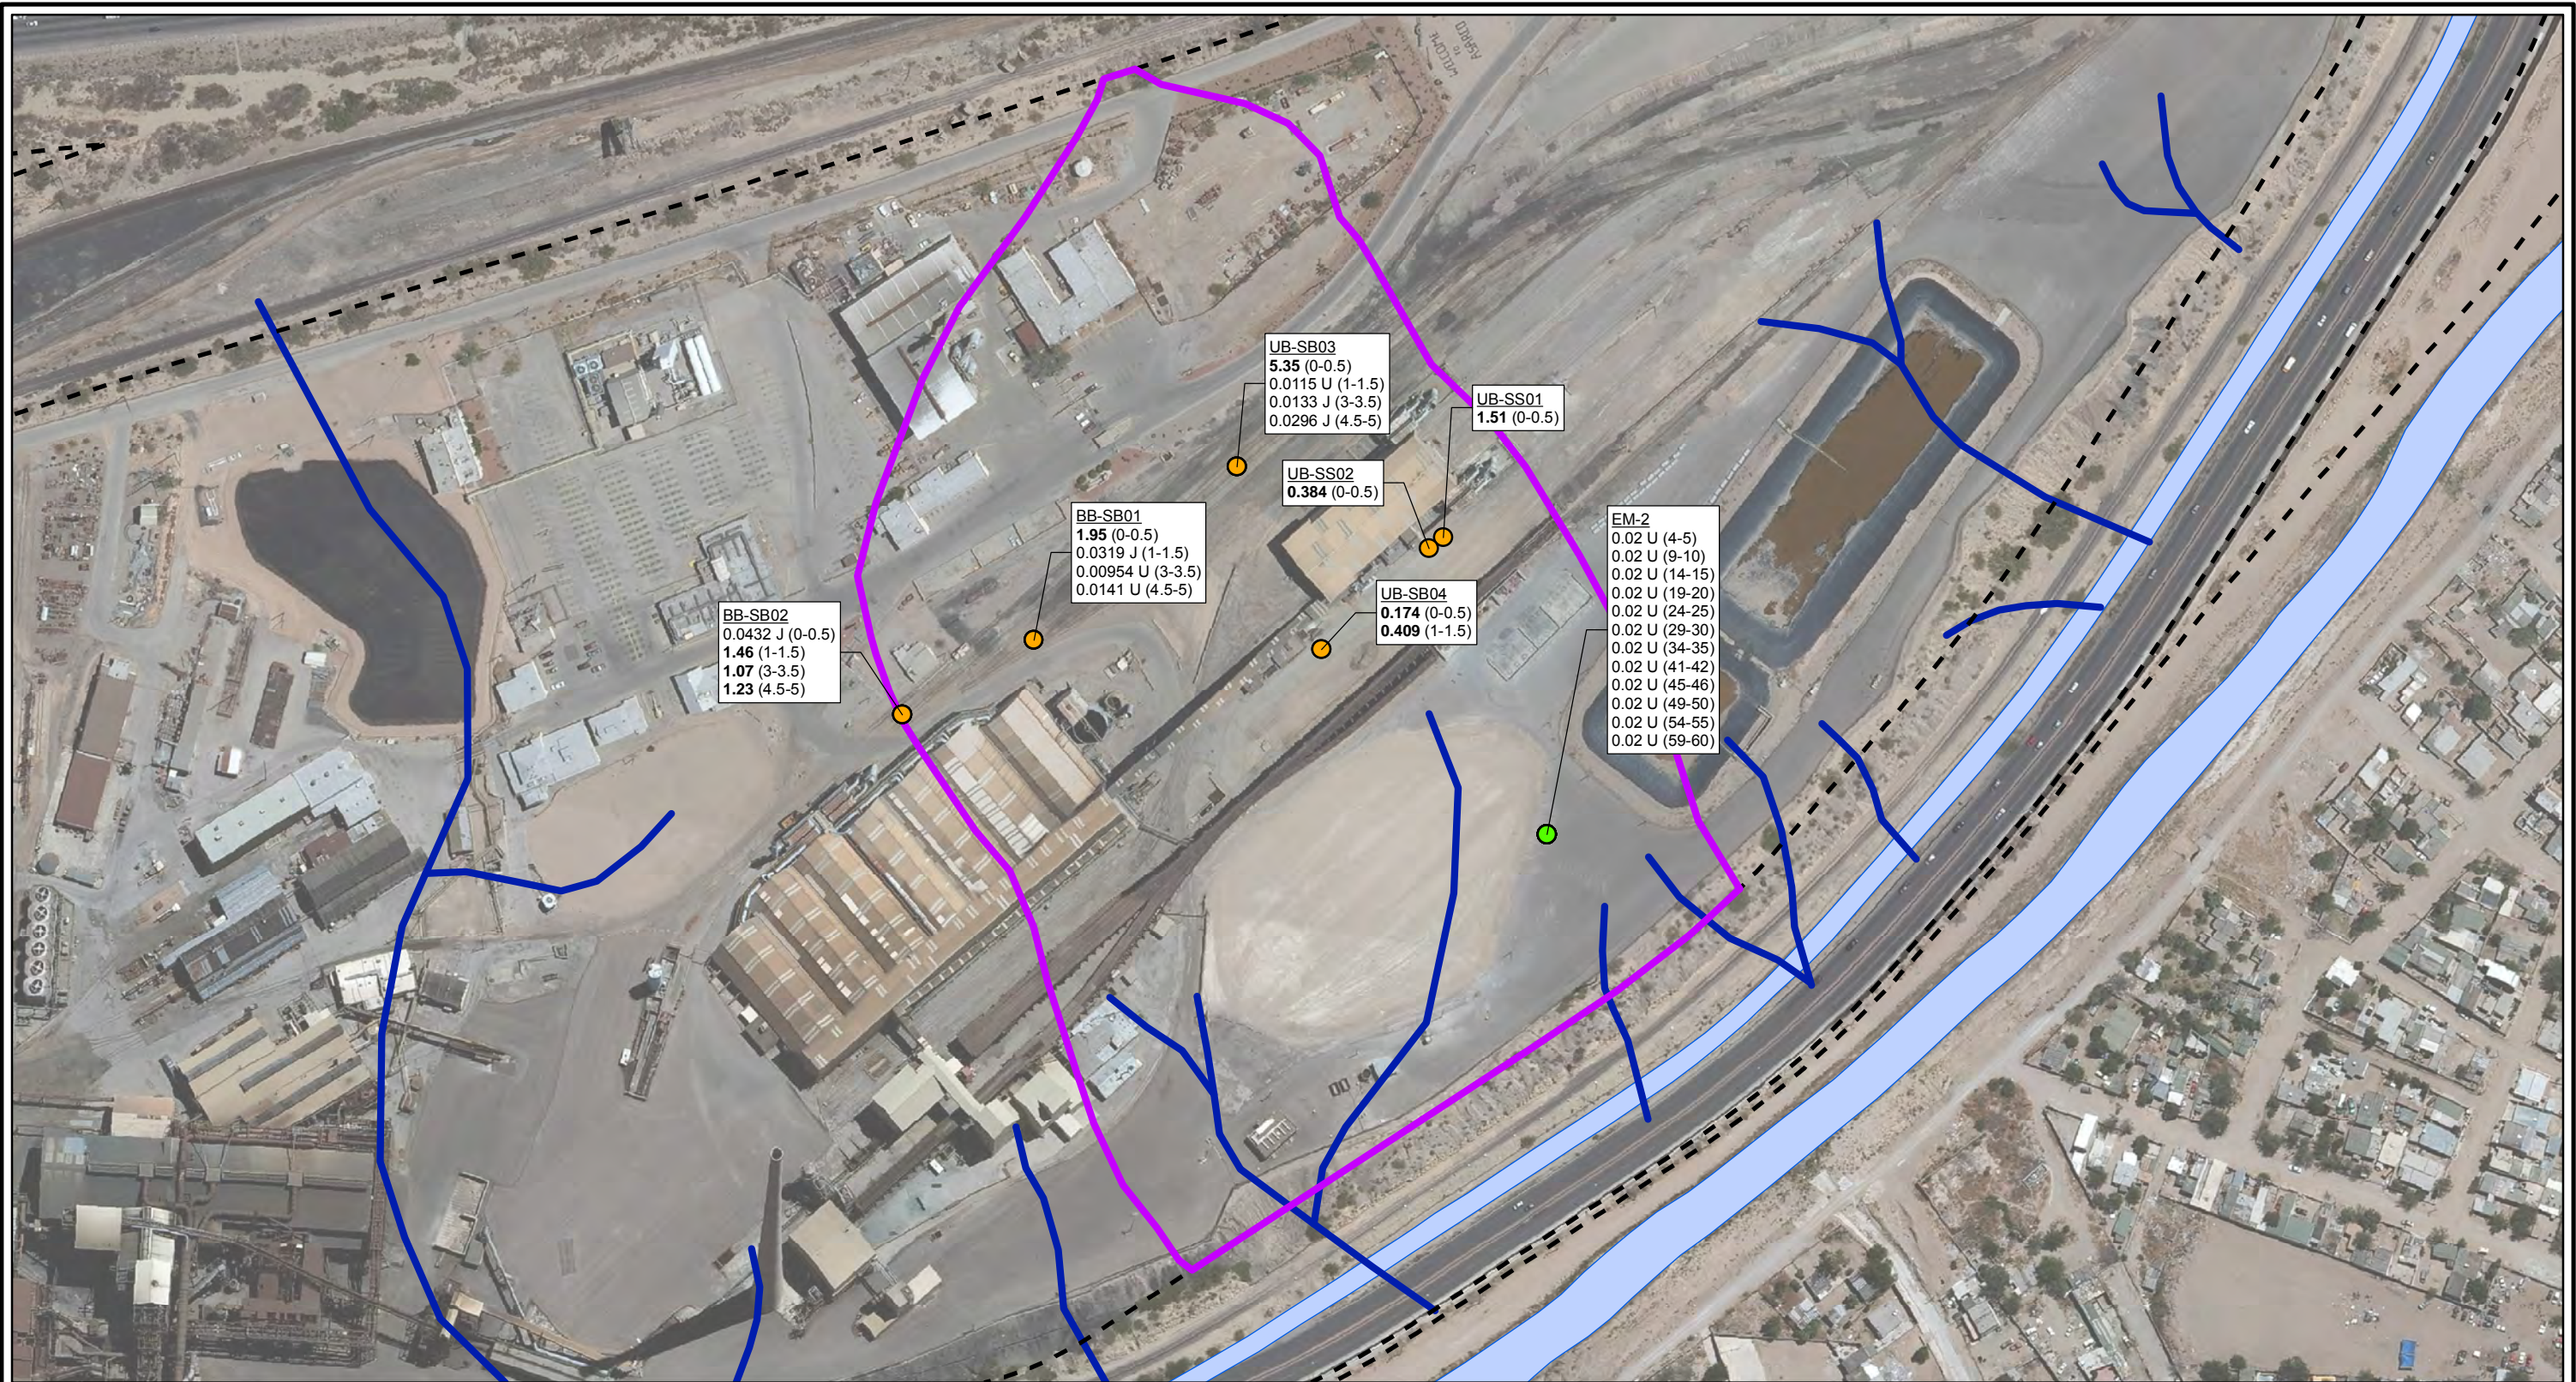
**NOTE:**  
 Screening Level (RRR SAI-Ind = 0.15 mg/kg)

**Bolded** Value exceeds screening level

*Italics* indicate below the water table
