FORMER EL PASO SMELTER SITE
 EL PASO, TEXAS

**ARSENIC DISTRIBUTION IN SOIL
 POND 5,6 ARROYO**

**FIGURE
 4-40**

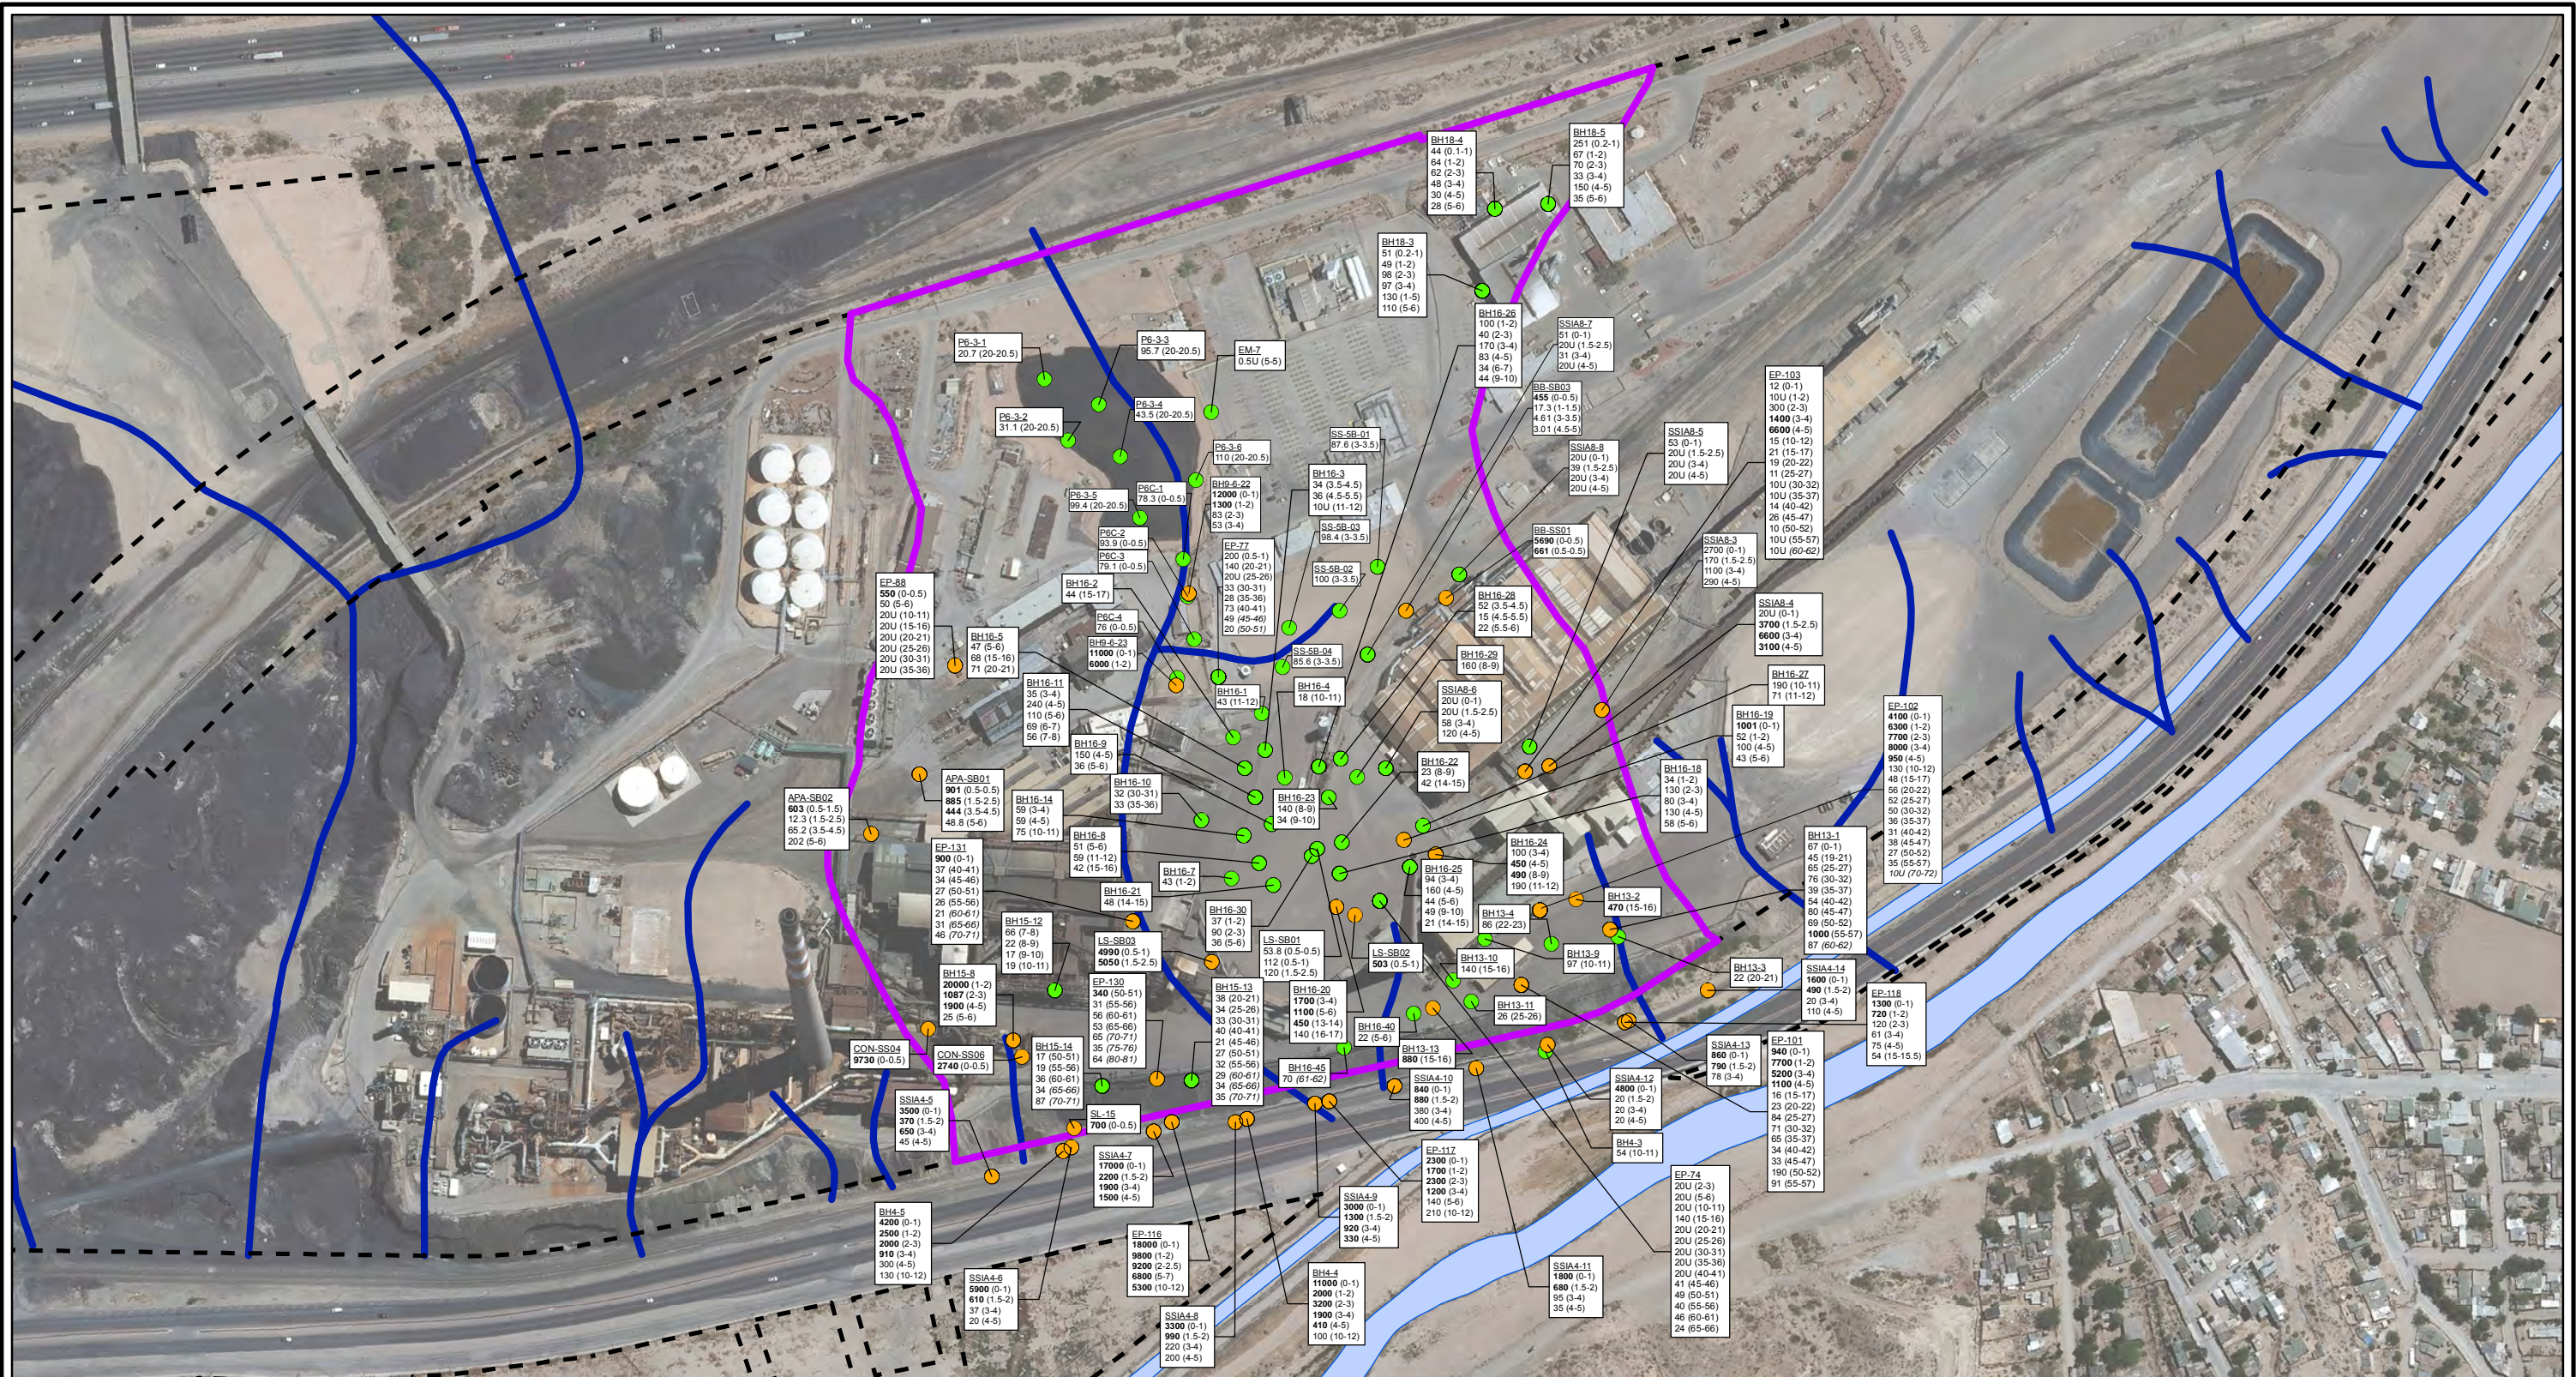
NOTE:
 Screening Level (RRR SAI-Ind = 320 mg/kg)
Bolded Value exceeds screening level
Italics indicate below the water table
 J = Estimated Value
 U = Not detected at or above reporting limit
 Date of Aerial Photo: 2009

Sample ID
 BH16-7
 43 (1-2)
 Depth (ft bgs)
 Arsenic Concentration in mg/kg
