FORMER EL PASO SMELTER SITE  
 EL PASO, TEXAS

**LEAD DISTRIBUTION IN SOIL  
 POND 5,6 ARROYO**

**FIGURE  
 4-42**

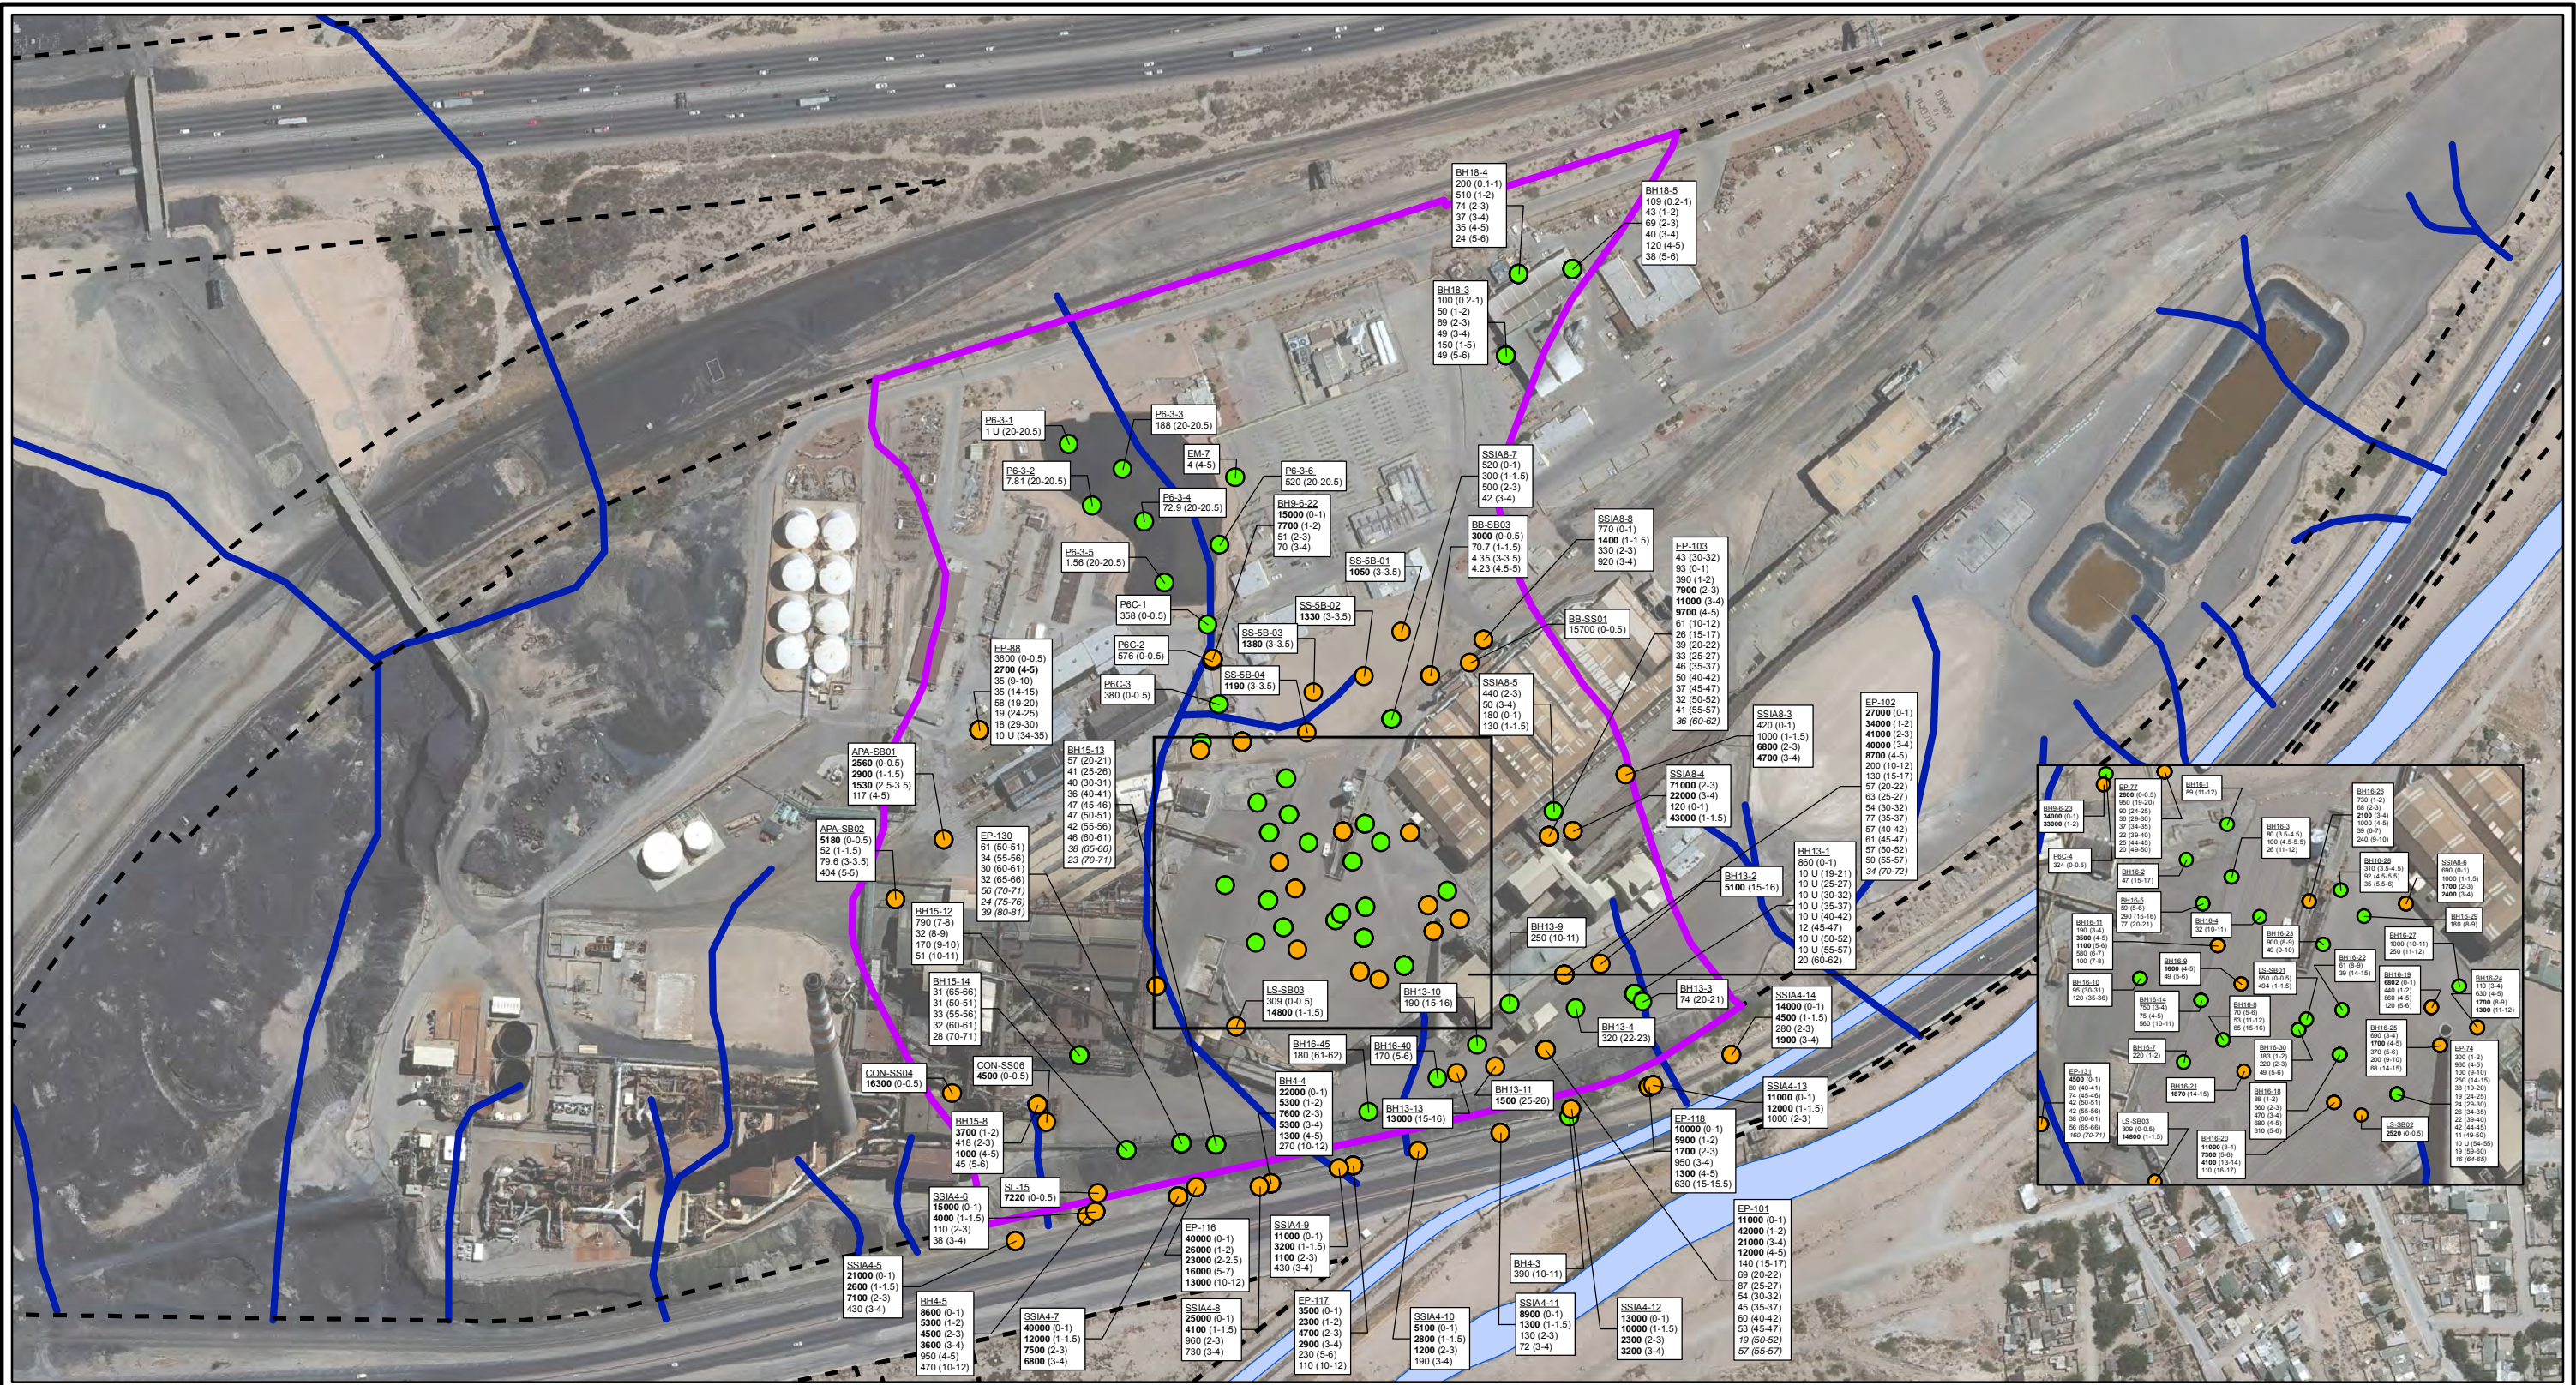
**NOTE:**  
 Screening Level (RRR SAI-Ind = 1000 mg/kg)  
**Bolded** Value exceeds screening level  
*Italics* indicate below the water table  
 J = Estimated Value  
 U = Not detected at or above reporting limit  
 Date of Aerial Photo: 2009
