FORMER EL PASO SMELTER SITE  
EL PASO, TEXAS

**ARSENIC DISTRIBUTION IN SOIL  
FLOODPLAIN**

**FIGURE  
4-54**

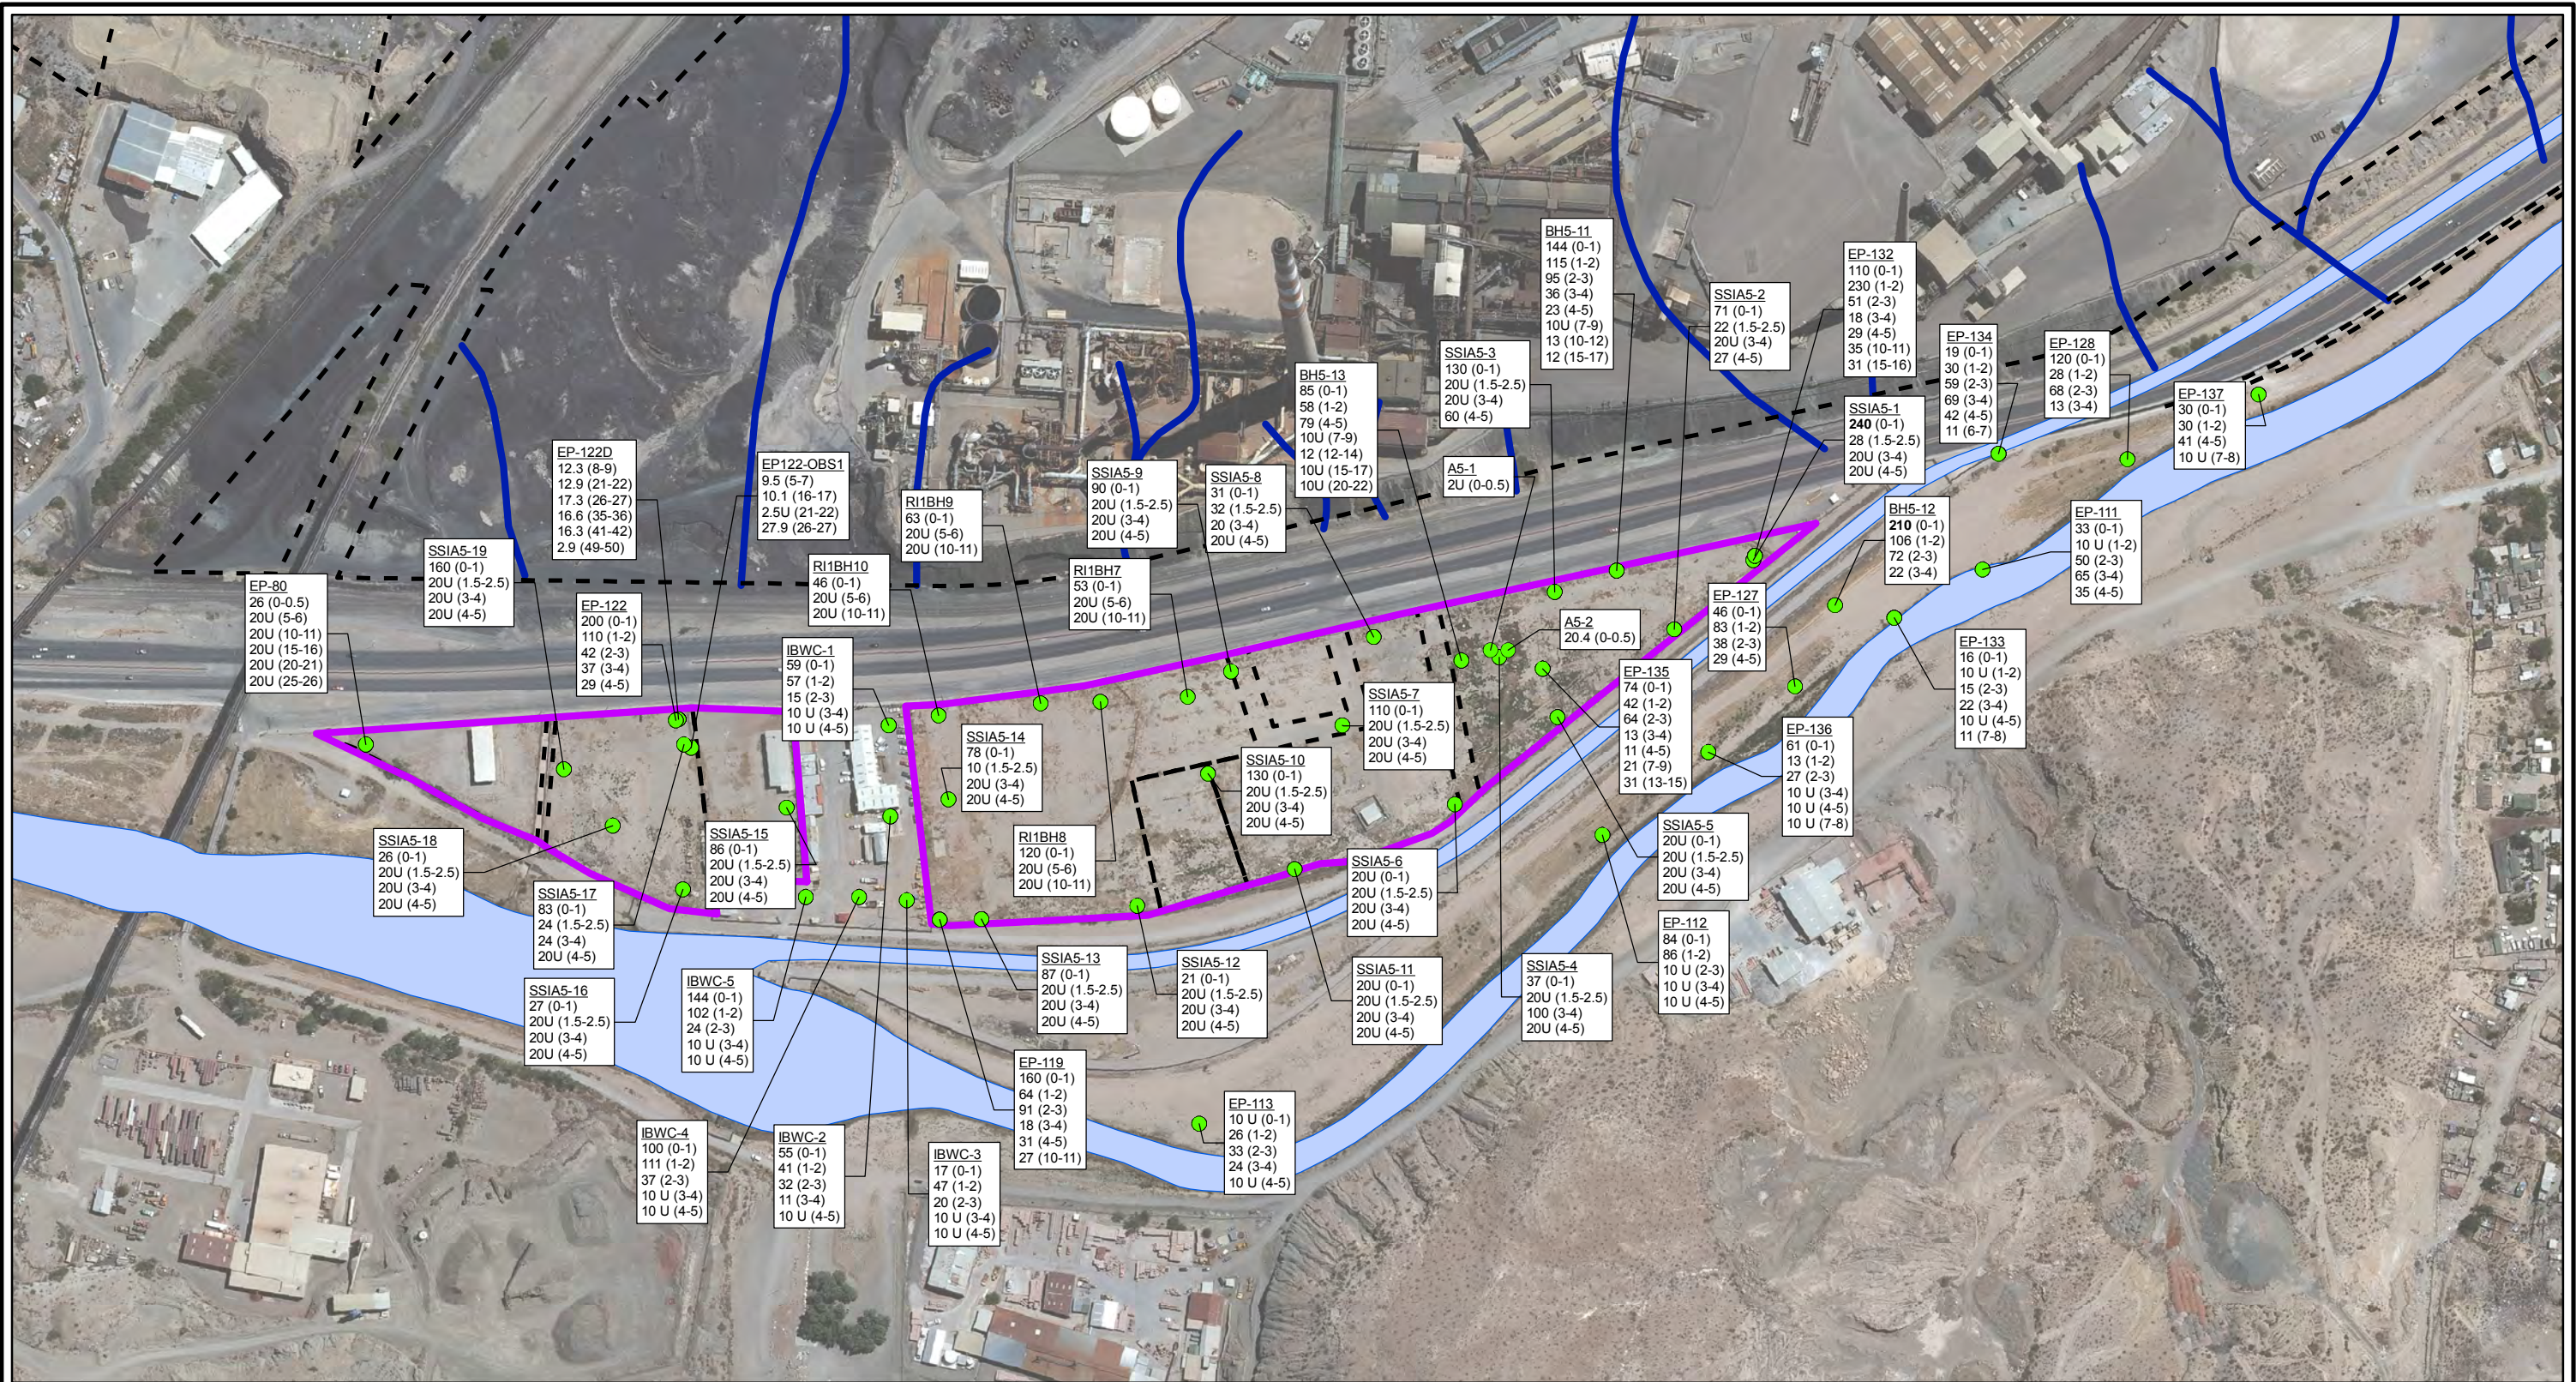
**NOTE:**  
 Screening Level (RRR SAI-Ind = 320 mg/kg)  
**Bolded** Value exceeds screening level  
*Italics* indicate below the water table  
 J = Estimated Value  
 U = Not detected at or above reporting limit  
 Date of Aerial Photo: 2009
