FORMER EL PASO SMELTER SITE
EL PASO, TEXAS

**CADMIUM DISTRIBUTION IN SOIL
EAST PROPERTY**

**FIGURE
4-10**

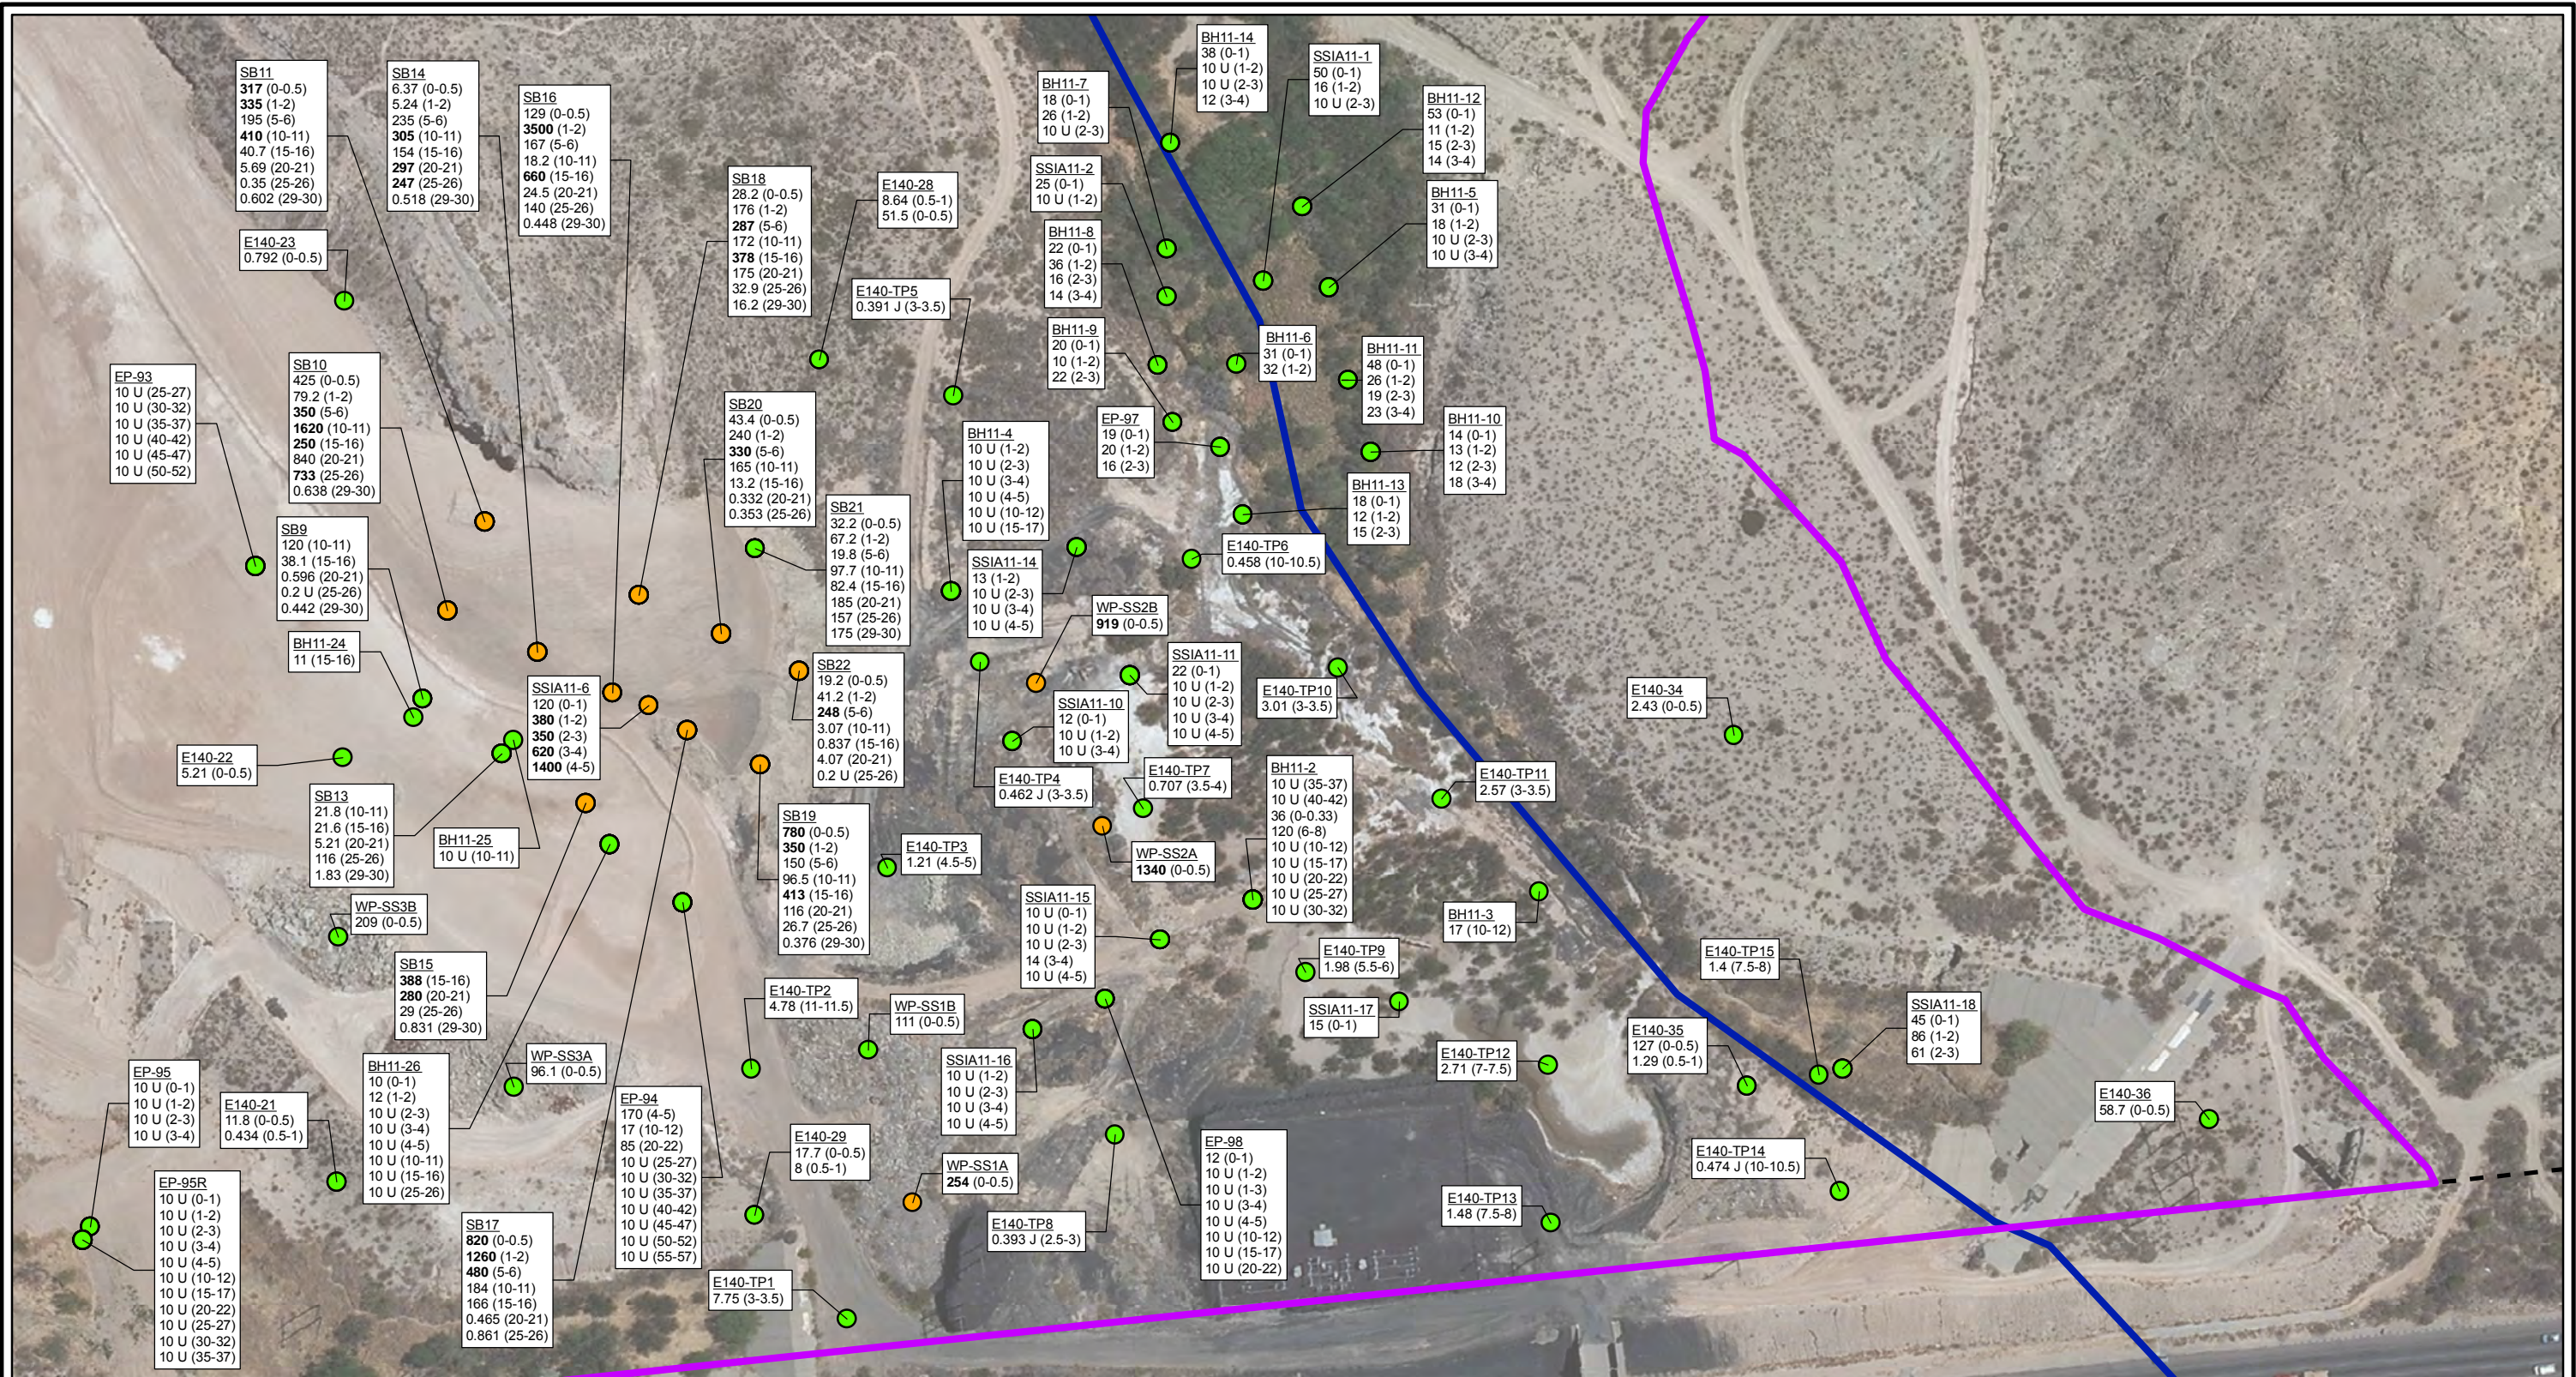
NOTE:
 Screening Level (RRR SAI-Res = 240 mg/kg)
Bolded Value exceeds screening level
Italics indicate below the water table
 J = Estimated Value
 U = Not detected at or above reporting limit
 Date of Aerial Photo: 2009
