FORMER EL PASO SMELTER SITE
EL PASO, TEXAS

**ARSENIC DISTRIBUTION IN SOIL
PLANT ENTRANCE**

**FIGURE
4-28**

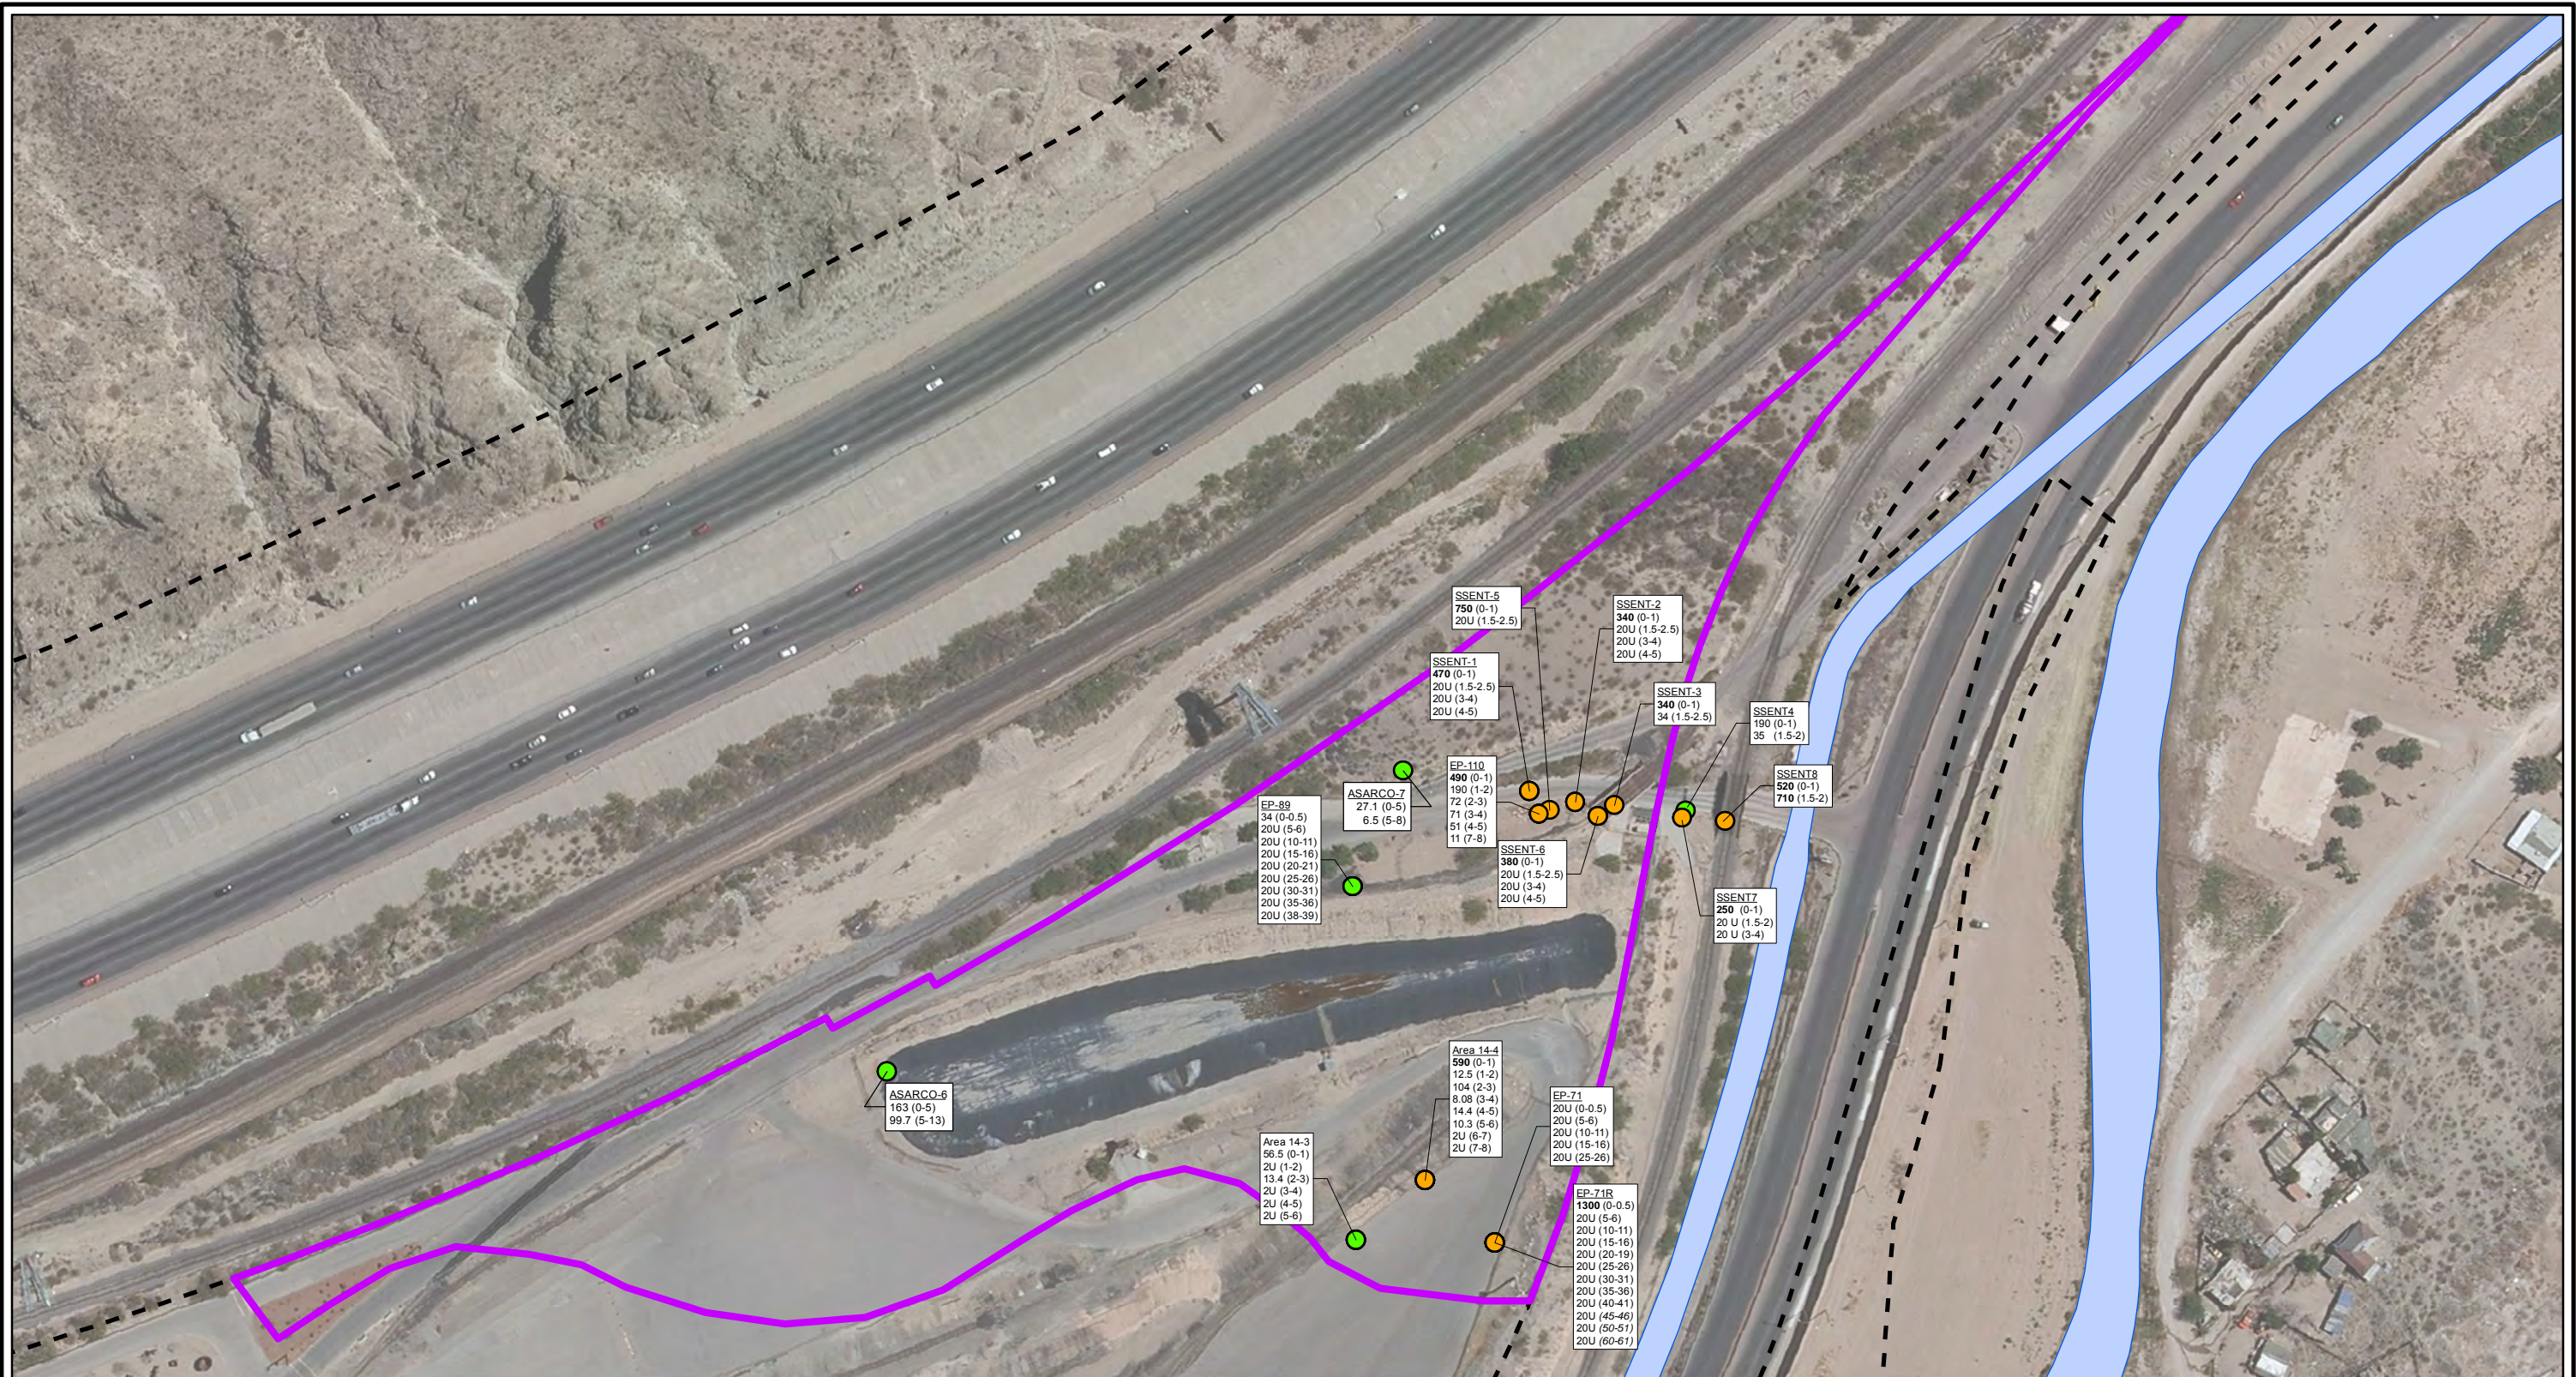
NOTE:
 Screening Level (RRR SAI-Ind = 200 mg/kg)

Bolded Value exceeds screening level

Italics indicate below the water table
