FORMER EL PASO SMELTER SITE  
EL PASO, TEXAS

**CADMIUM DISTRIBUTION IN SOIL  
SOUTH TERRACE ARROYO**

**FIGURE  
4-31**

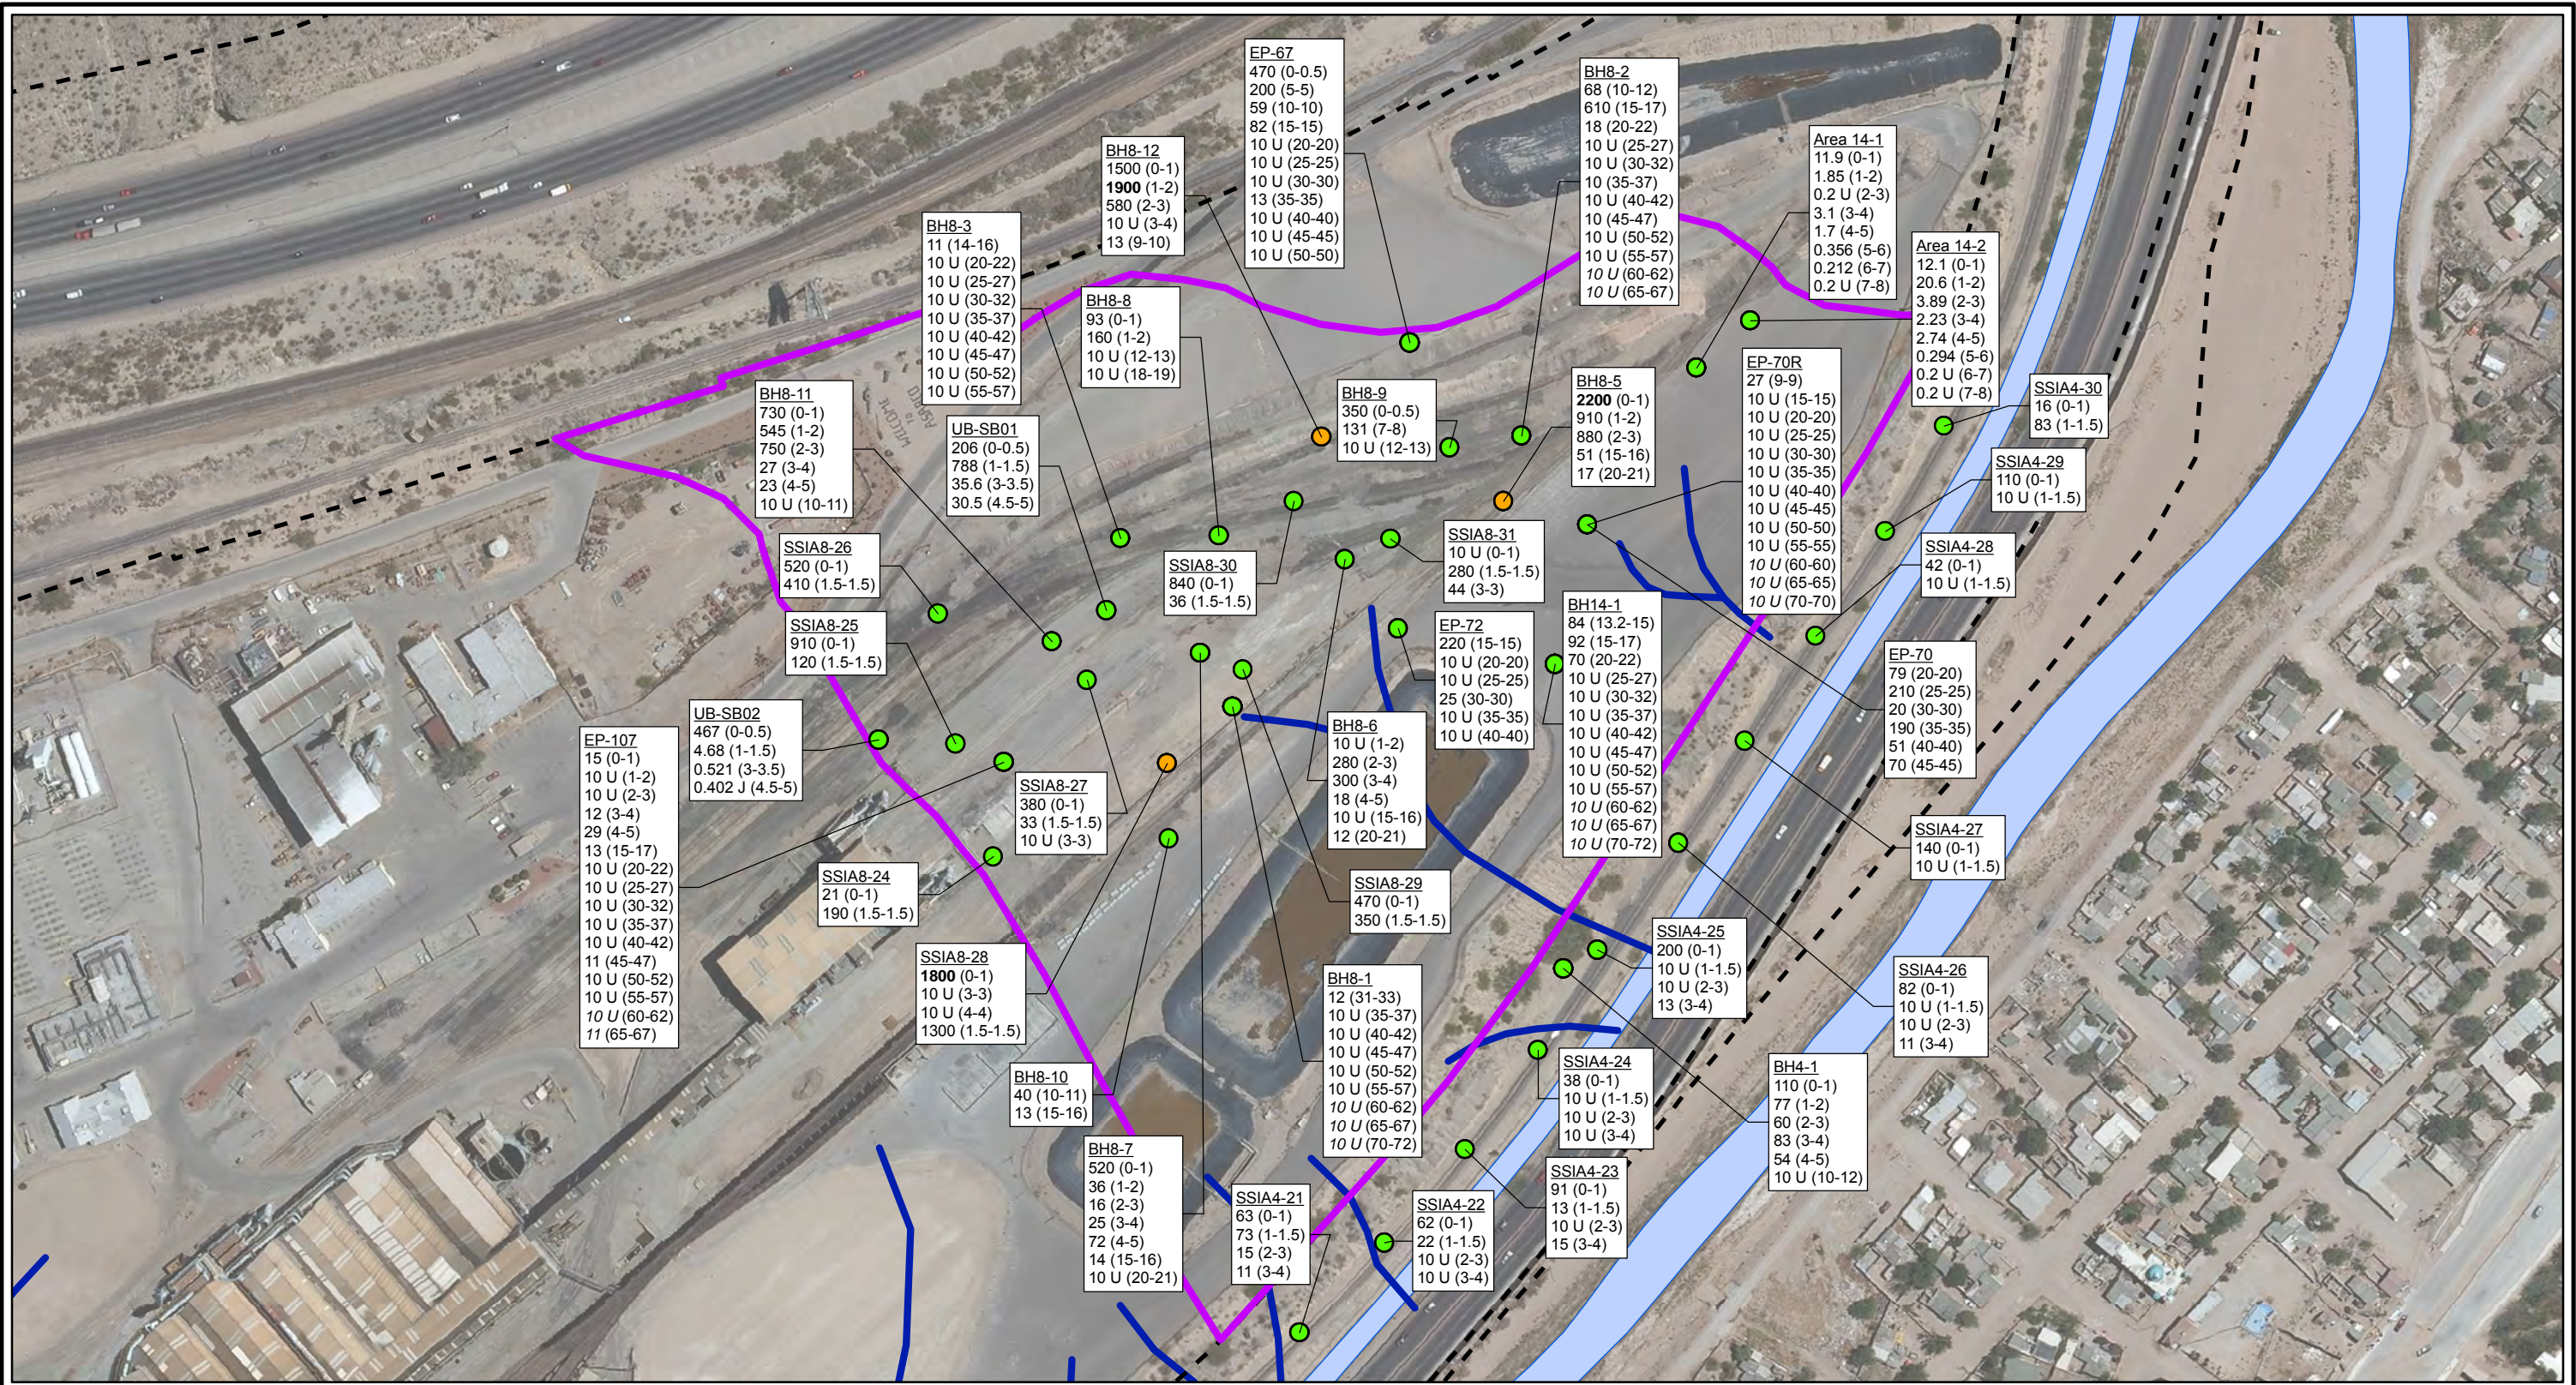
**NOTE:**  
 Screening Level (RRR SAI-Ind = 1500 mg/kg)

**Bolded** Value exceeds screening level
