FORMER EL PASO SMELTER SITE EL PASO, TEXAS	
<b>ANTIMONY DISTRIBUTION IN SOIL POND 5,6 ARROYO</b>	
	<b>FIGURE 4-39</b>

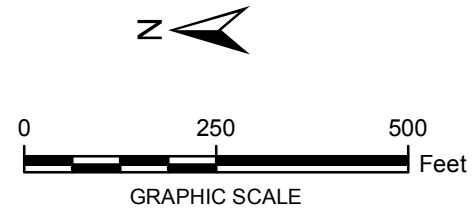
**NOTE:**  
 Screening Level (RRR SAI-Ind = 490 mg/kg)  
**Bolded** Value exceeds screening level  
*Italics* indicate below the water table  
 J = Estimated Value  
 U = Not detected at or above reporting limit  
 Date of Aerial Photo: 2009
