FORMER EL PASO SMELTER SITE
EL PASO, TEXAS

**MERCURY DISTRIBUTION IN SOIL
POND 5,6 ARROYO**

**FIGURE
4-43**

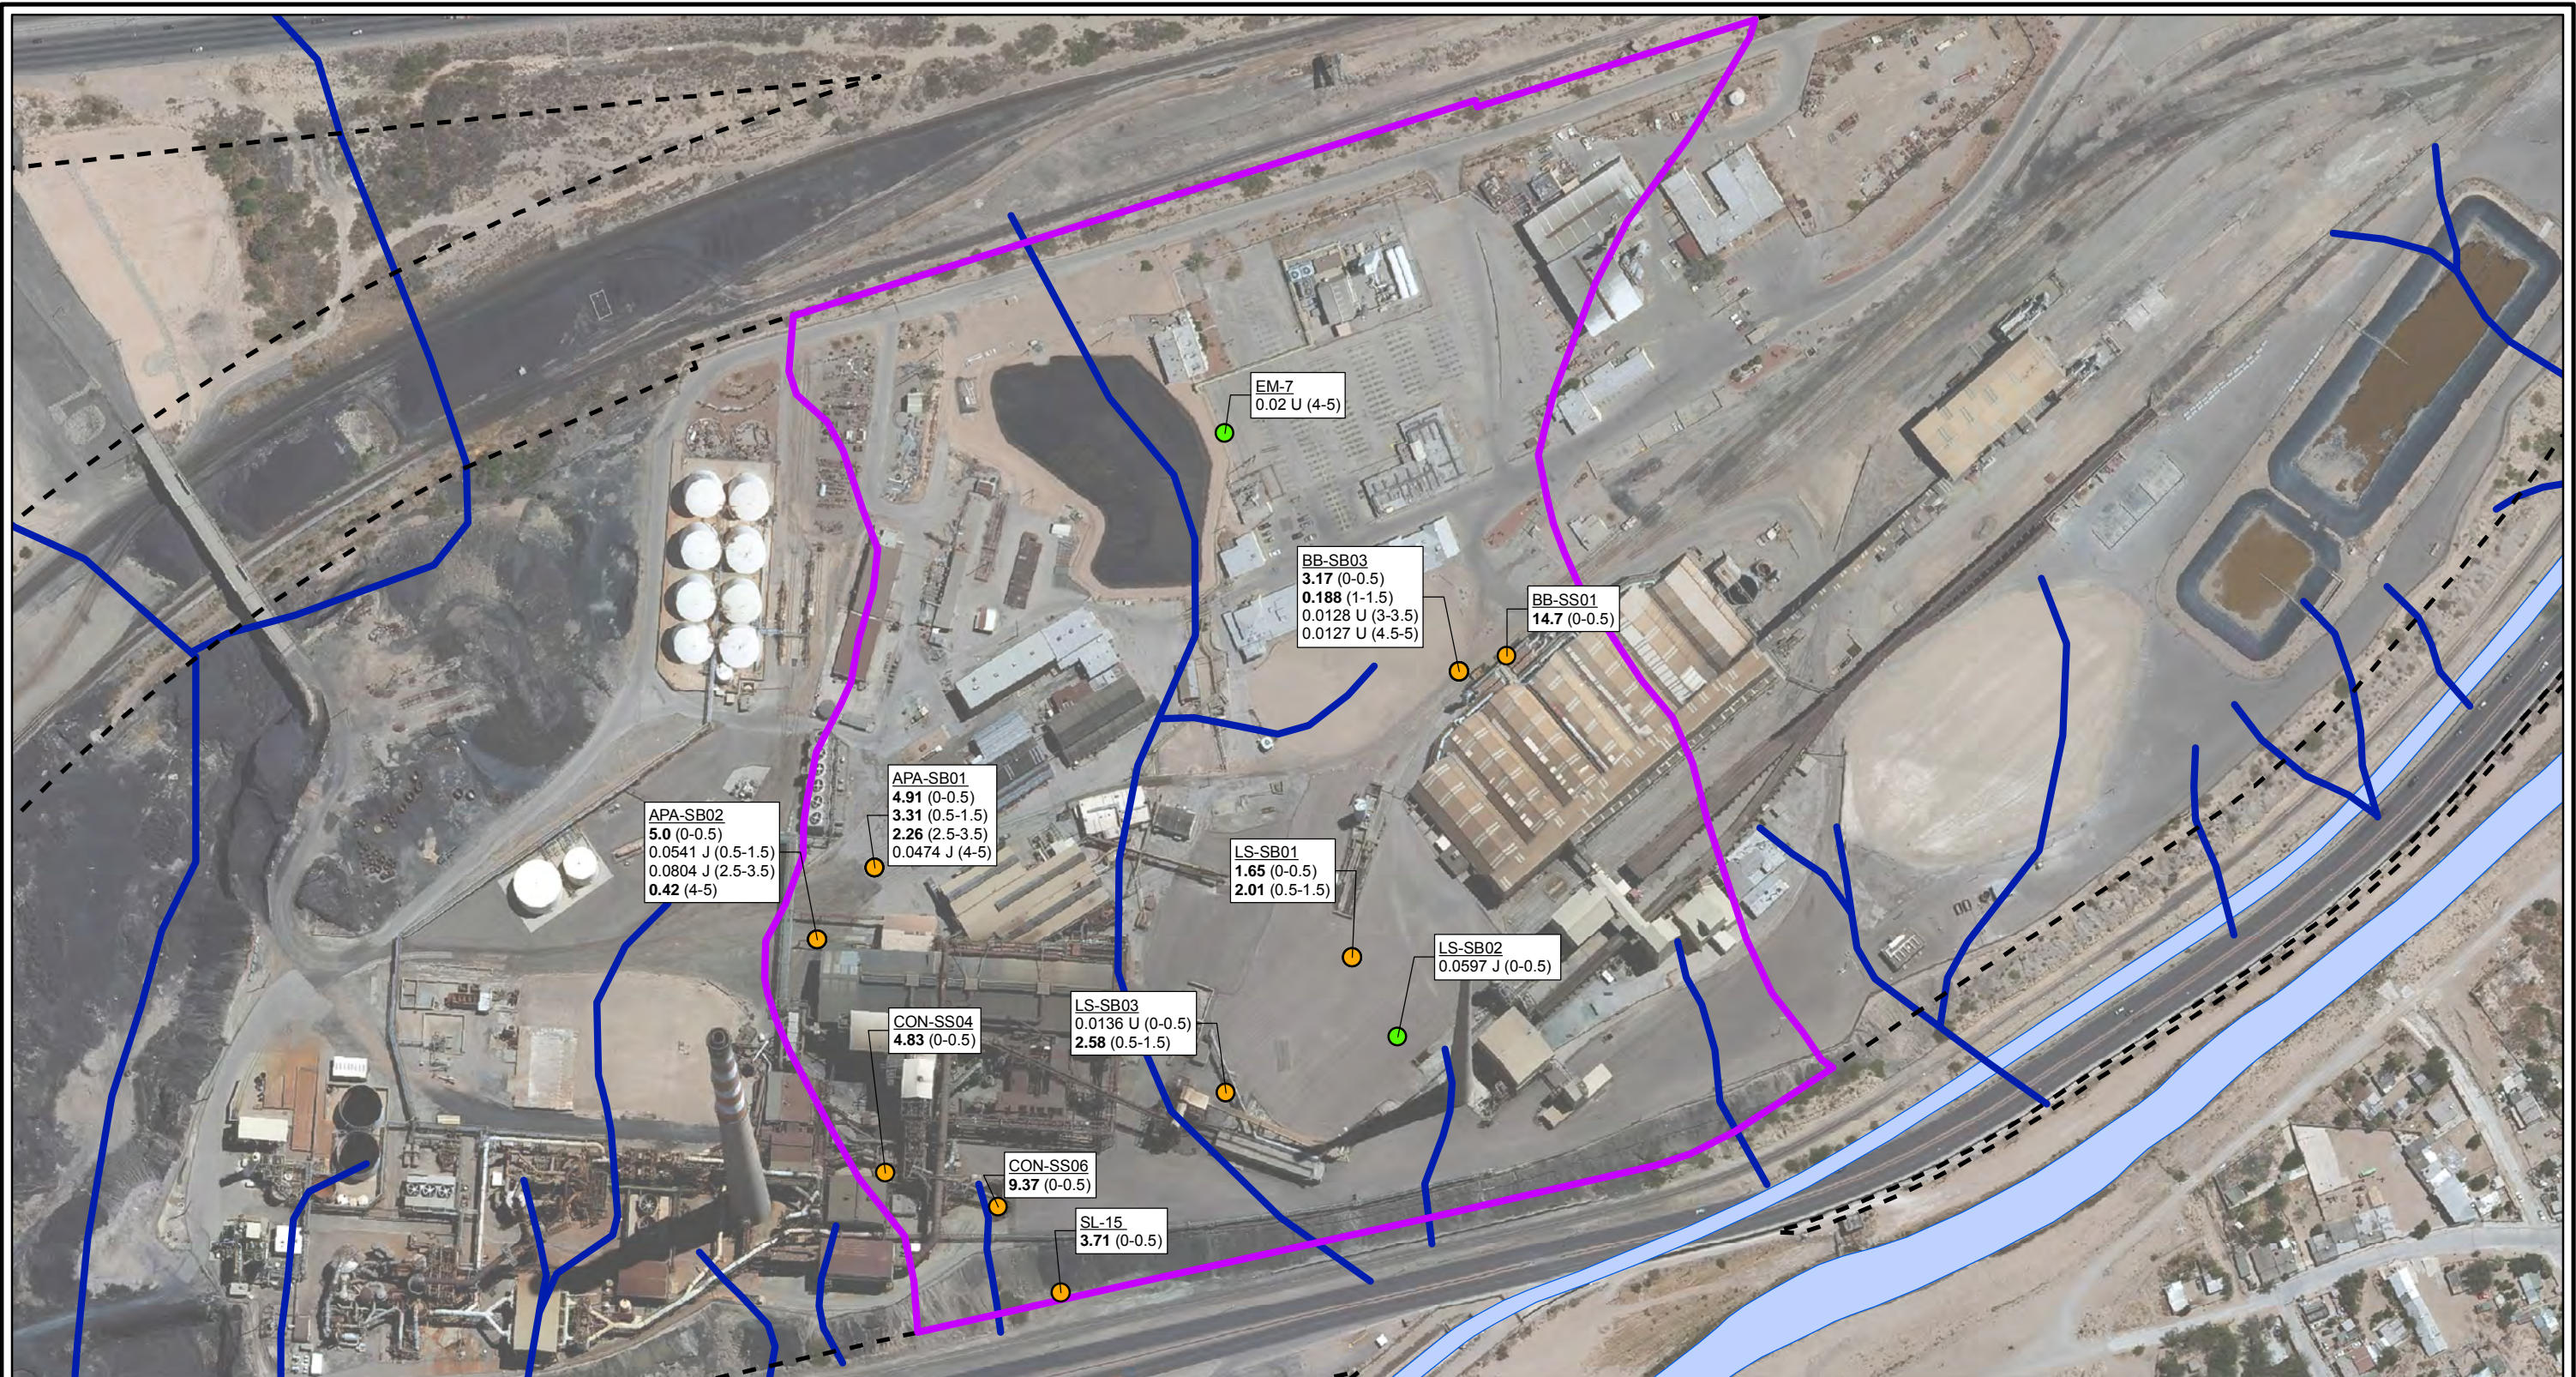
NOTE:
 Screening Level (RRR SAI-Ind = 0.15 mg/kg)
Bolded Value exceeds screening level
Italics indicate below the water table
 J = Estimated Value
 U = Not detected at or above reporting limit
 Date of Aerial Photo: 2009
