FORMER EL PASO SMELTER SITE EL PASO, TEXAS
ANTIMONY DISTRIBUTION IN SOIL ACID PLANT ARROYO
FIGURE 4-44

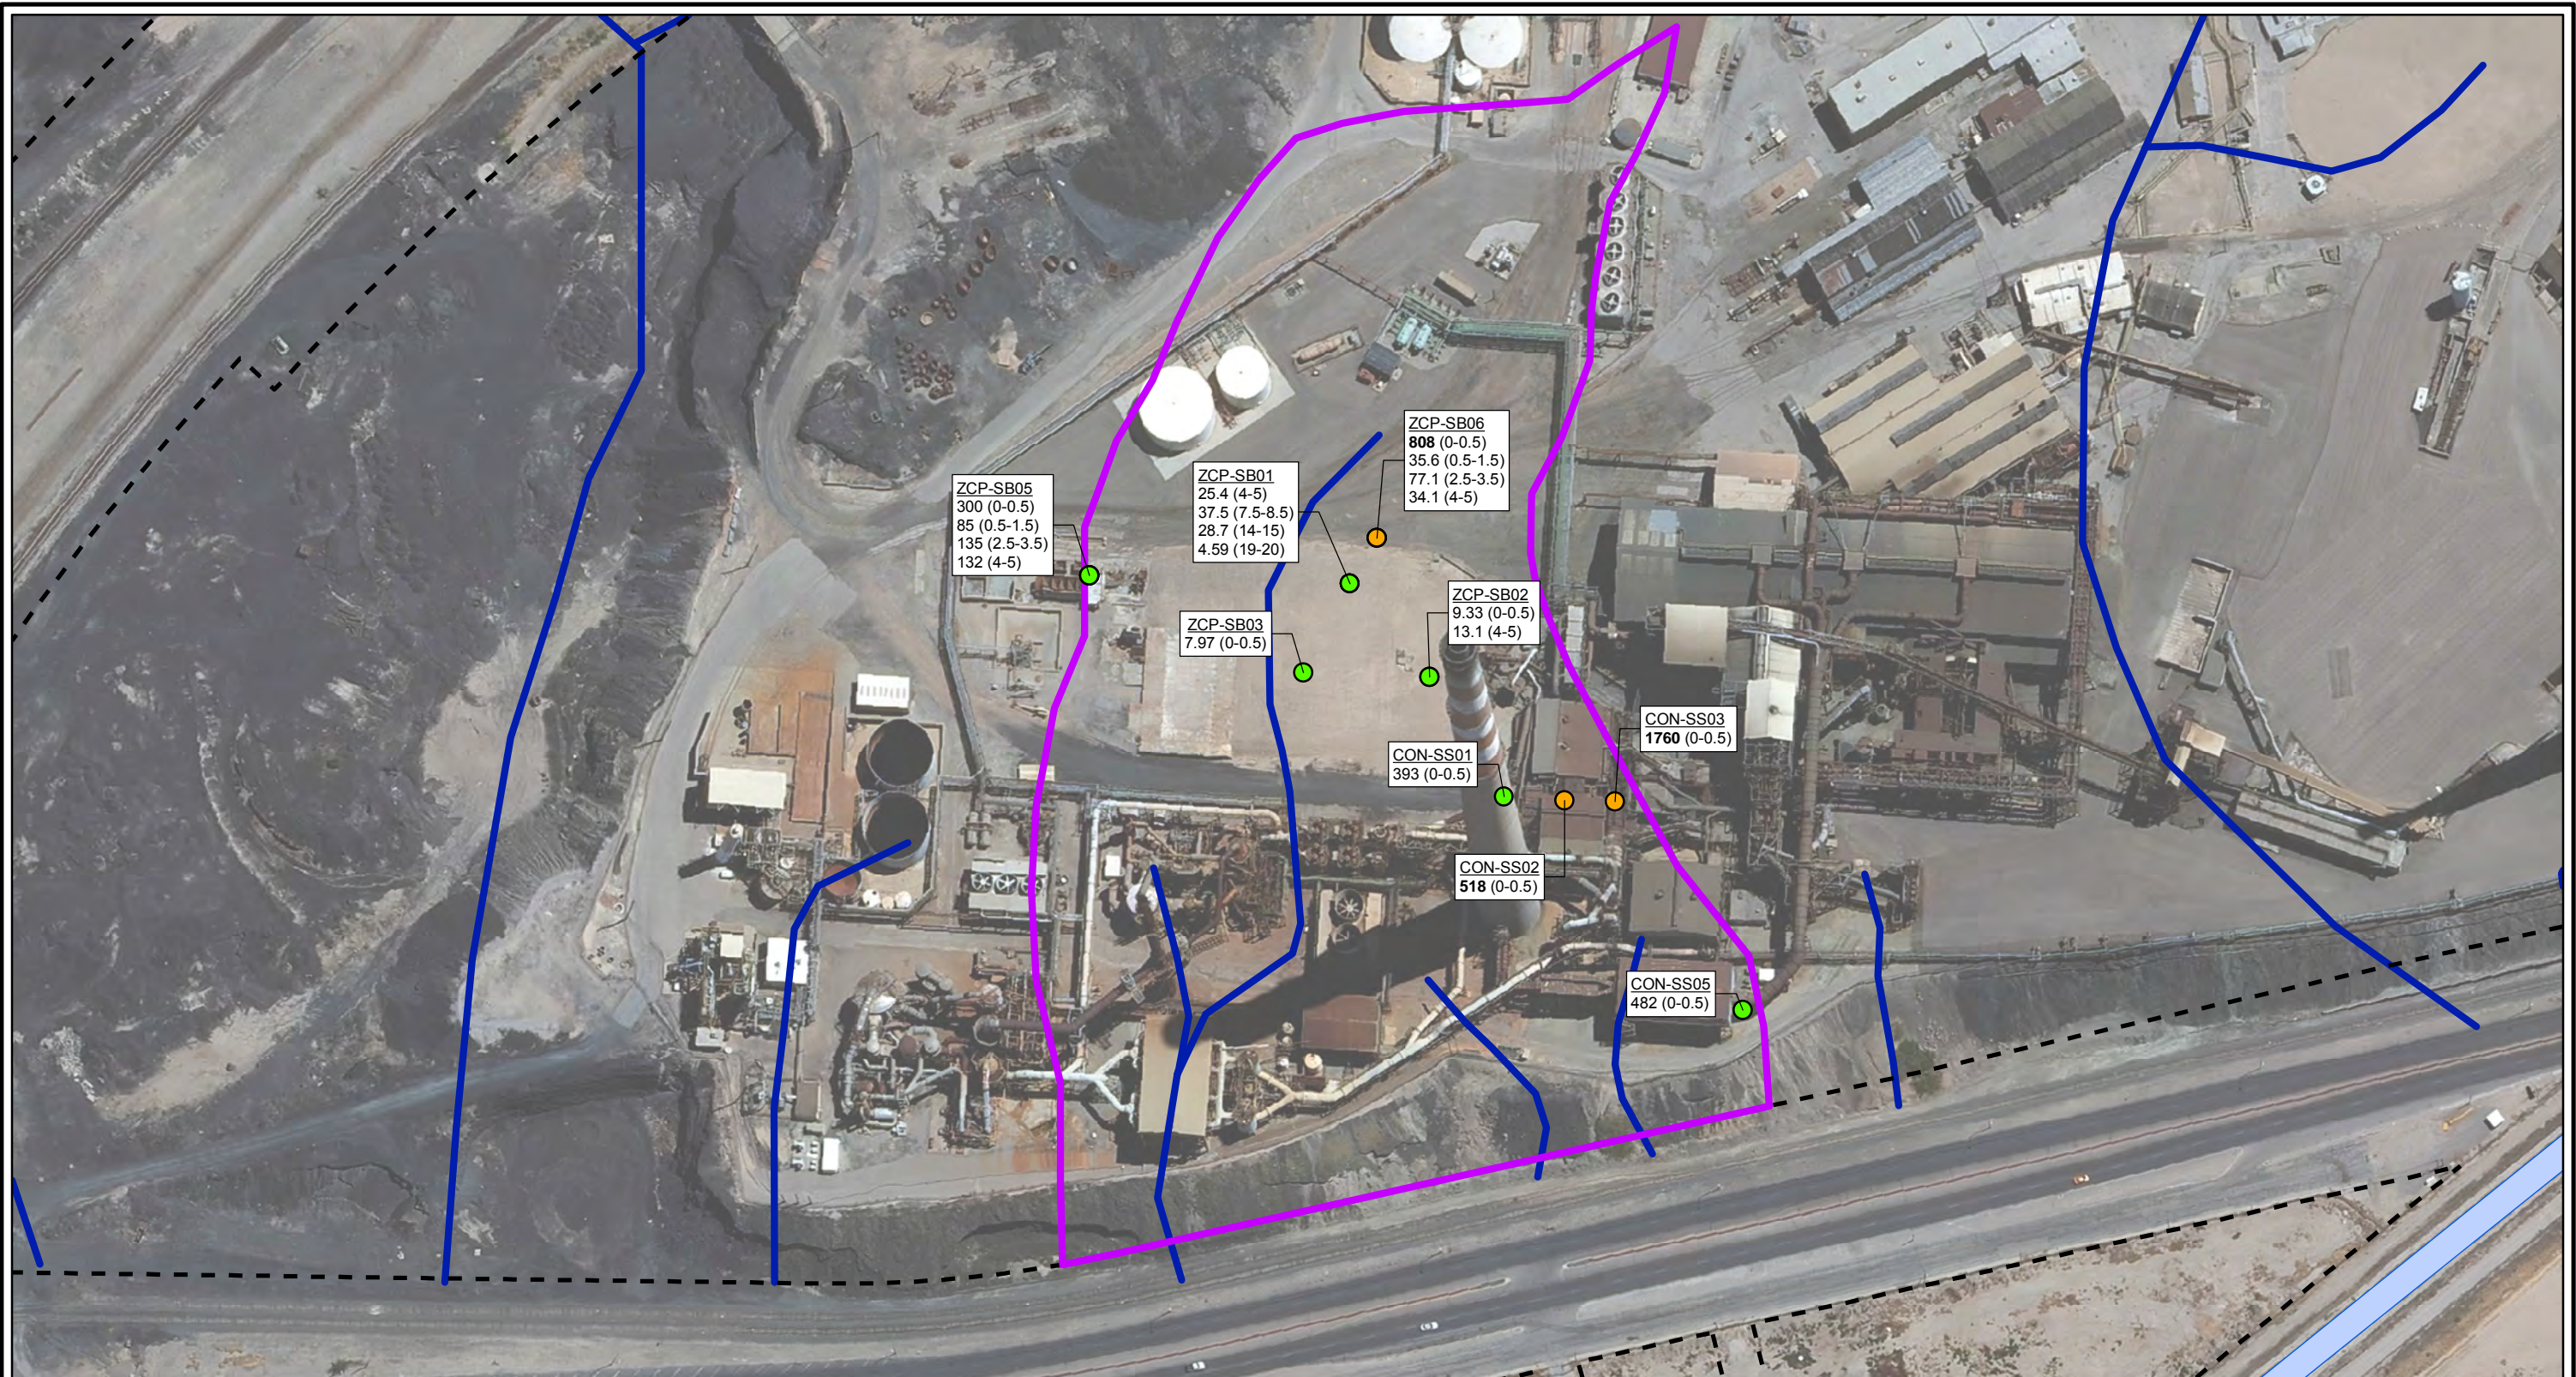
Sample ID
ZCP-SB02
9.33 (0-0.5)
13.1 (4-5)
Depth (ft bgs)
Antimony Concentration in mg/kg
