FORMER EL PASO SMELTER SITE  
EL PASO, TEXAS

**ARSENIC DISTRIBUTION IN SOIL  
ACID PLANT ARROYO**

**FIGURE  
4-45**

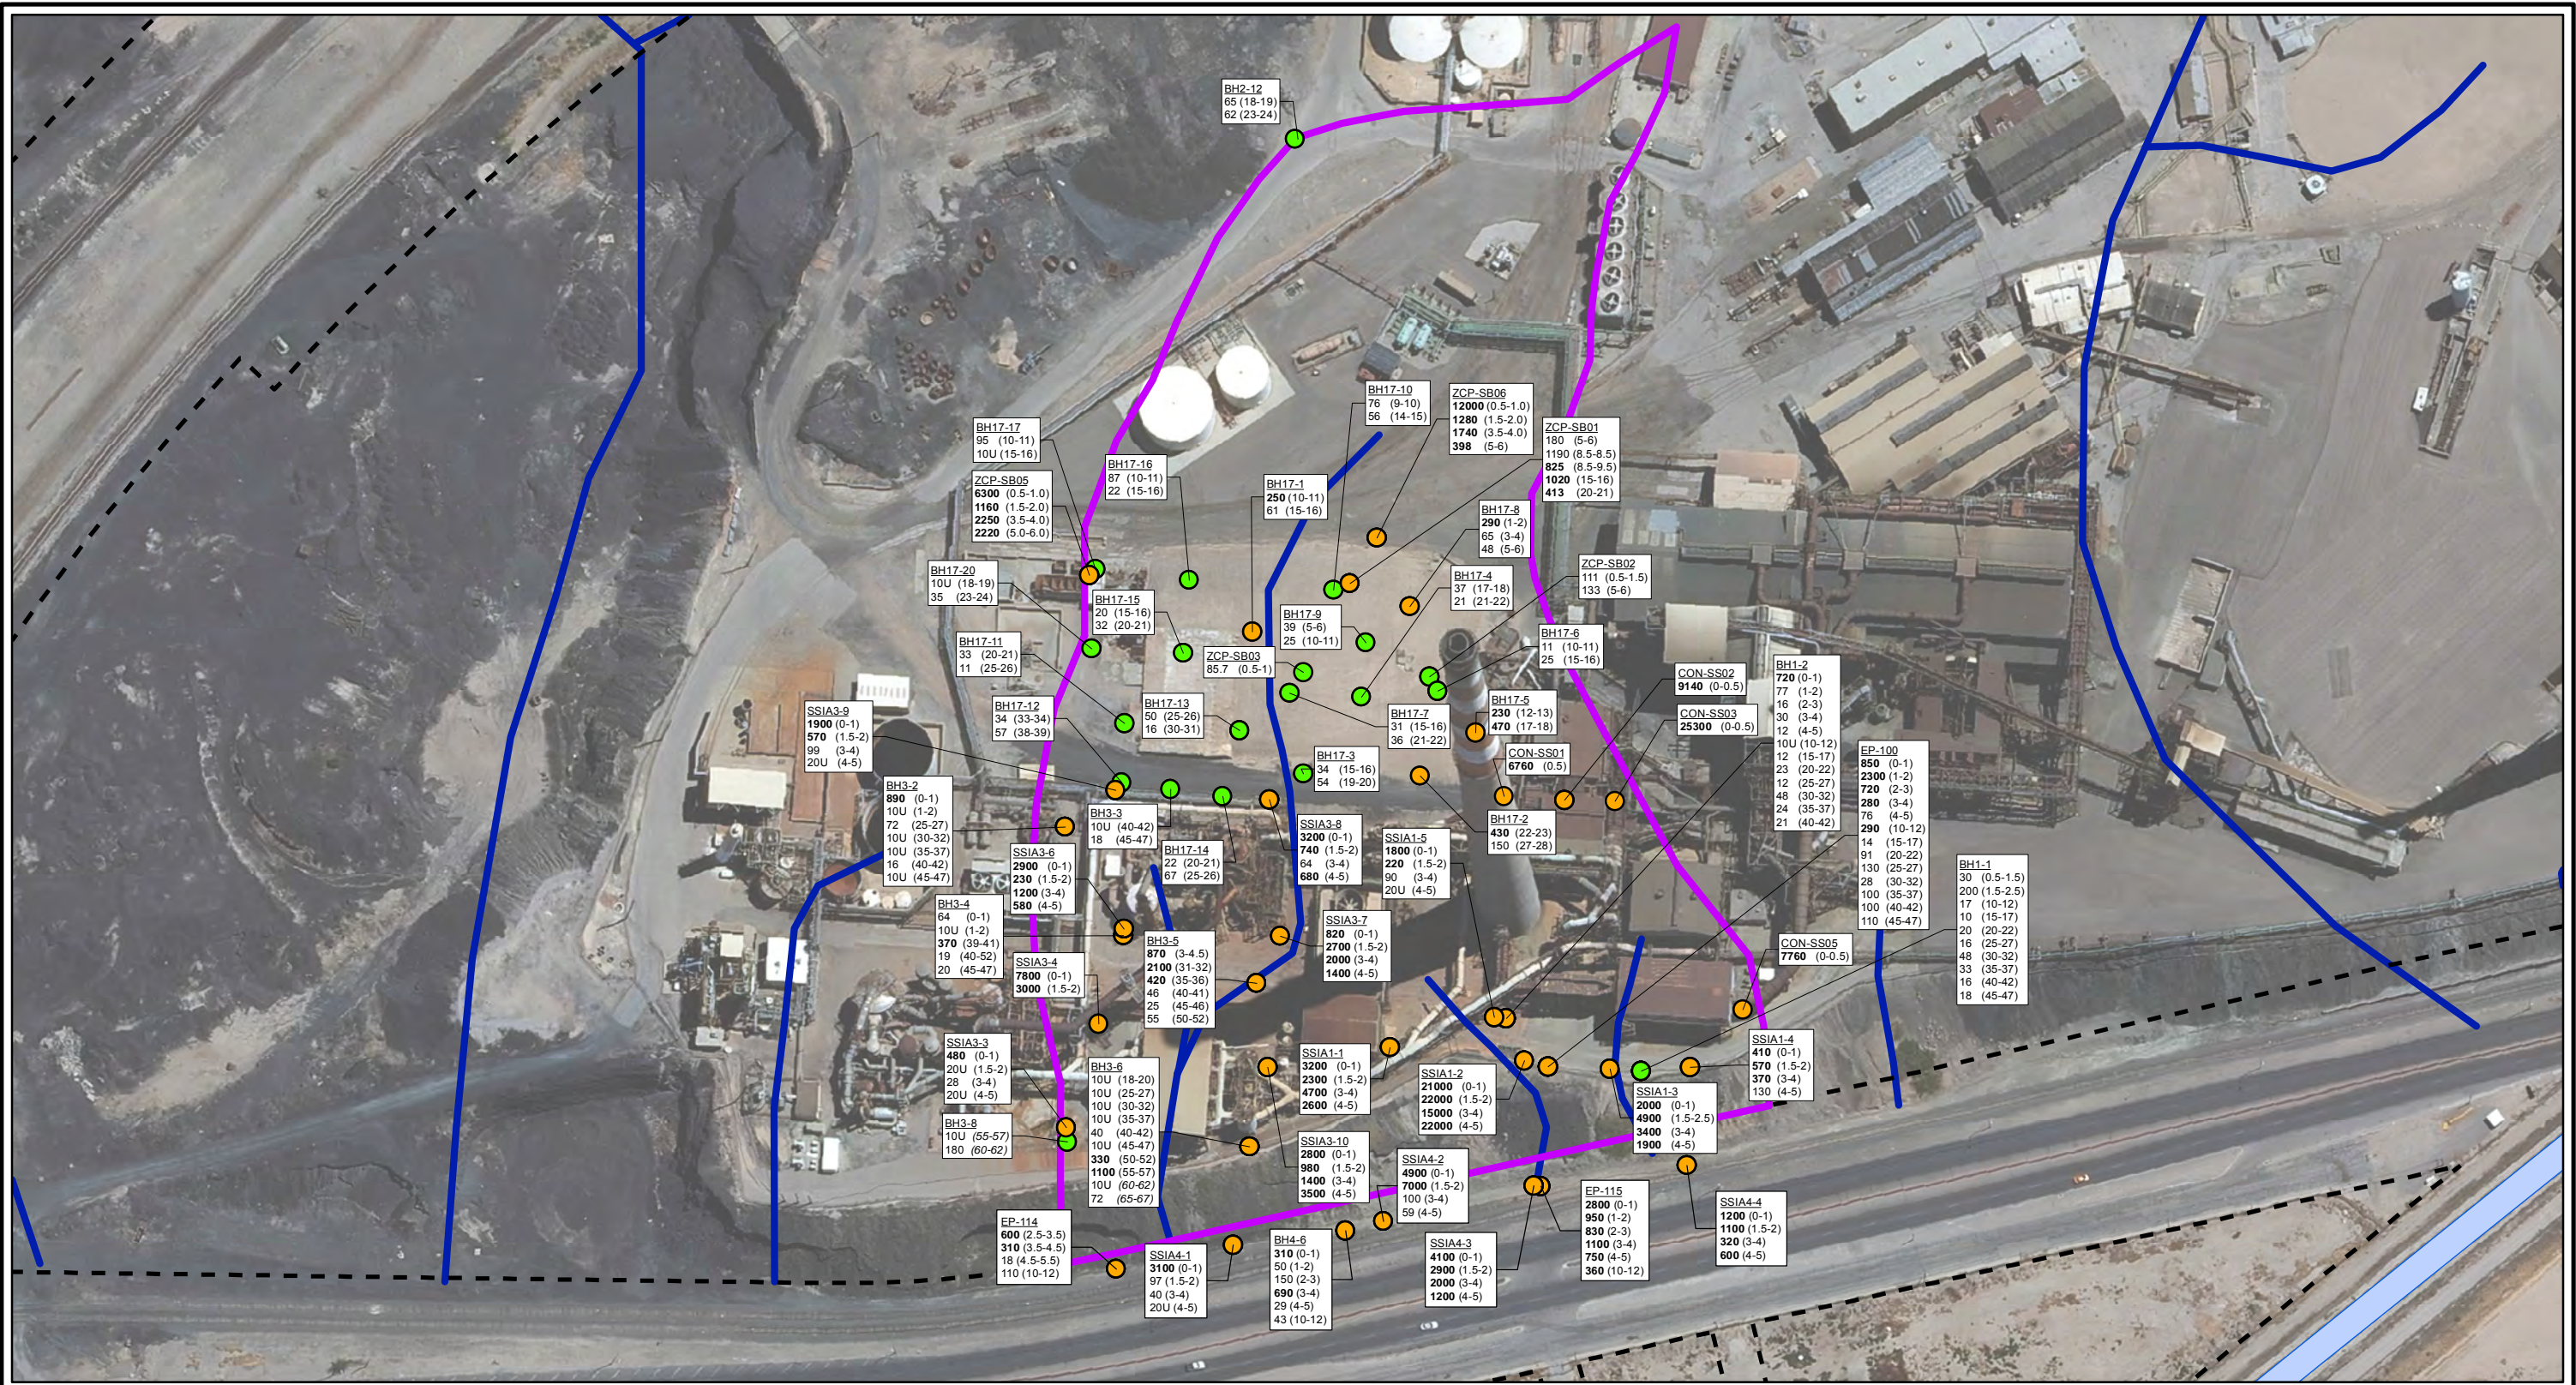
**NOTE:**  
 Screening Level (RRR SAI-Ind = 200 mg/kg)  
**Bolded** Value exceeds screening level  
*Italics* indicate below the water table  
 J = Estimated Value  
 U = Not detected at or above reporting limit  
 Date of Aerial Photo: 2009
