FORMER EL PASO SMELTER SITE
EL PASO, TEXAS

**ARSENIC DISTRIBUTION IN SOIL
FLOODPLAIN**

**FIGURE
4-52**

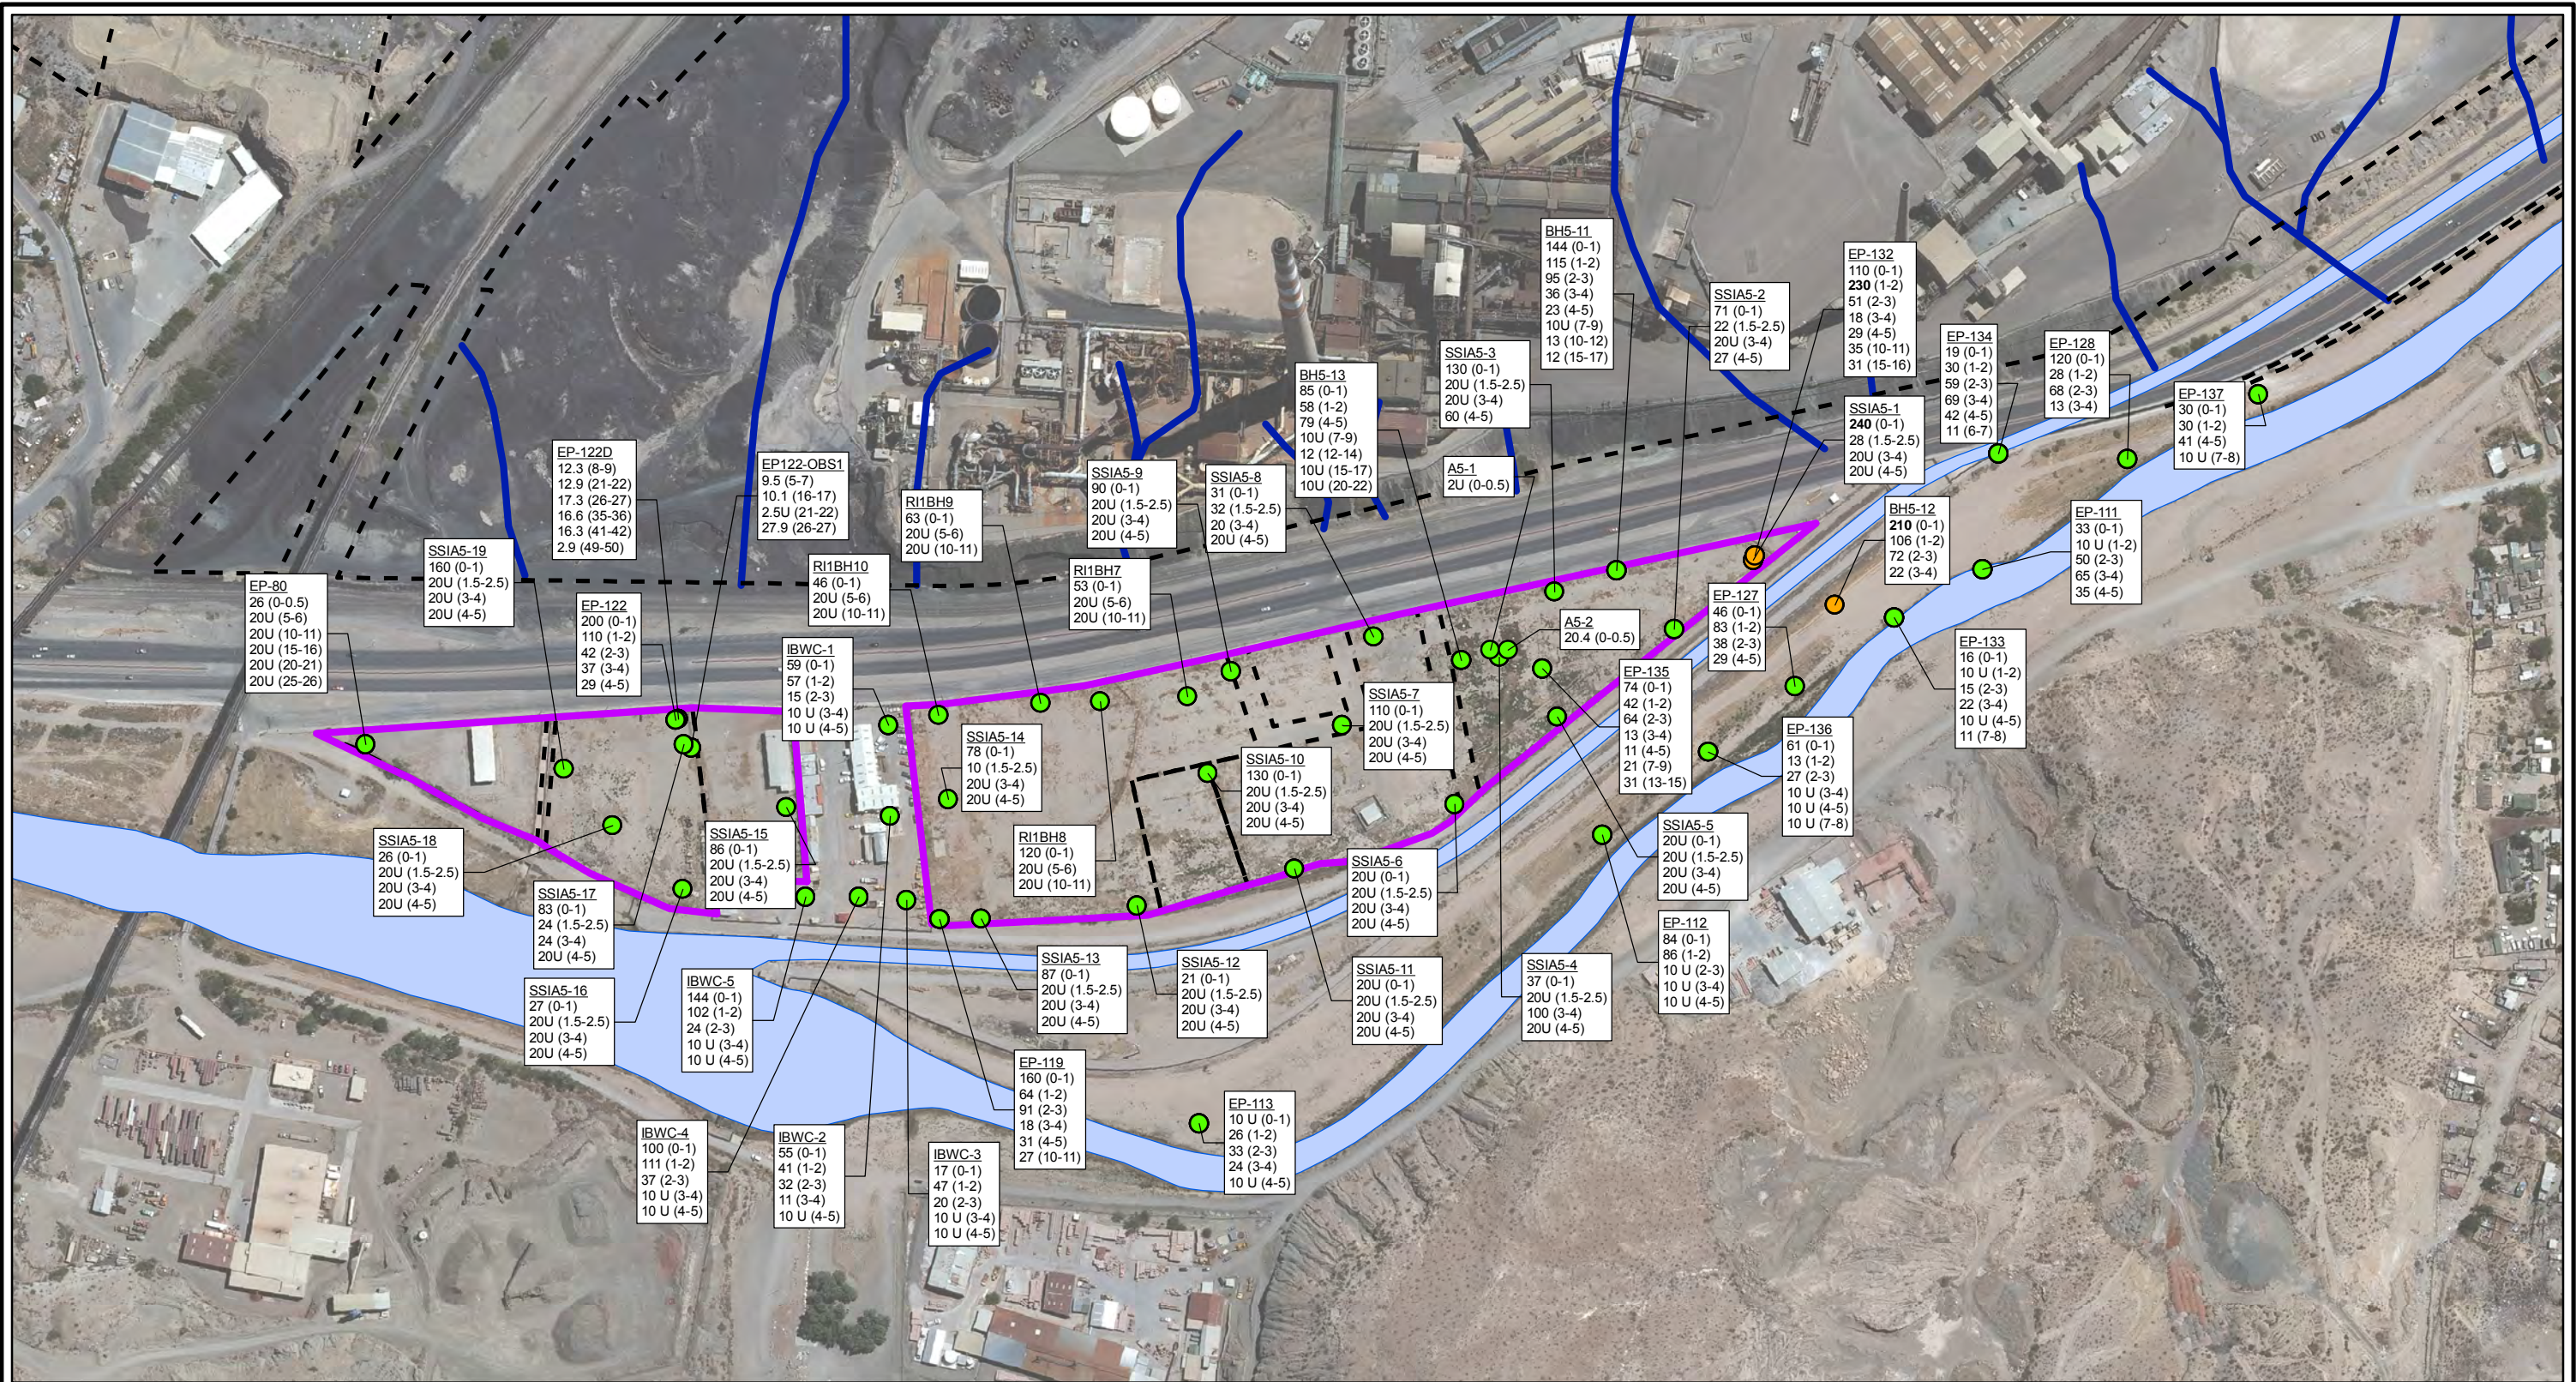
NOTE:
 Screening Level (RRR SAI-Ind = 200 mg/kg)
Bolded Value exceeds screening level
Italics indicate below the water table
 J = Estimated Value
 U = Not detected at or above reporting limit
 Date of Aerial Photo: 2009
