FORMER EL PASO SMELTER SITE  
EL PASO, TEXAS

**LEAD DISTRIBUTION IN SOIL  
FLOODPLAIN**

**FIGURE  
4-53**

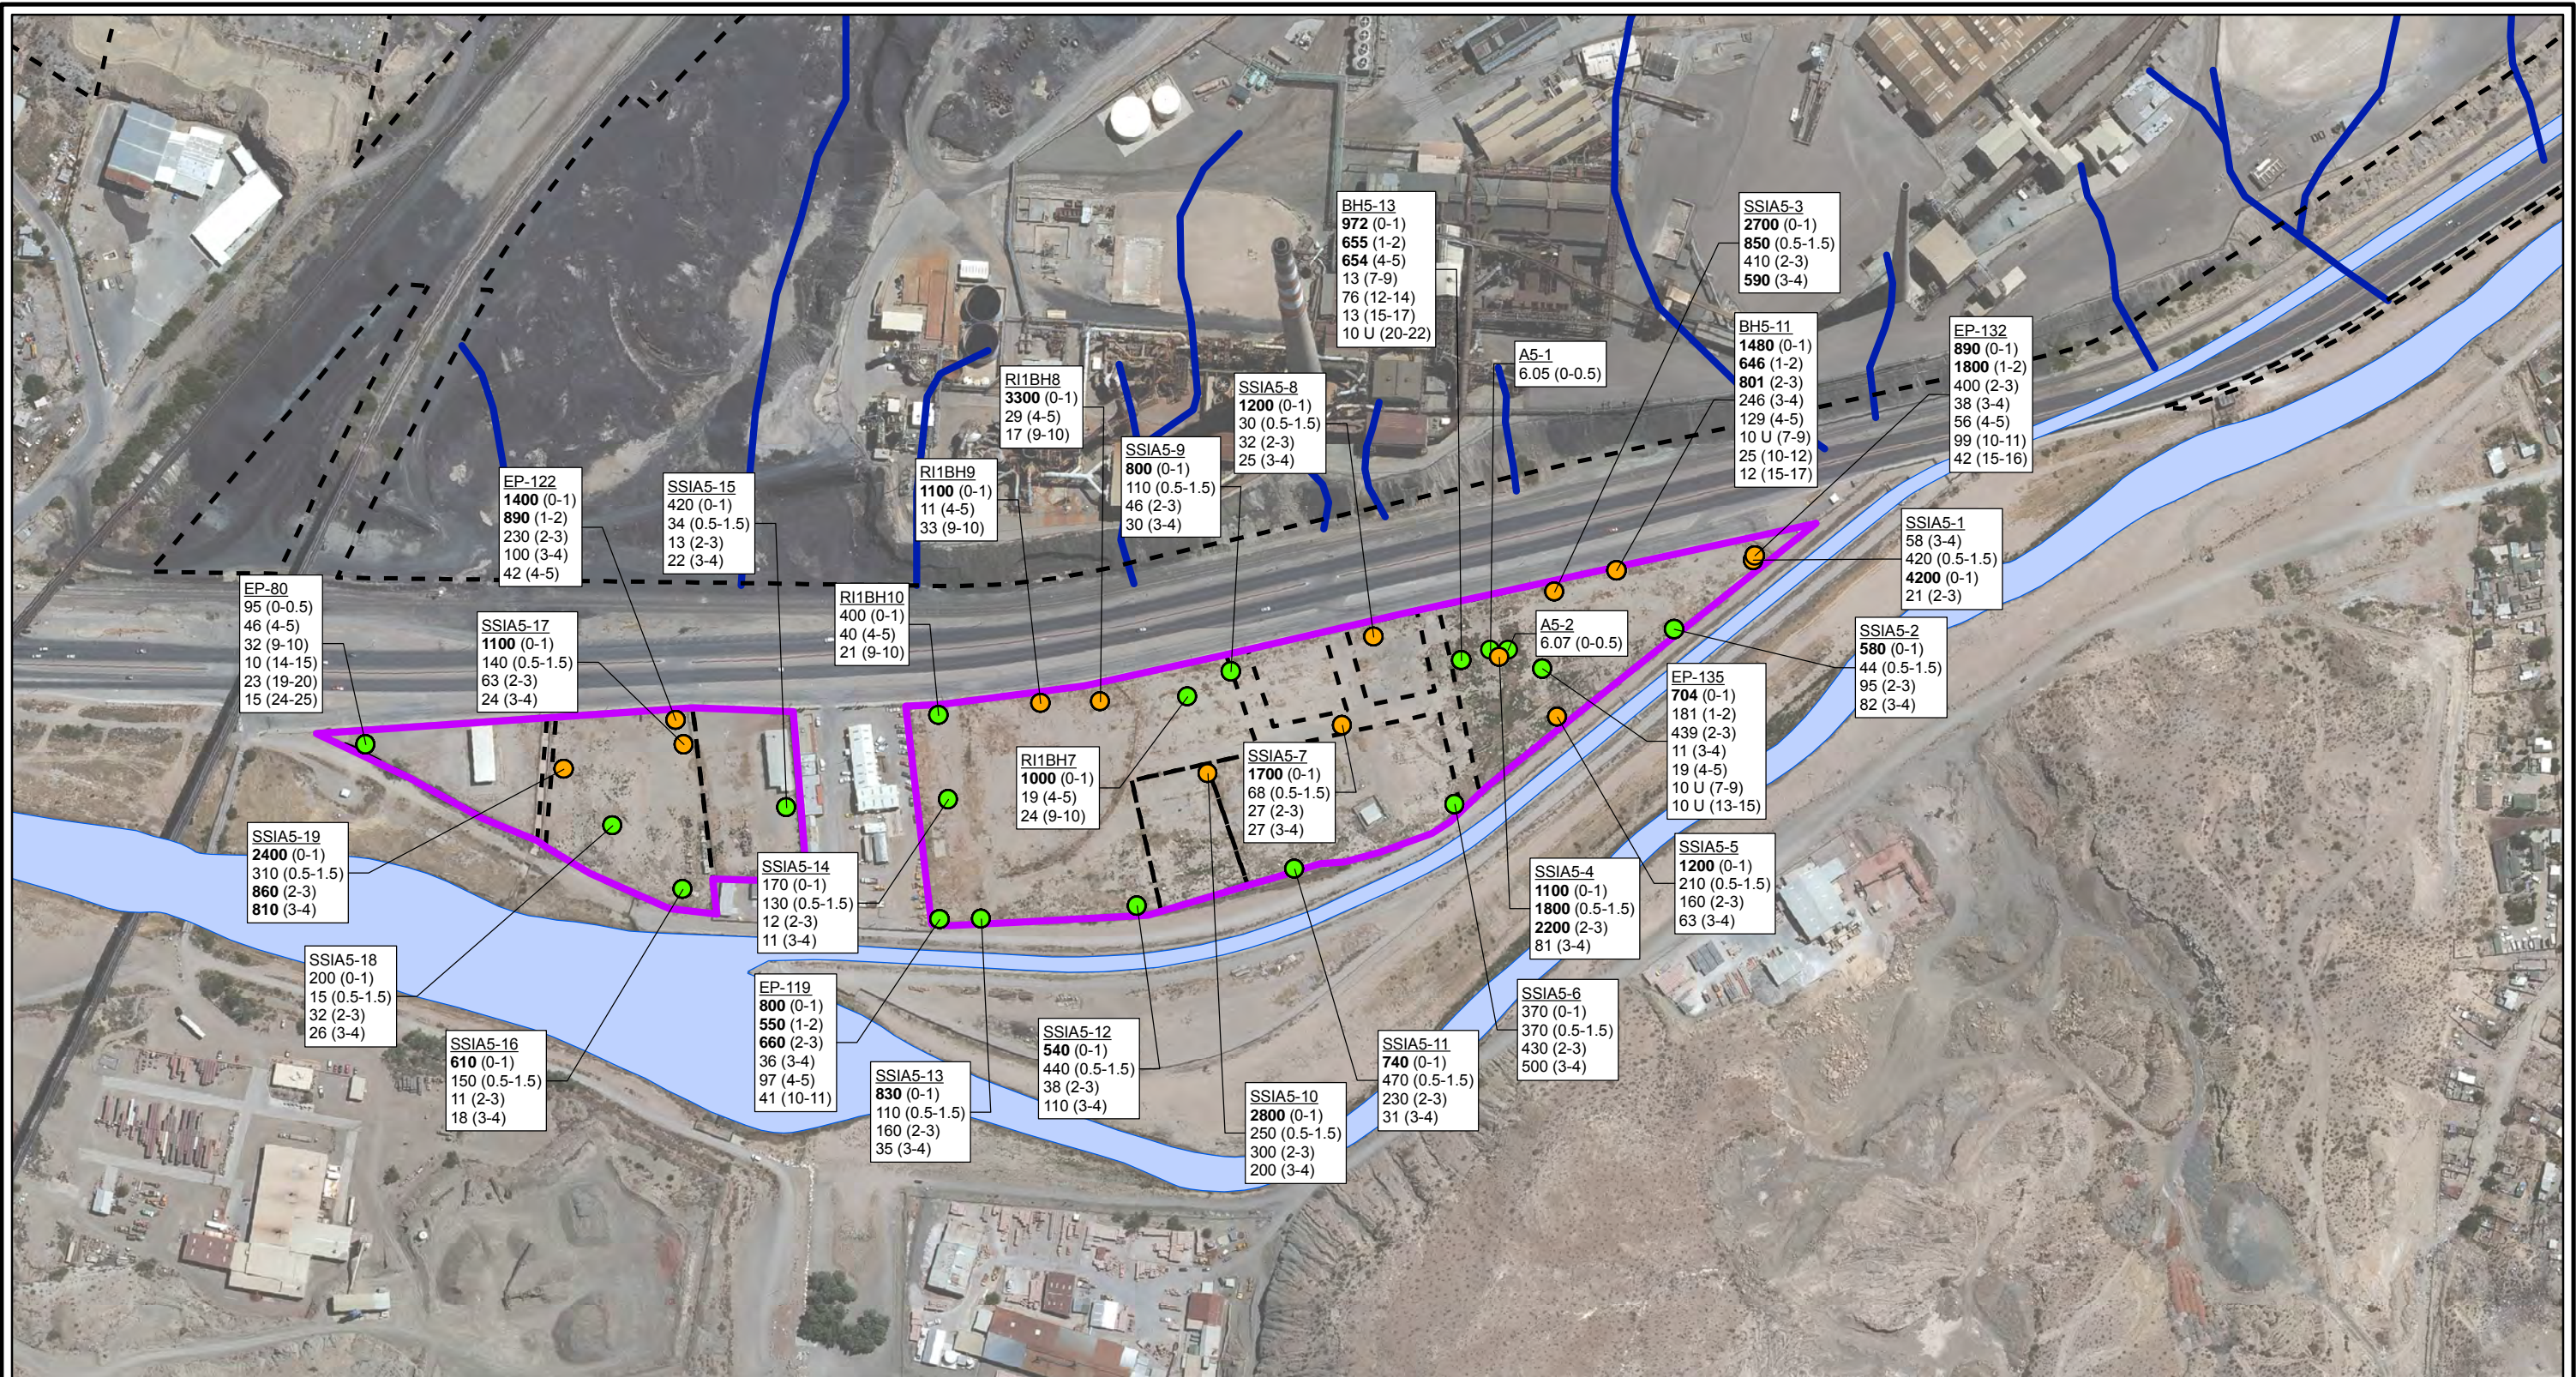
**NOTE:**  
 Screening Level (RRR SAI-Ind = 1000 mg/kg)  
**Bolded** Value exceeds screening level  
*Italics* indicate below the water table  
 J = Estimated Value  
 U = Not detected at or above reporting limit  
 Date of Aerial Photo: 2009
