ATTACHMENT 1C.6

**Parker Brothers Arroyo Features:
Lower Parker Brothers Arroyo Cat II Removal, Cell 4 Construction,
Lower Parker Brothers Arroyo Channel Construction, Upper Parker
Brothers Arroyo Construction, Texas Custodial Trust Pile 1 Slag
Removal, Permeable Reactive Barrier Installation**

FORMER EL PASO SMELTER SITE
 EL PASO, TEXAS

**PARKER BROTHERS
 ARROYO FEATURES**

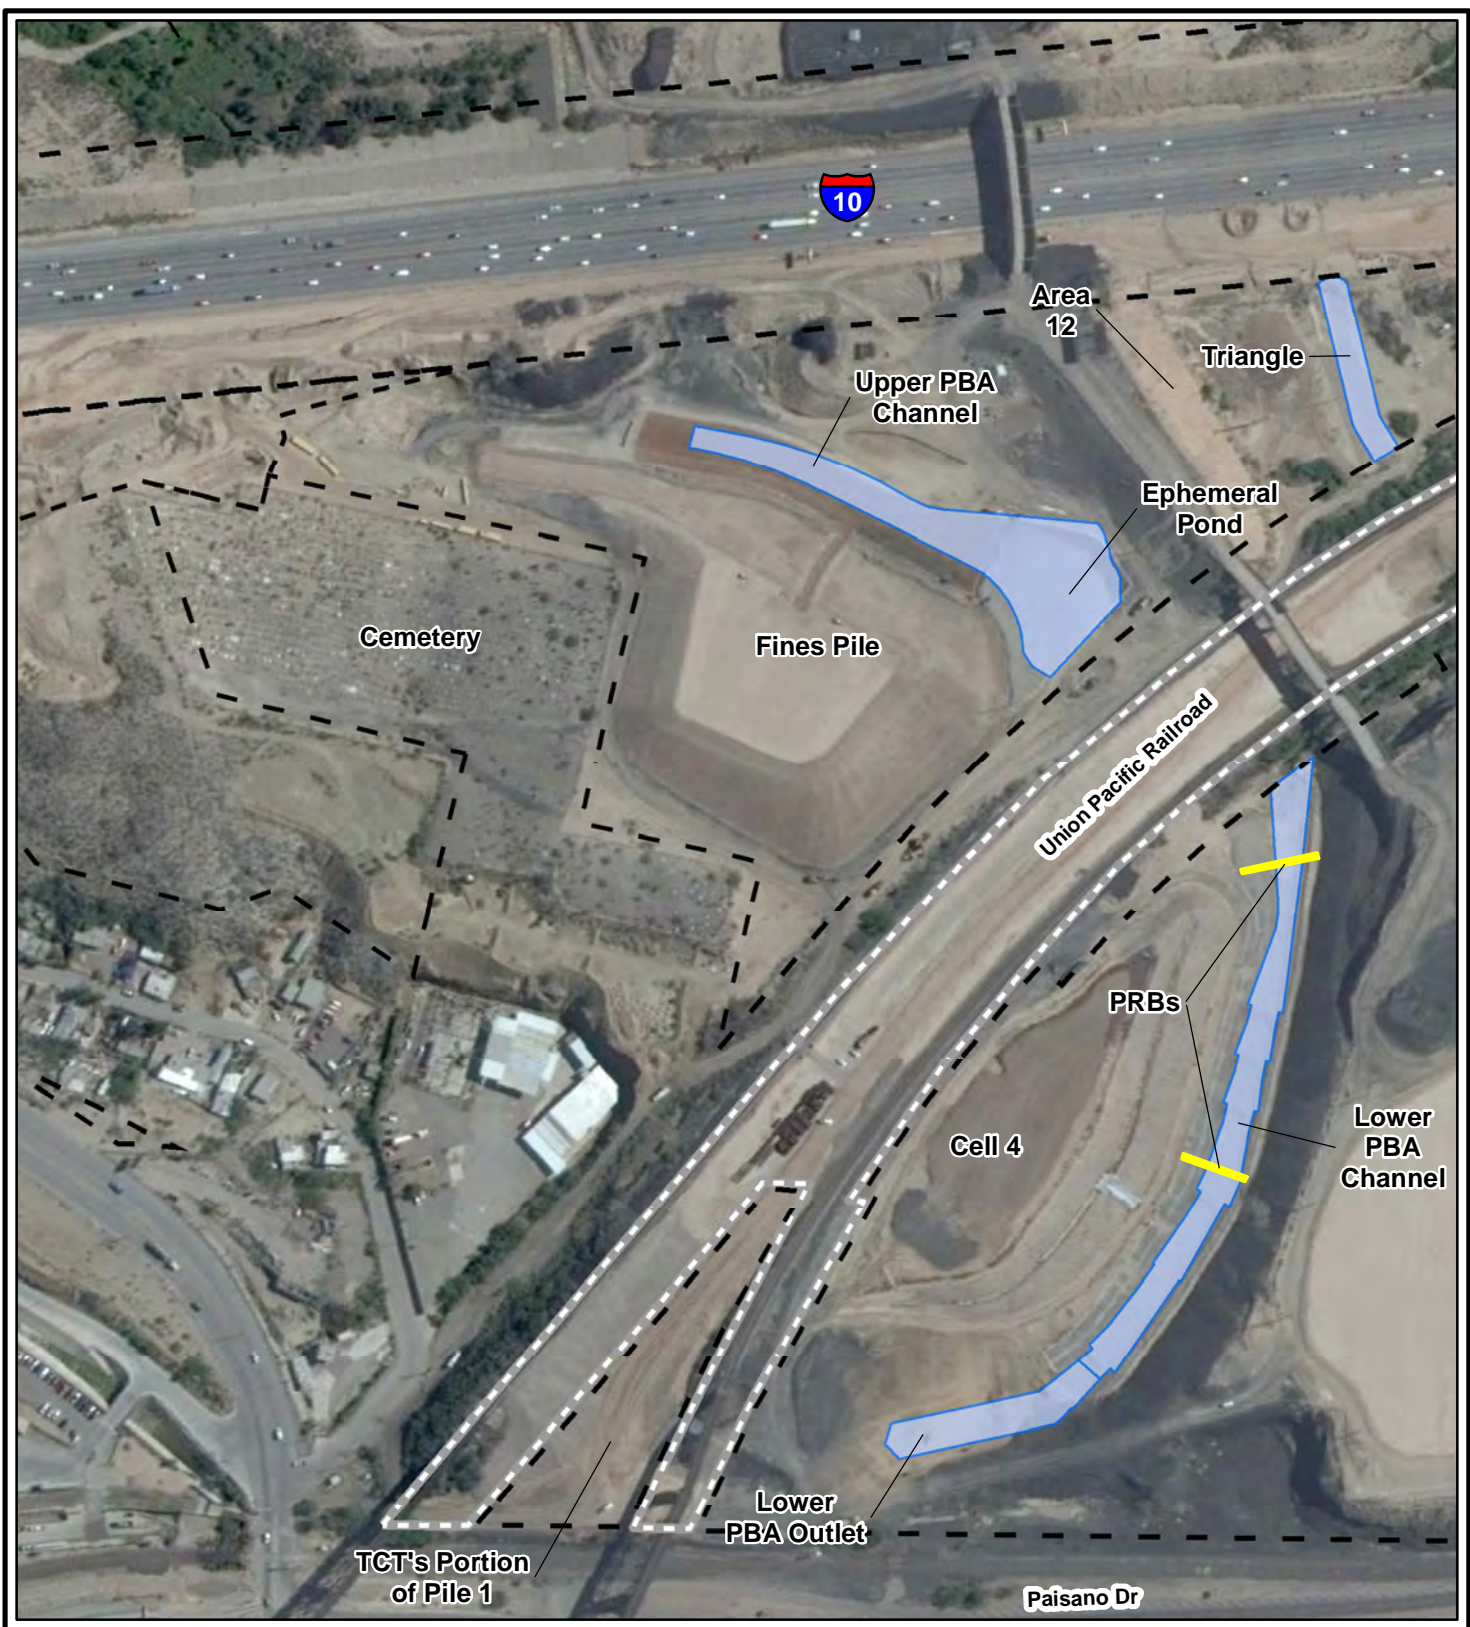
| **FIGURE 1**

Figure 1 included in this attachment shows these features.

As described on page 3 in Worksheet 1.0 of the Response Action Plan (RAP), the Parker Brothers Arroyo (PBA) is divided by the Union Pacific Railroad track into upper (UPBA) and lower (LPBA) reaches. The LPBA includes the Cell 4 Landfill footprint, an area between UPRR tracks and just east of West Paisano Drive known as TCT Pile 1, as well as the construction of channel improvements within the channel itself. Prior to channel improvements, TCT installed two below-ground Permeable Reactive Barriers (PRBs) within the LPBA channel.

The UPBA includes two storm water flow channels which merge on the west side of the UPRR tracks. The southernmost channel, which flows through an area referred to as the "Triangle Area", was improved by placement of a geomembrane liner and riprap. The northernmost channel flows adjacent to the Fines Pile and into the Ephemeral Pond and was also improved with a liner and riprap.
