FORMER EL PASO SMELTER SITE  
EL PASO, TEXAS

**LEAD DISTRIBUTION IN SOIL  
EAST PROPERTY**

**FIGURE  
4-13**

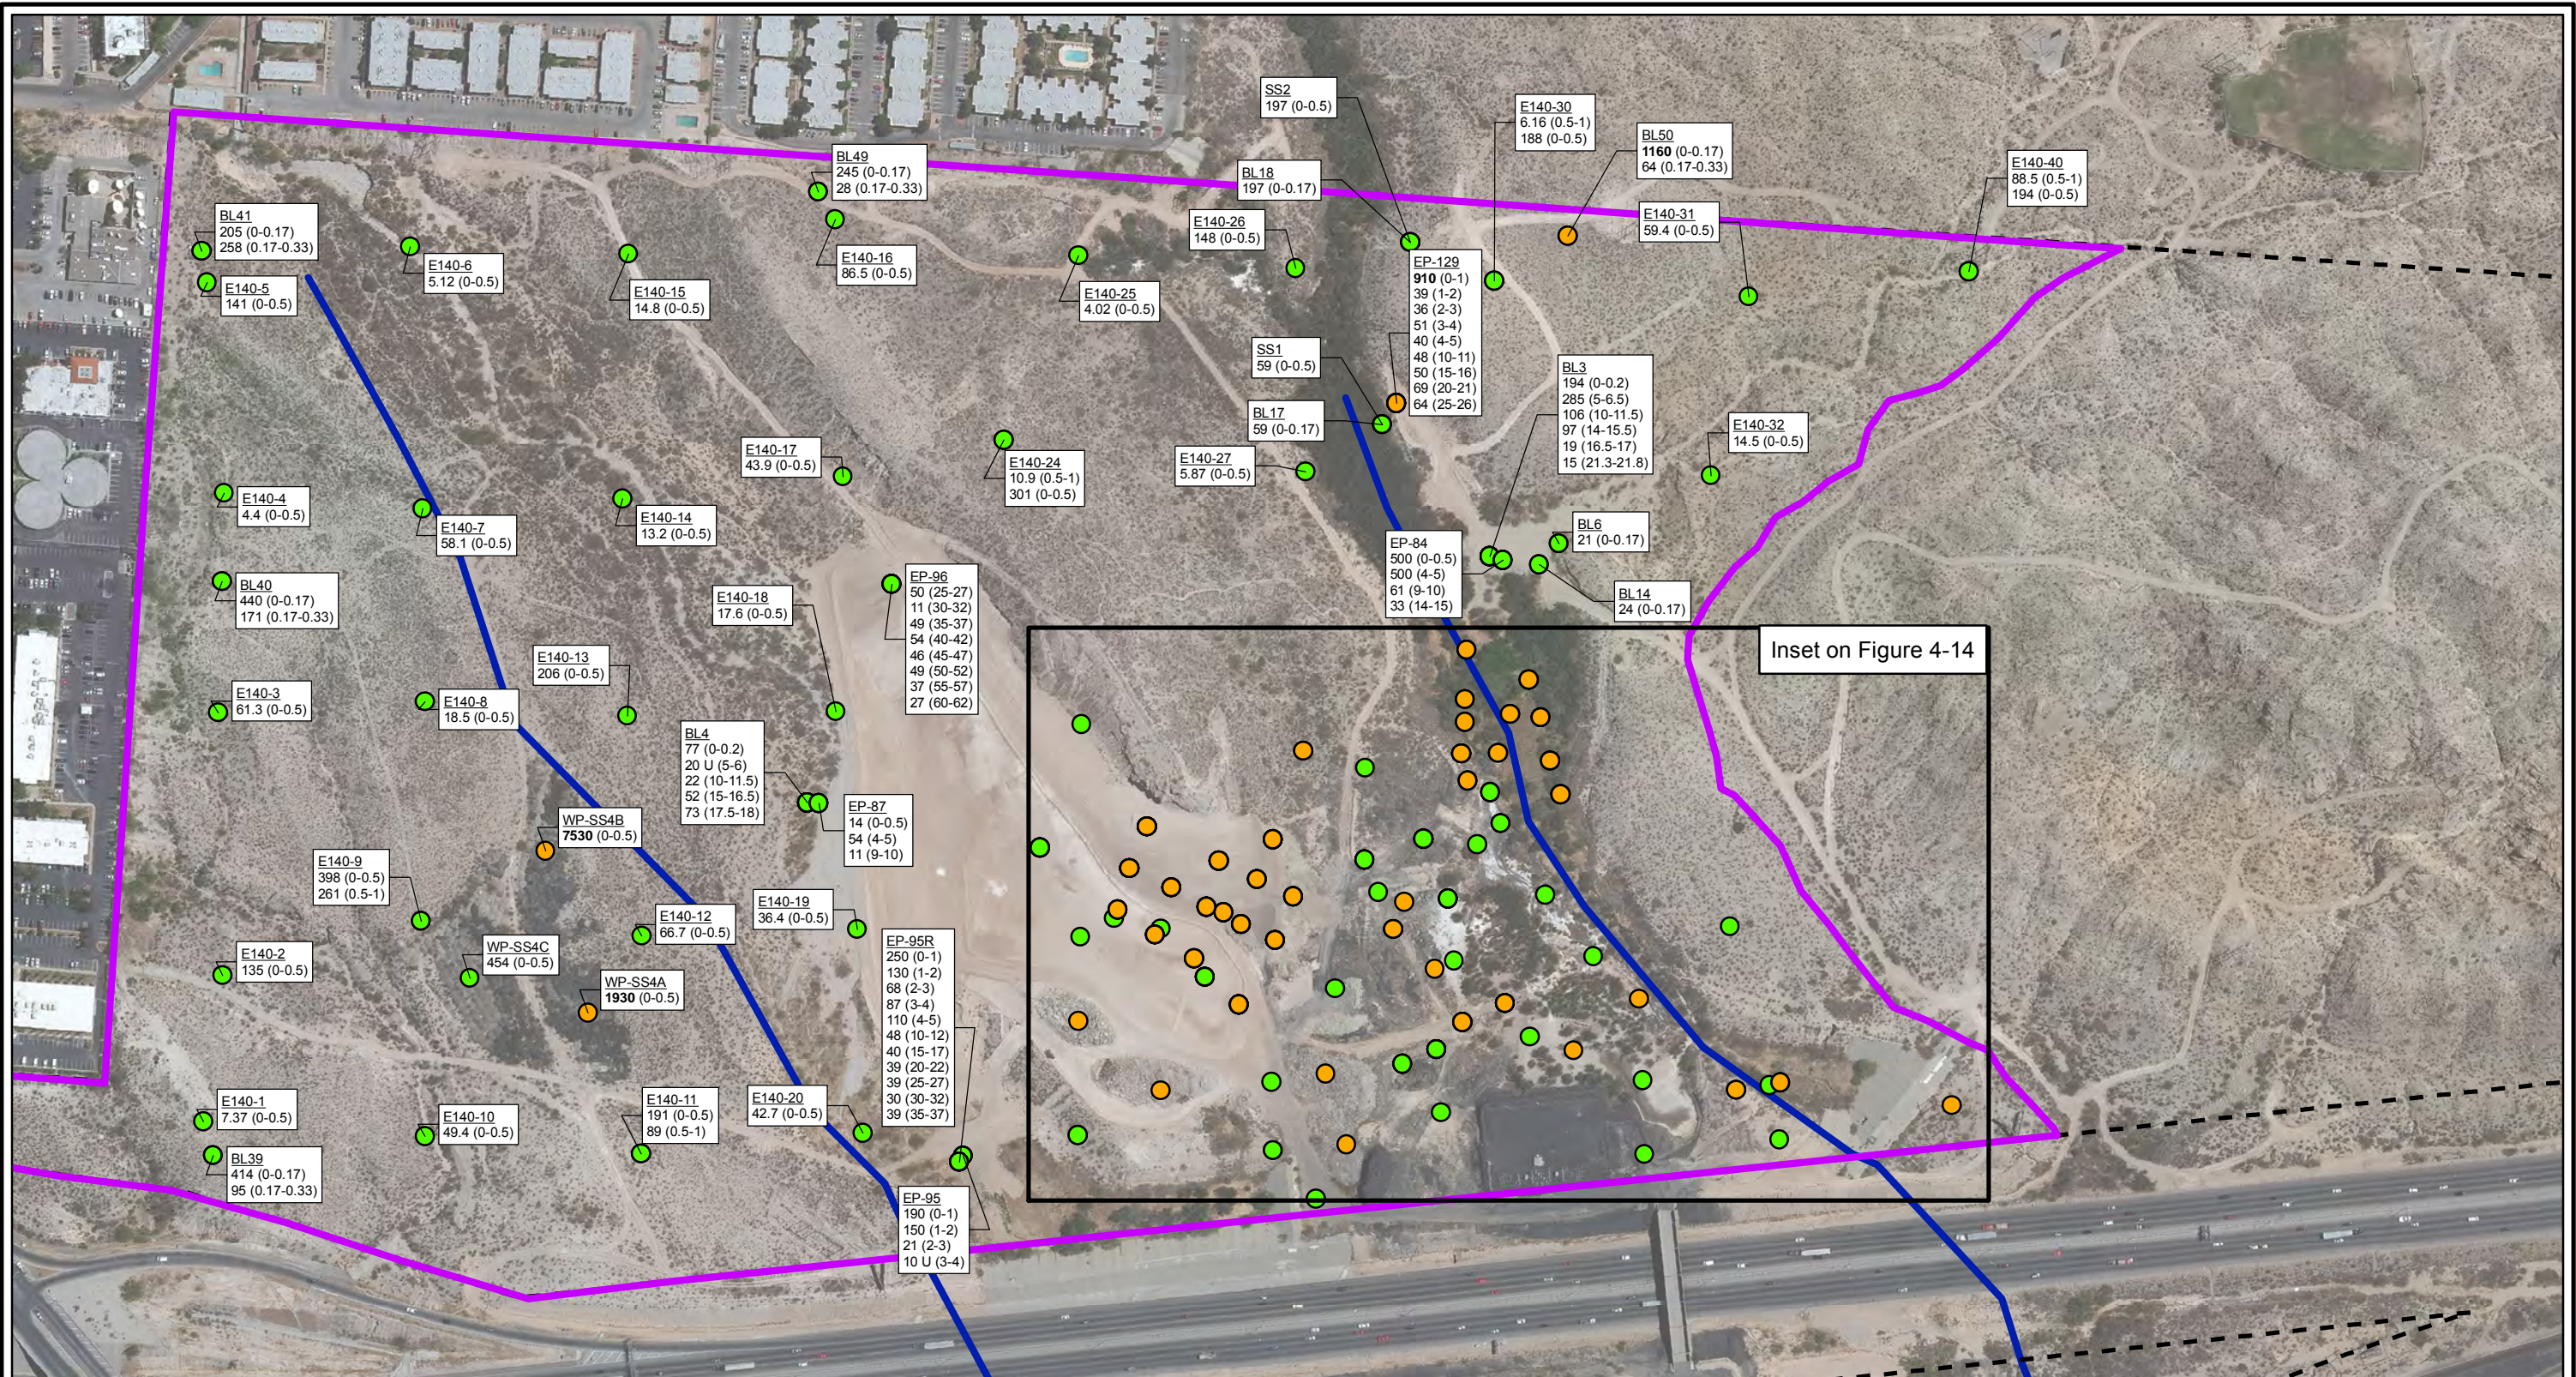
**NOTE:**  
 Screening Level (RRR SAI-Res = 500 mg/kg)  
**Bolded Value** exceeds screening level  
*Italics* Depth below groundwater  
 J = Estimated Value  
 U = Not detected at or above reporting limit  
 Date of Aerial Photo: 2009
