FORMER EL PASO SMELTER SITE  
EL PASO, TEXAS

**MERCURY DISTRIBUTION IN SOIL  
EAST PROPERTY**

**FIGURE  
4-15**

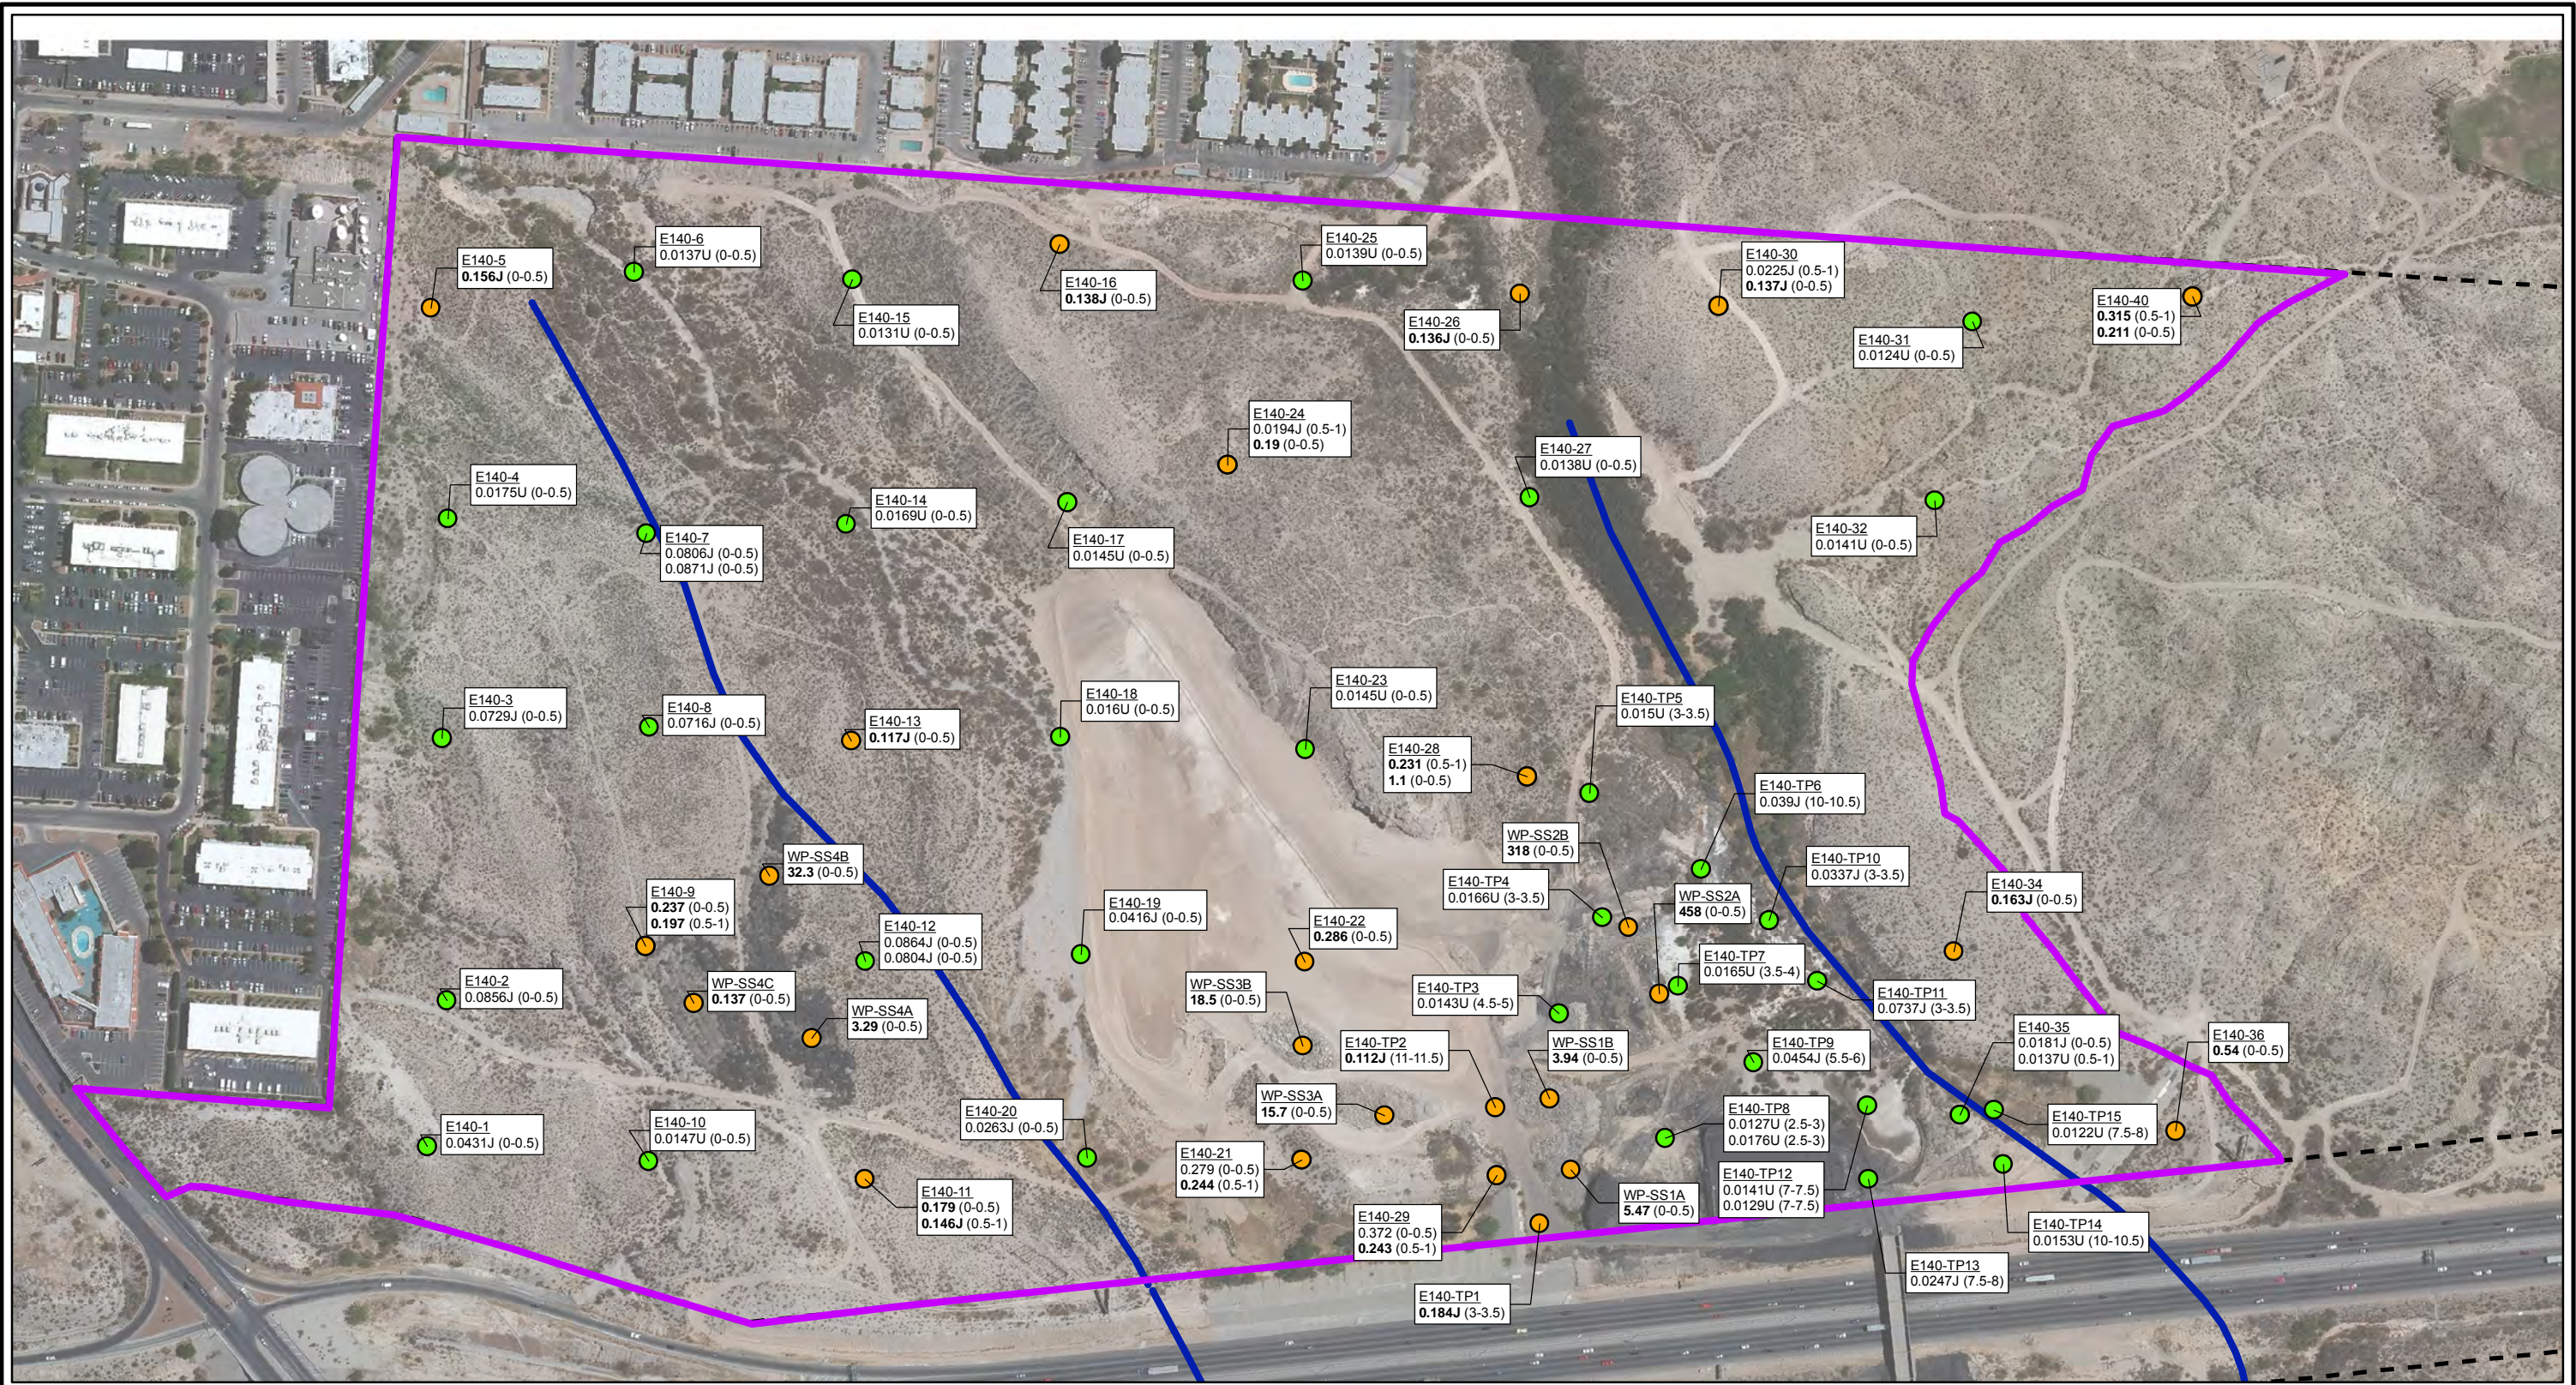
**NOTE:**  
 Screening Level (RRR SAI-Res = 0.11 mg/kg)  
**Bolded** Value exceeds screening level  
 J = Estimated Value  
 U = Not detected at or above reporting limit  
 Date of Aerial Photo: 2009
