FORMER EL PASO SMELTER SITE  
 EL PASO, TEXAS

**ARSENIC DISTRIBUTION IN SOIL  
 PARKER BROTHERS ARROYO/BONEYARD**

**FIGURE  
 4-20**

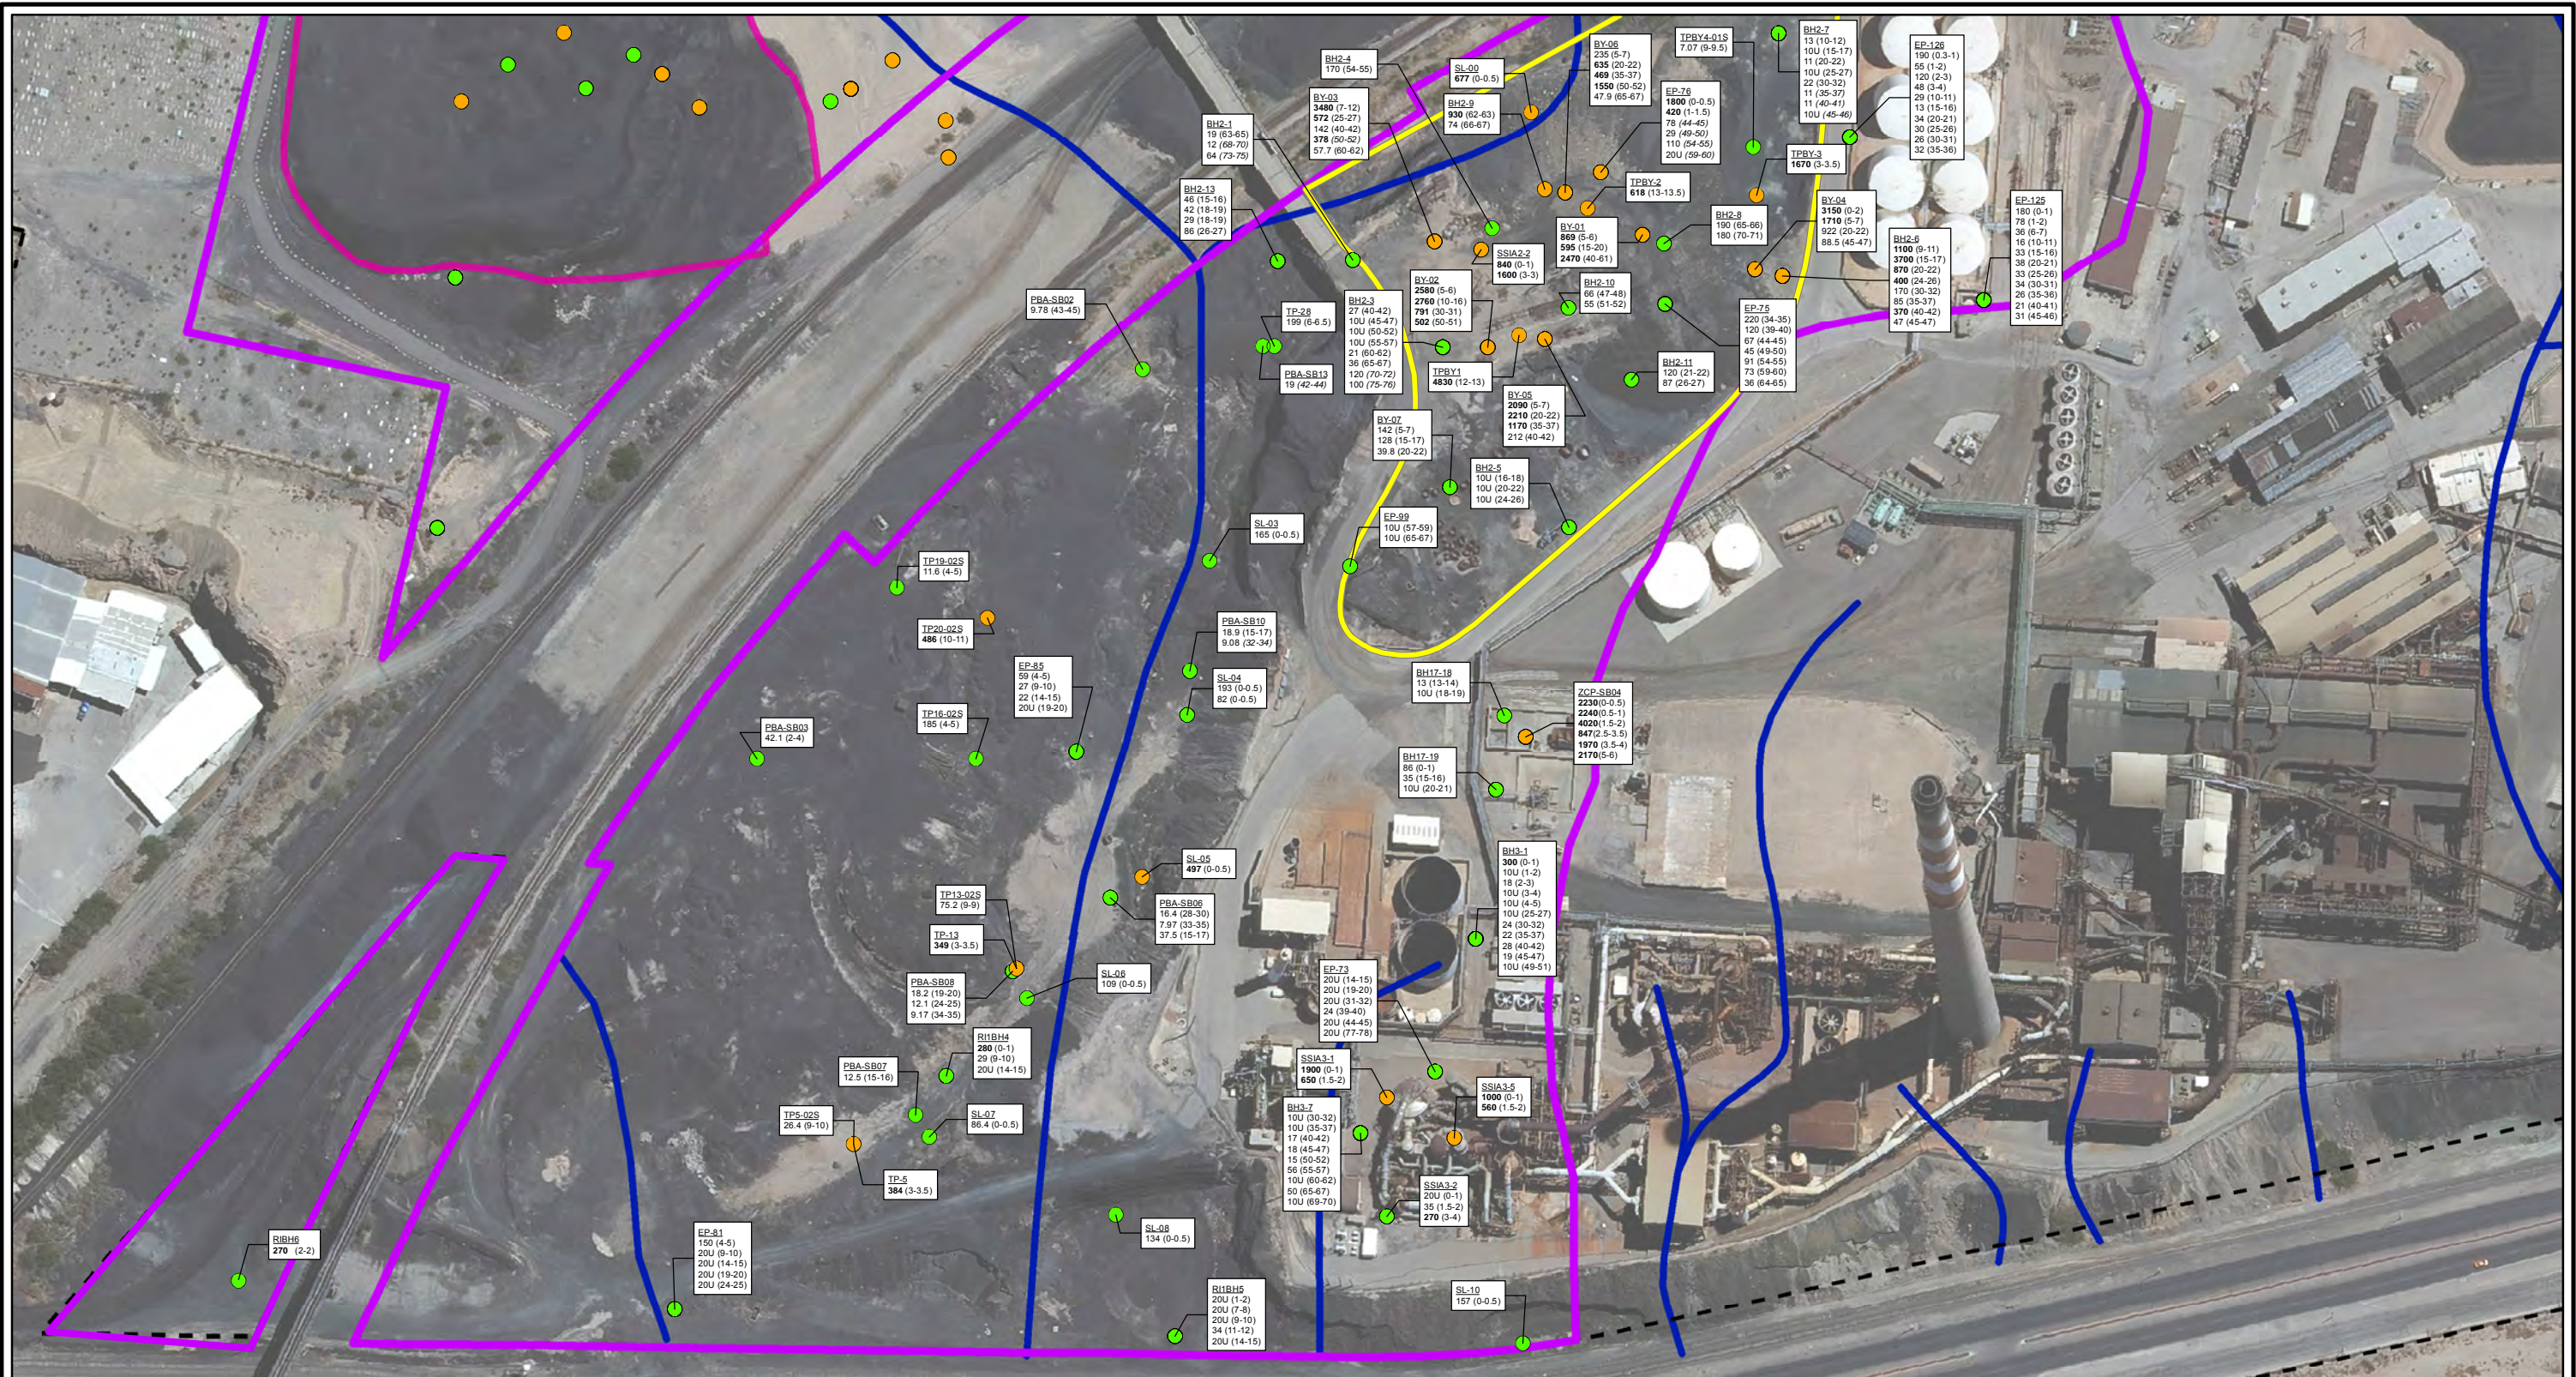
Sample ID  
**SL-07**  
 86.4 (0-0.5)  
 Depth (ft bgs)  
 Arsenic Concentration in mg/kg
