FORMER EL PASO SMELTER SITE
EL PASO, TEXAS

**COPPER DISTRIBUTION IN SOIL
PARKER BROTHERS ARROYO/BONEYARD**

**FIGURE
4-24**

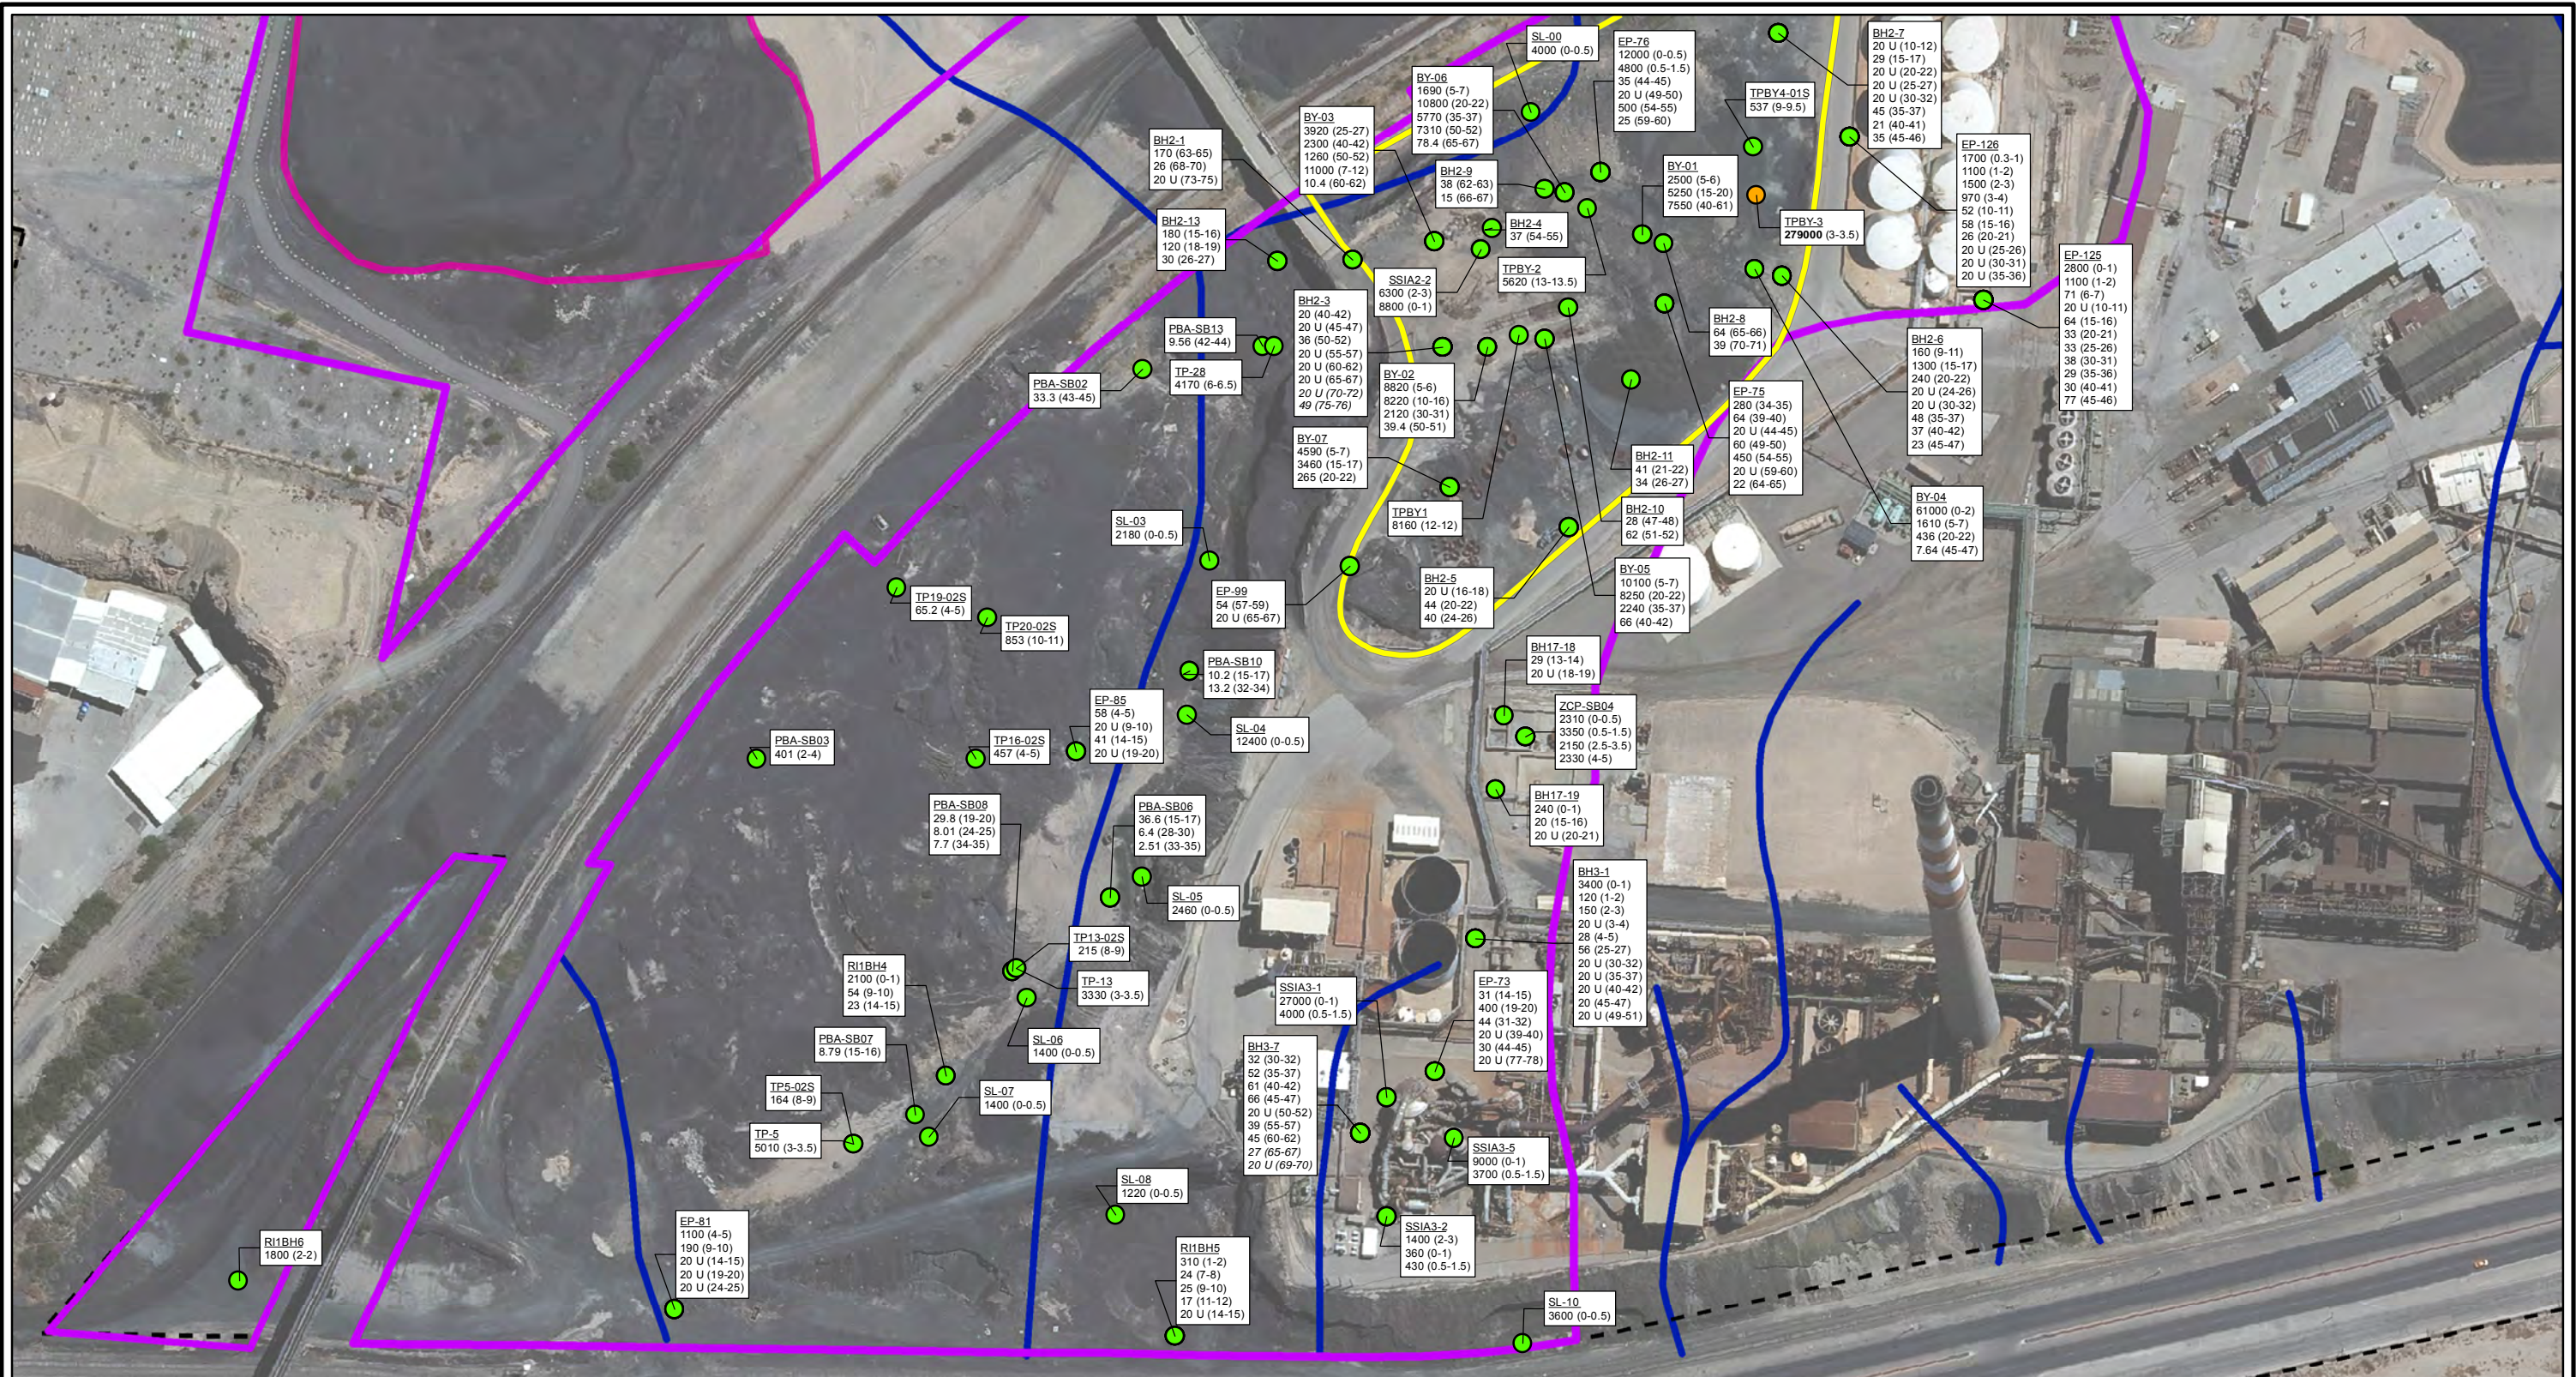
NOTE:
 Screening Level (RRR SAI-Ind = 74000 mg/kg)
