FORMER EL PASO SMELTER SITE
 EL PASO, TEXAS

**LEAD DISTRIBUTION IN SOIL
 PARKER BROTHERS ARROYO/BONEYARD**

**FIGURE
 4-26**

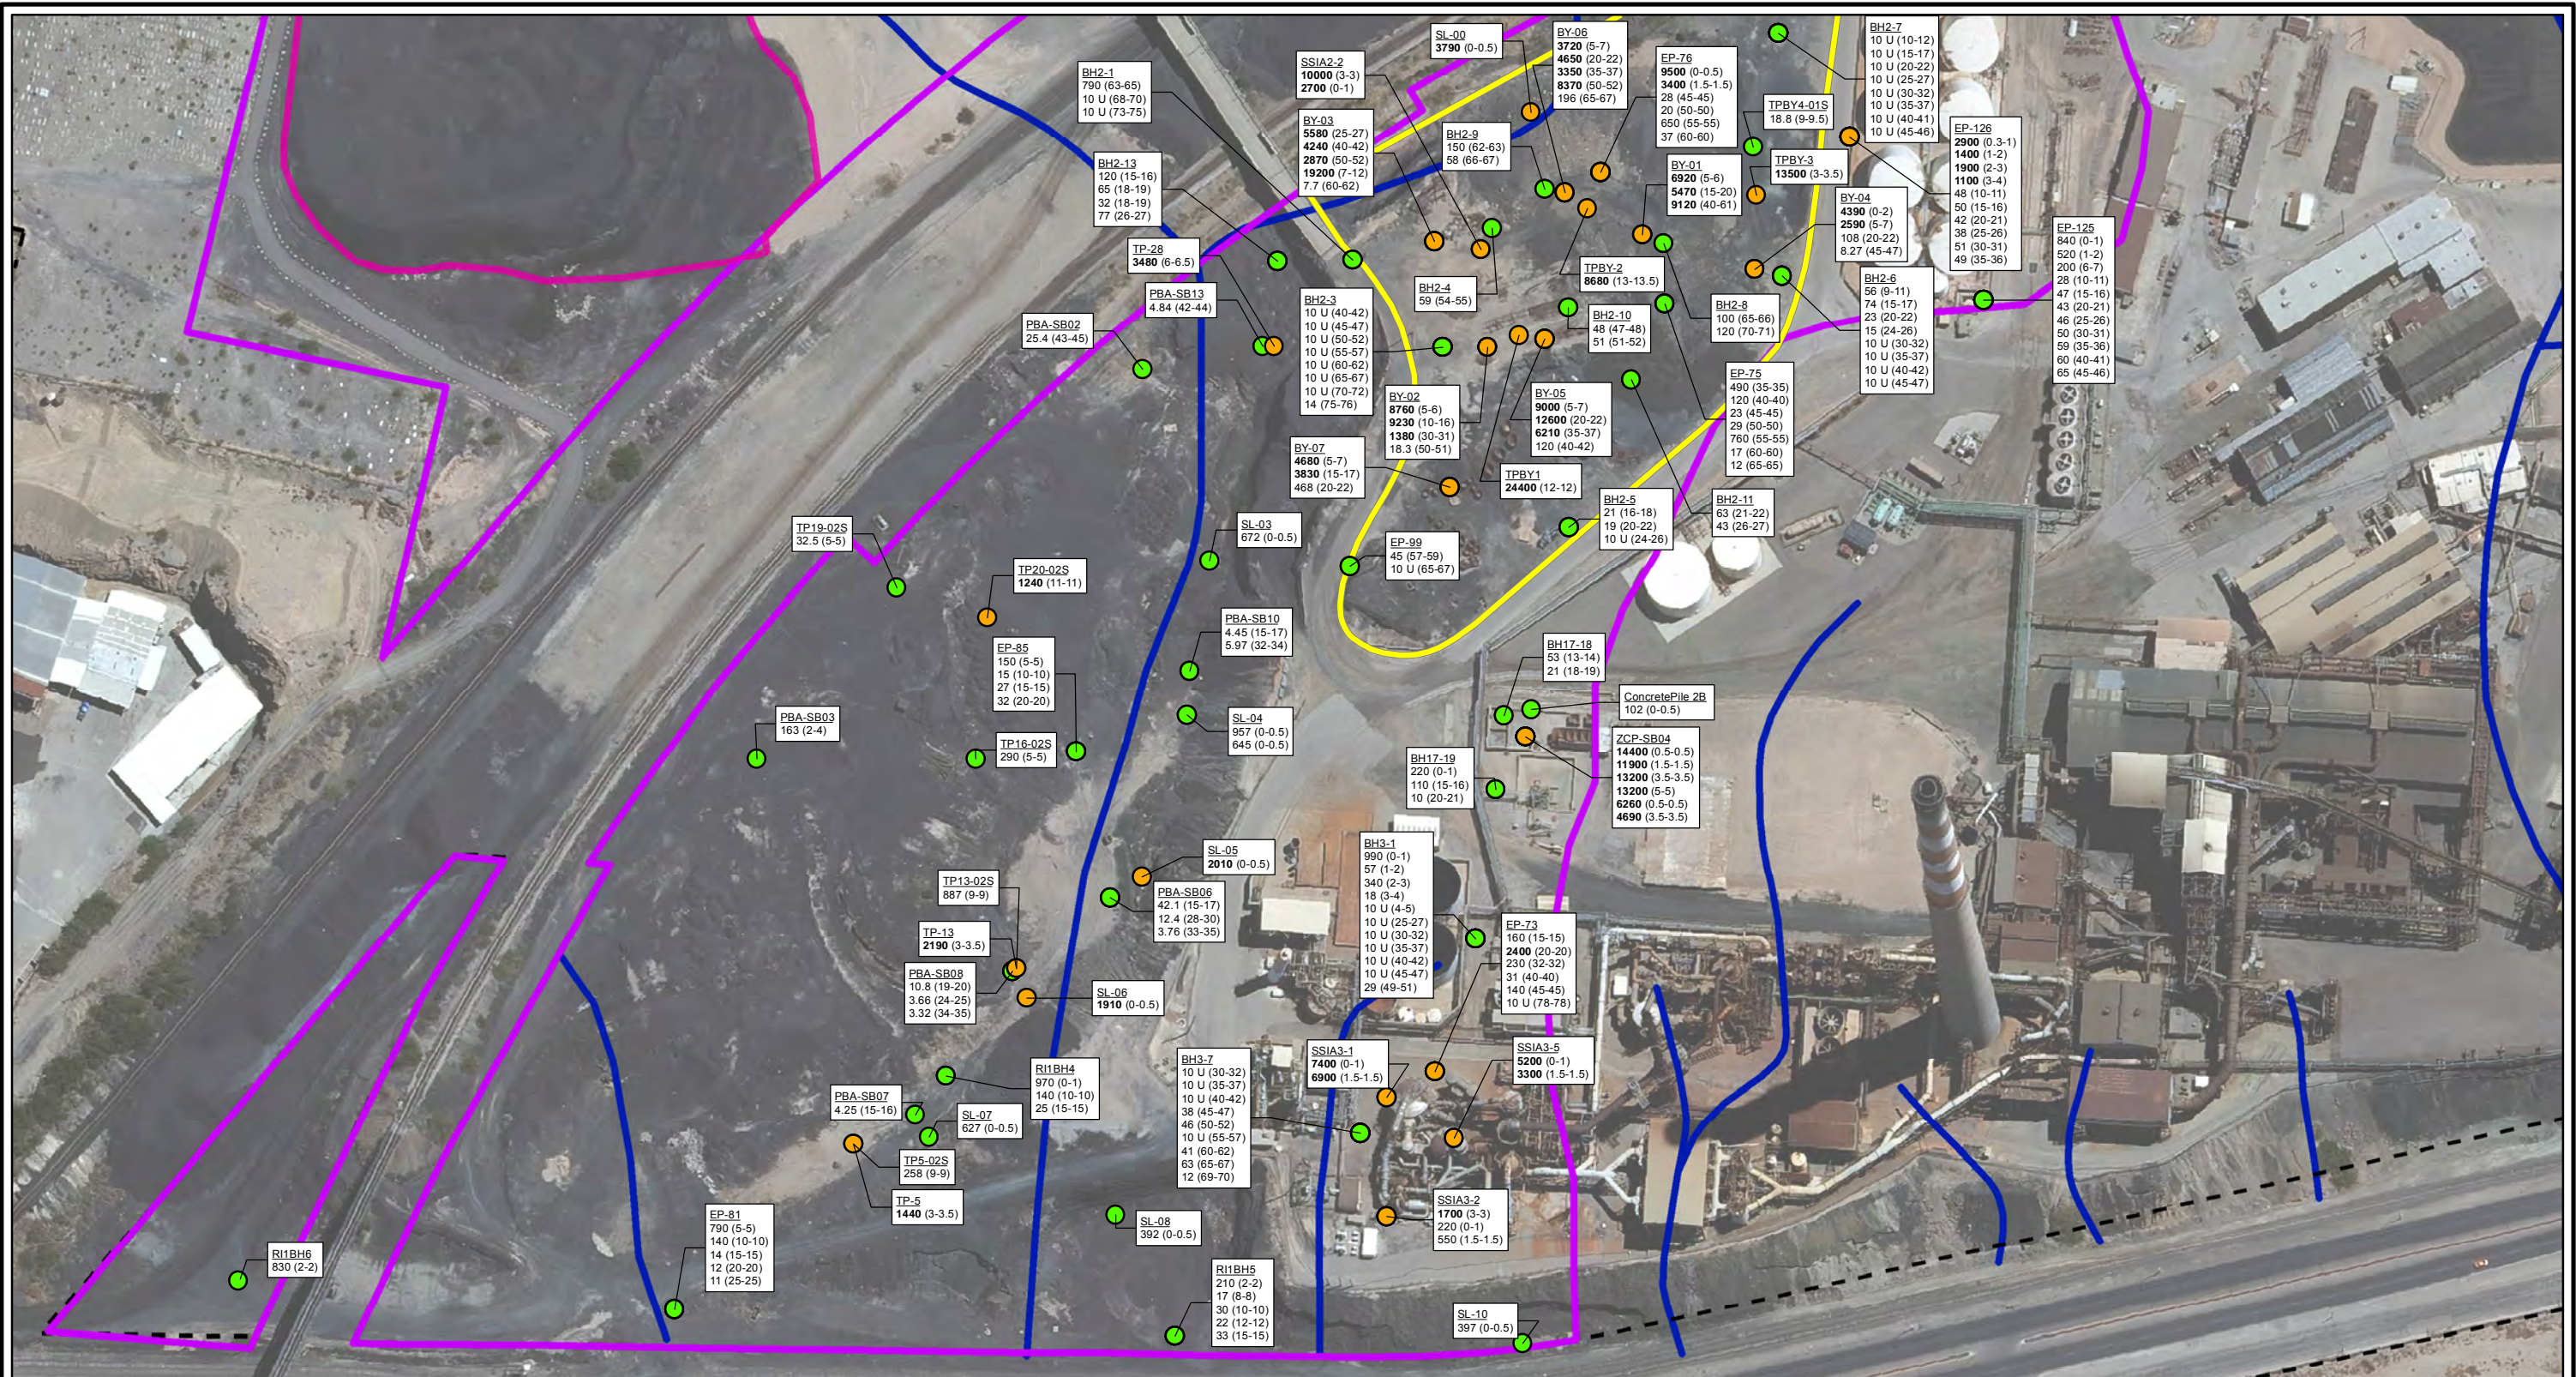
NOTE:
 Screening Level (RRR SAI-Ind = 1000 mg/kg)
Bolded Value exceeds screening level
Italics indicate below the water table
 J = Estimated Value
 U = Not detected at or above reporting limit
 Date of Aerial Photo: 2009
