FORMER EL PASO SMELTER SITE  
EL PASO, TEXAS

**LEAD DISTRIBUTION IN SOIL  
ACID PLANT ARROYO**

**FIGURE  
4-48**

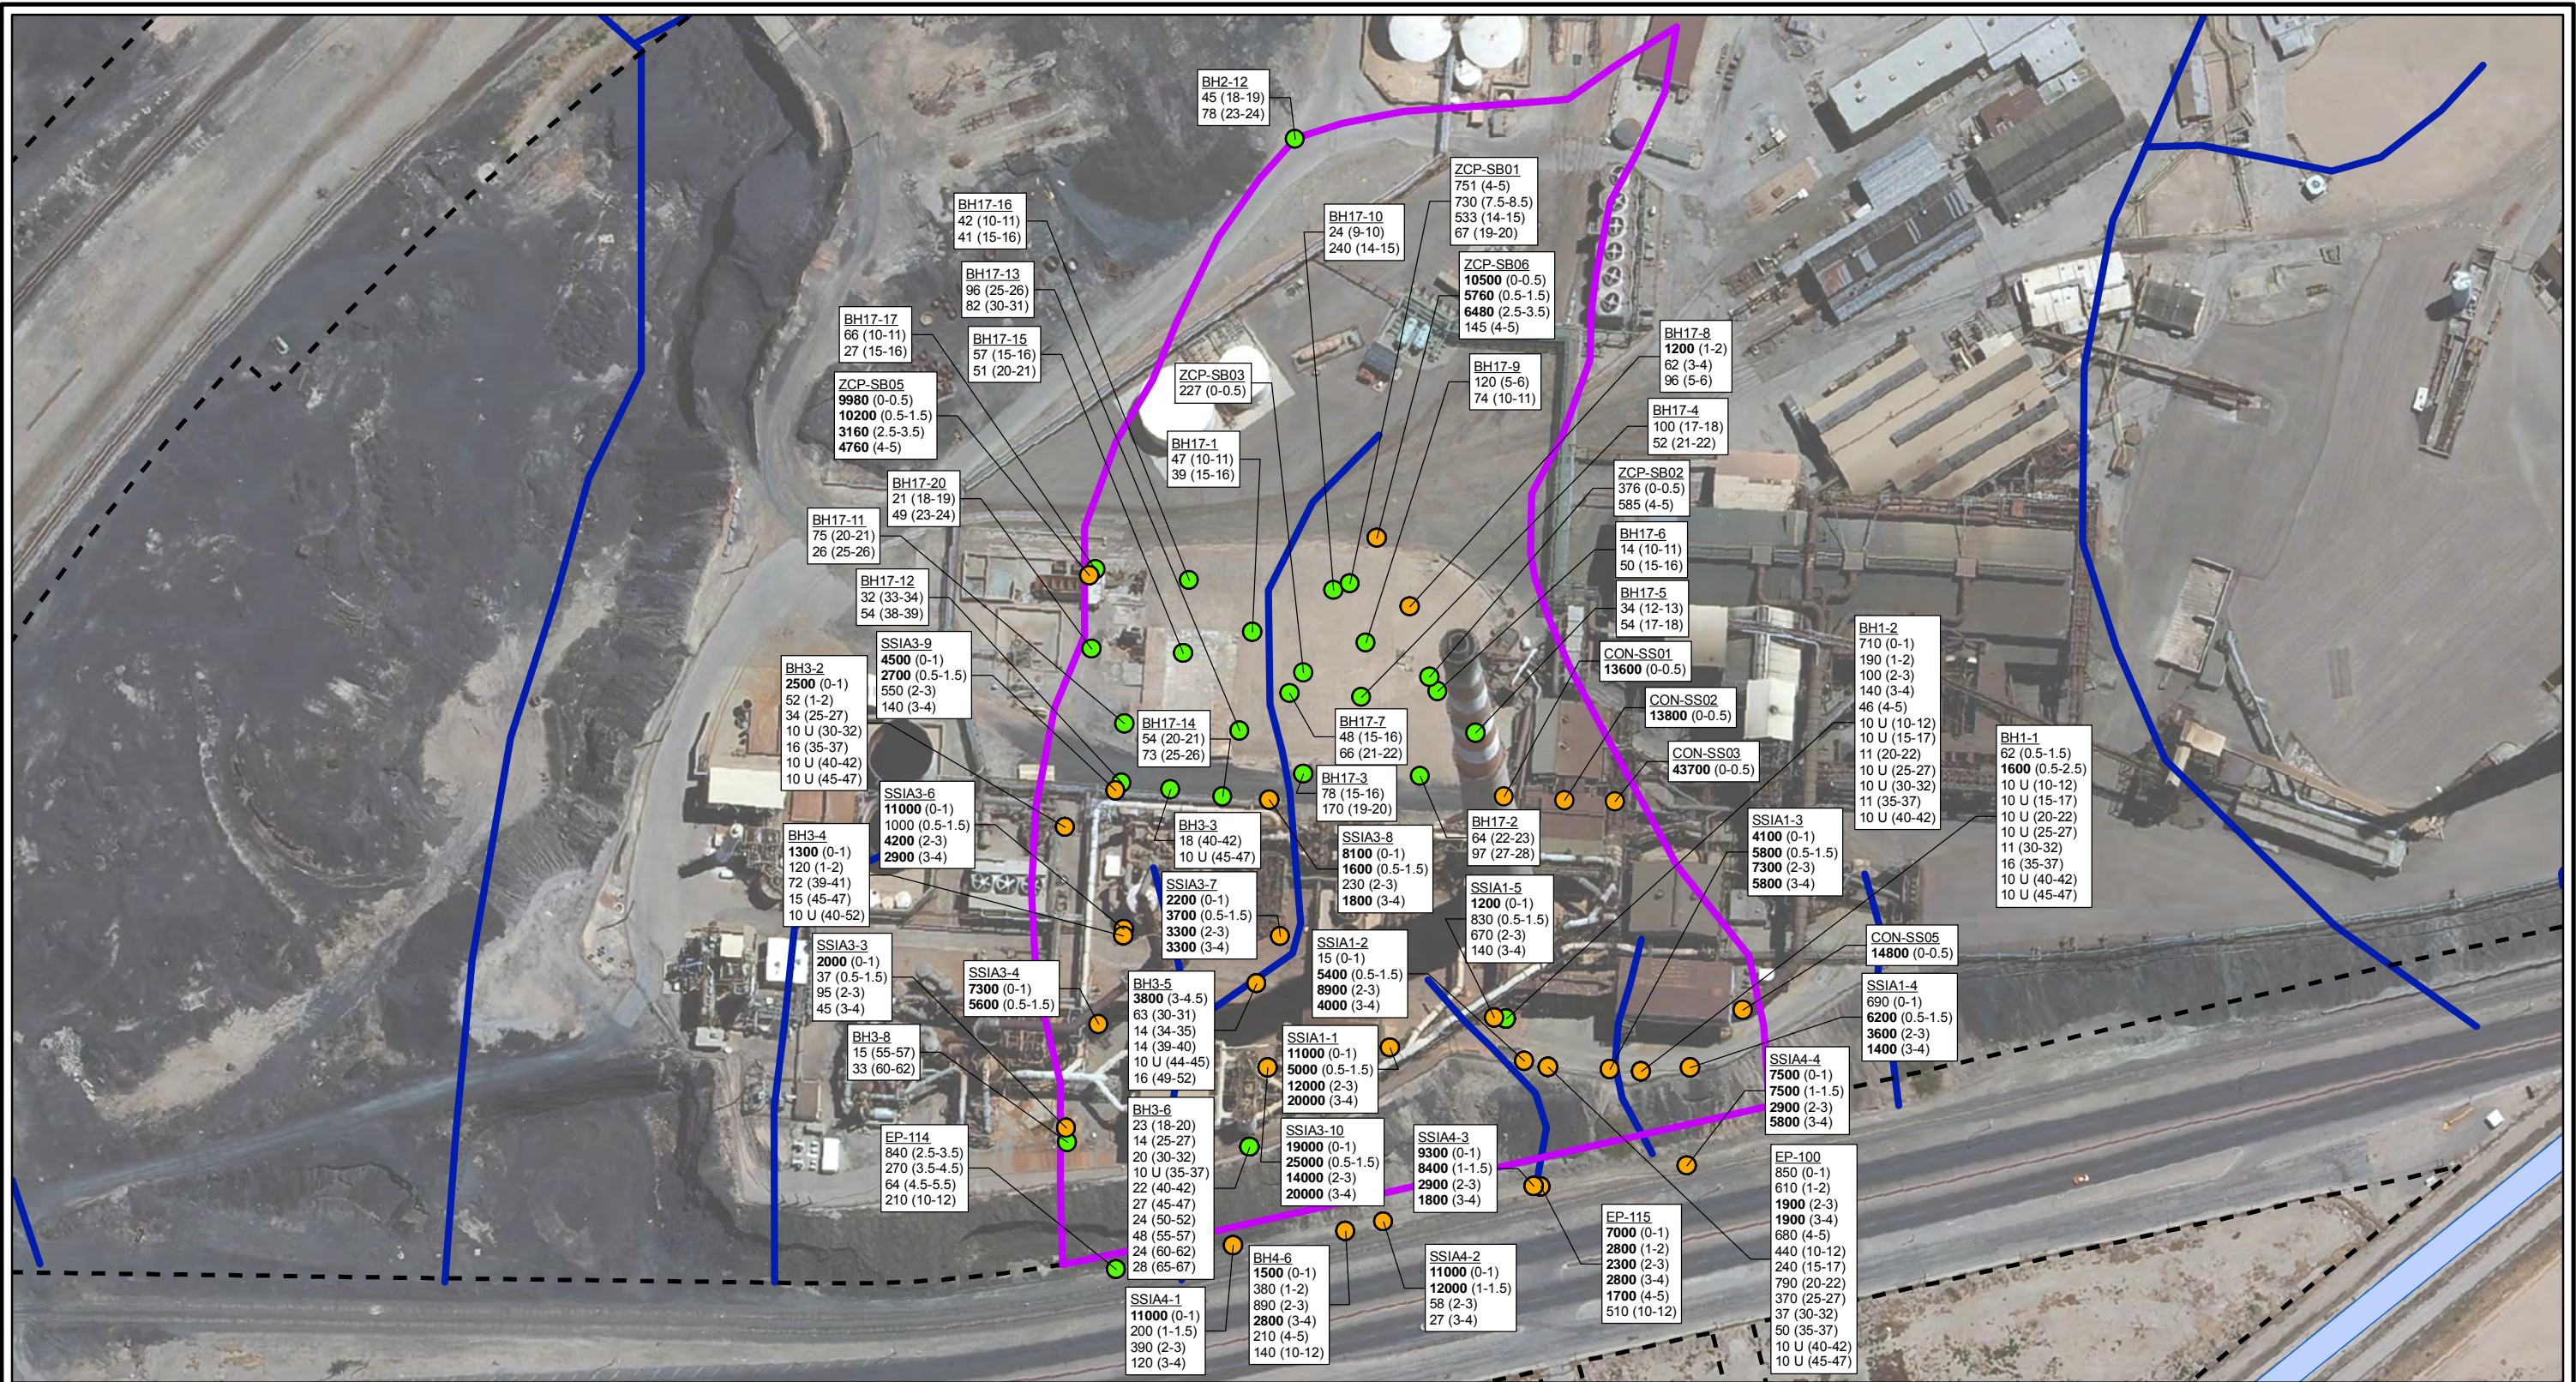
**NOTE:**  
 Screening Level (RRR SAI-Ind = 1000 mg/kg)  
**Bolded** Value exceeds screening level  
*Italics* indicate below the water table  
 J = Estimated Value  
 U = Not detected at or above reporting limit  
 Date of Aerial Photo: 2009
