FORMER EL PASO SMELTER SITE
 EL PASO, TEXAS

**ARSENIC DISTRIBUTION IN SOIL
 EAST PROPERTY**

**FIGURE
 4-8**

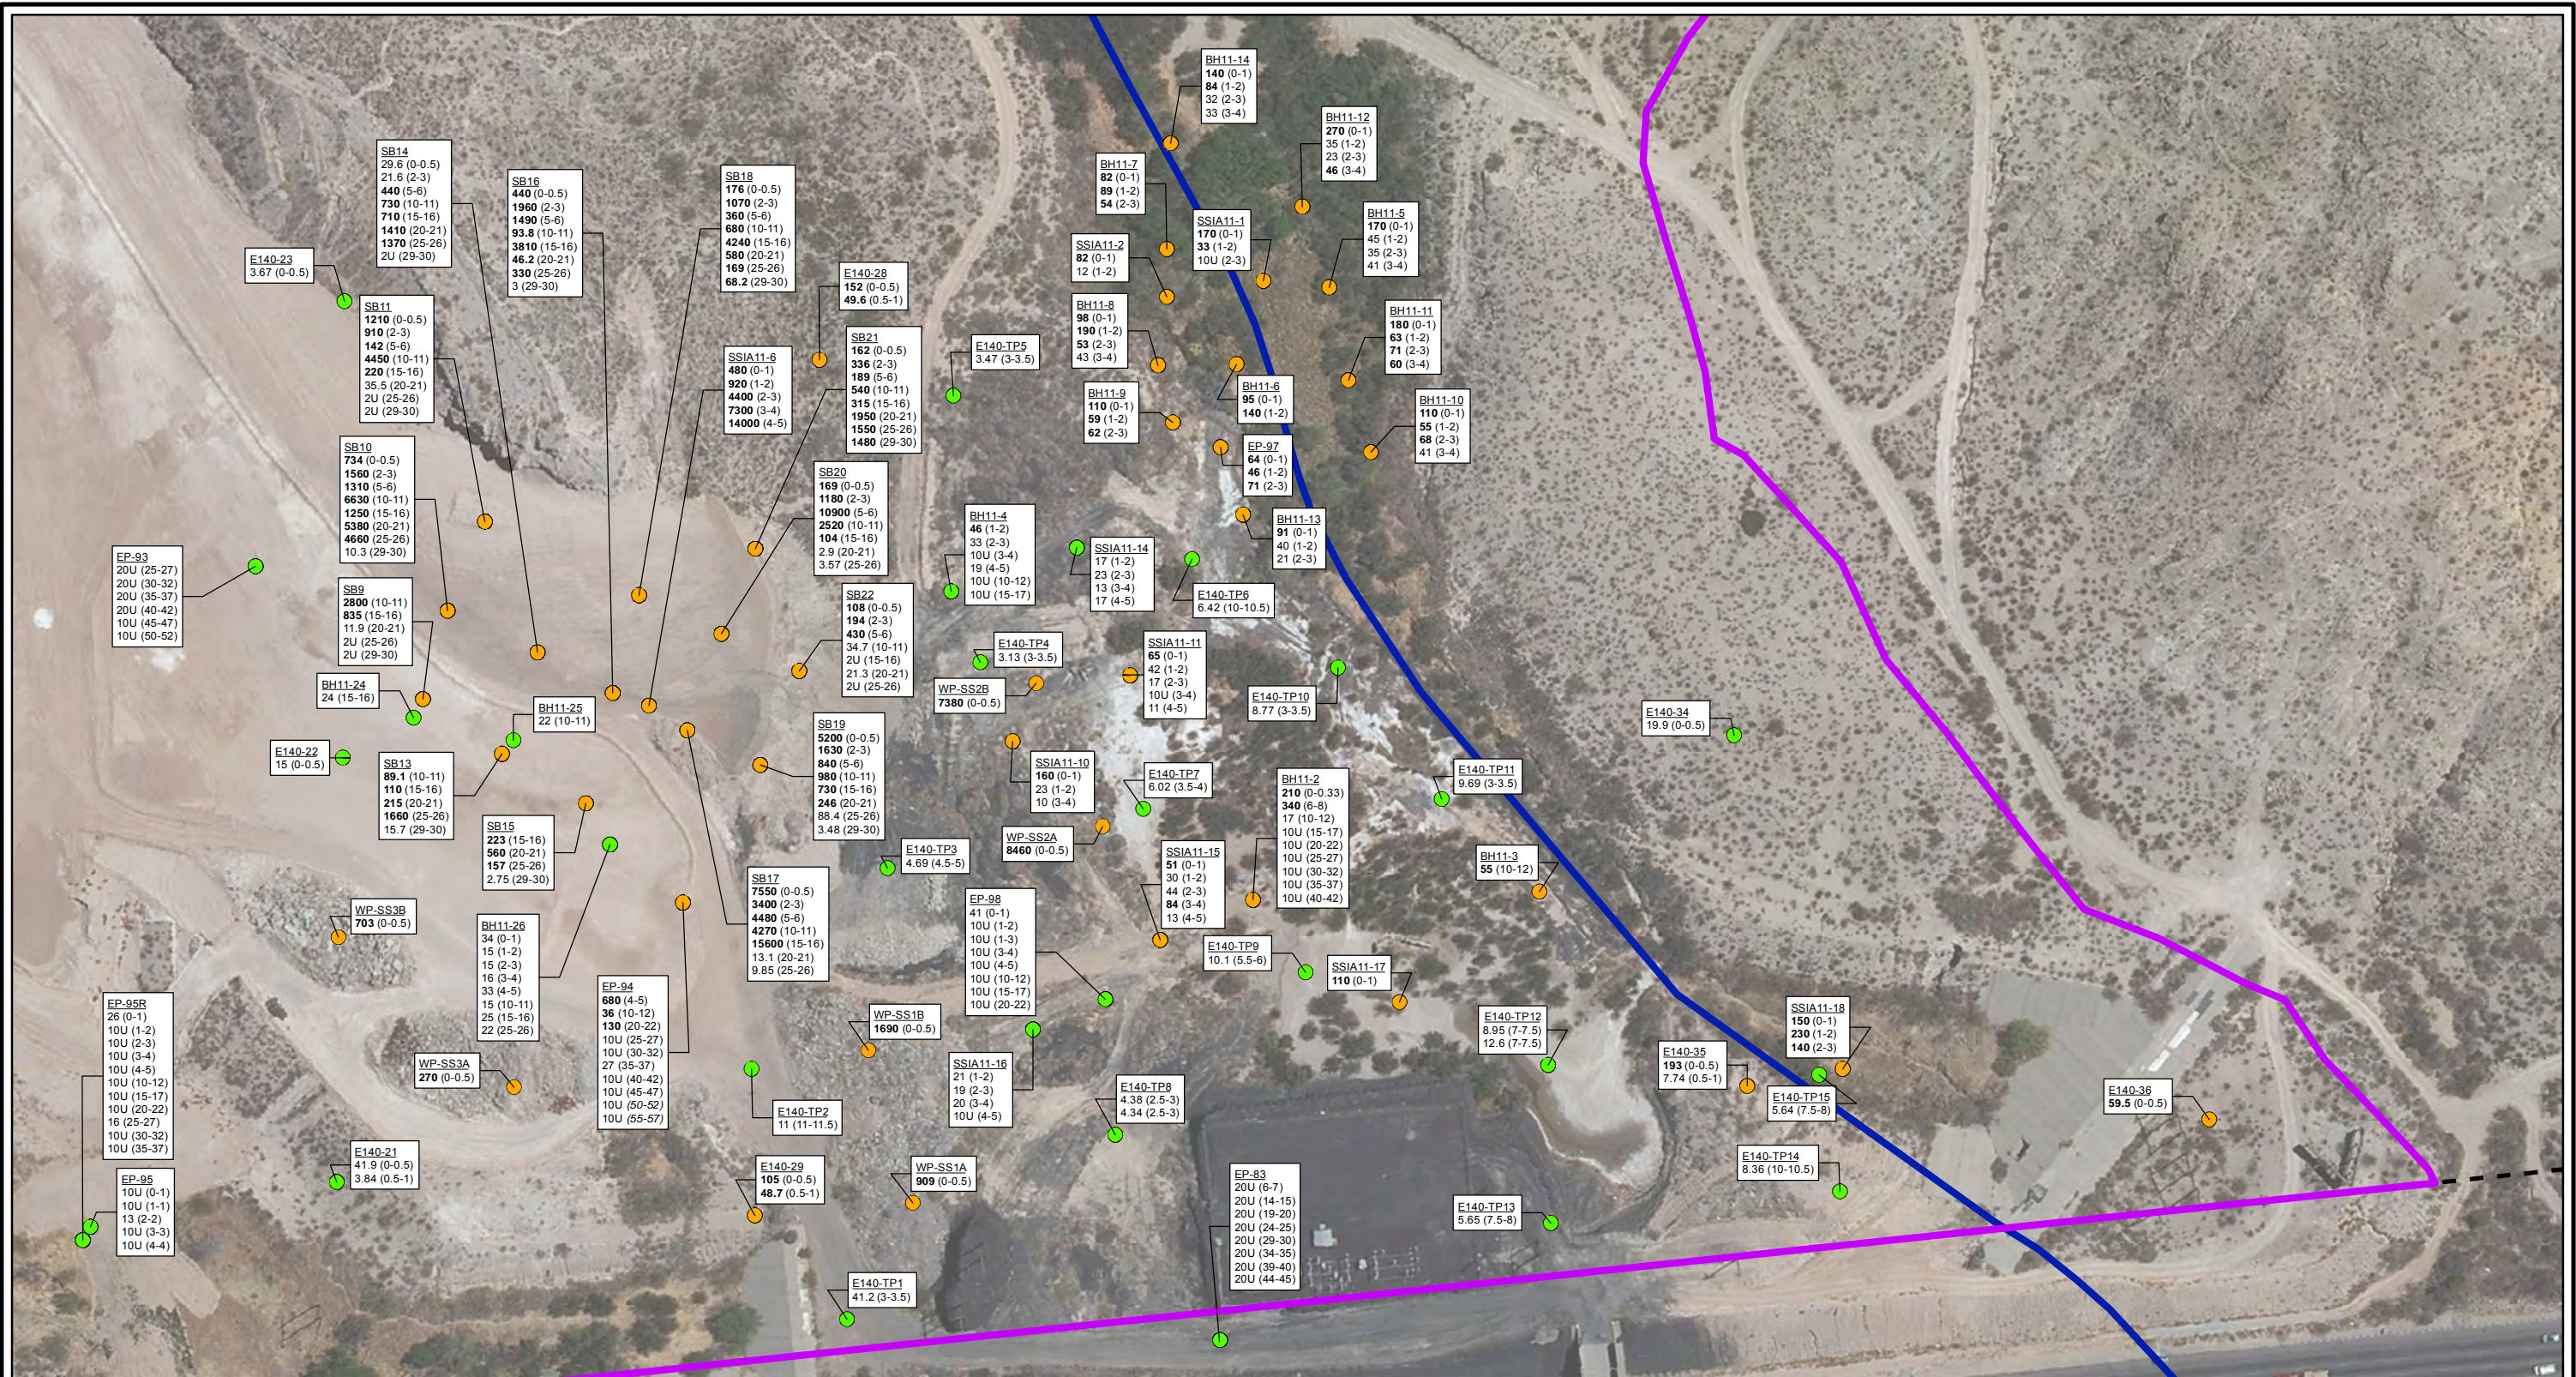
NOTE:
 Screening Level (RRR SAI-Res = 46 mg/kg)
Bolded Value exceeds screening level
Italics indicate below the water table
 J = Estimated Value
 U = Not detected at or above reporting limit
 Date of Aerial Photo: 2009

Sample ID
E140-29
 105 (0-0.5)
 48.7 (0.5-1)
 Depth (ft bgs)
 Arsenic Concentration in mg/kg
