FORMER EL PASO SMELTER SITE
EL PASO, TEXAS

**CADMIUM DISTRIBUTION IN SOIL
EAST PROPERTY**

**FIGURE
4-9**

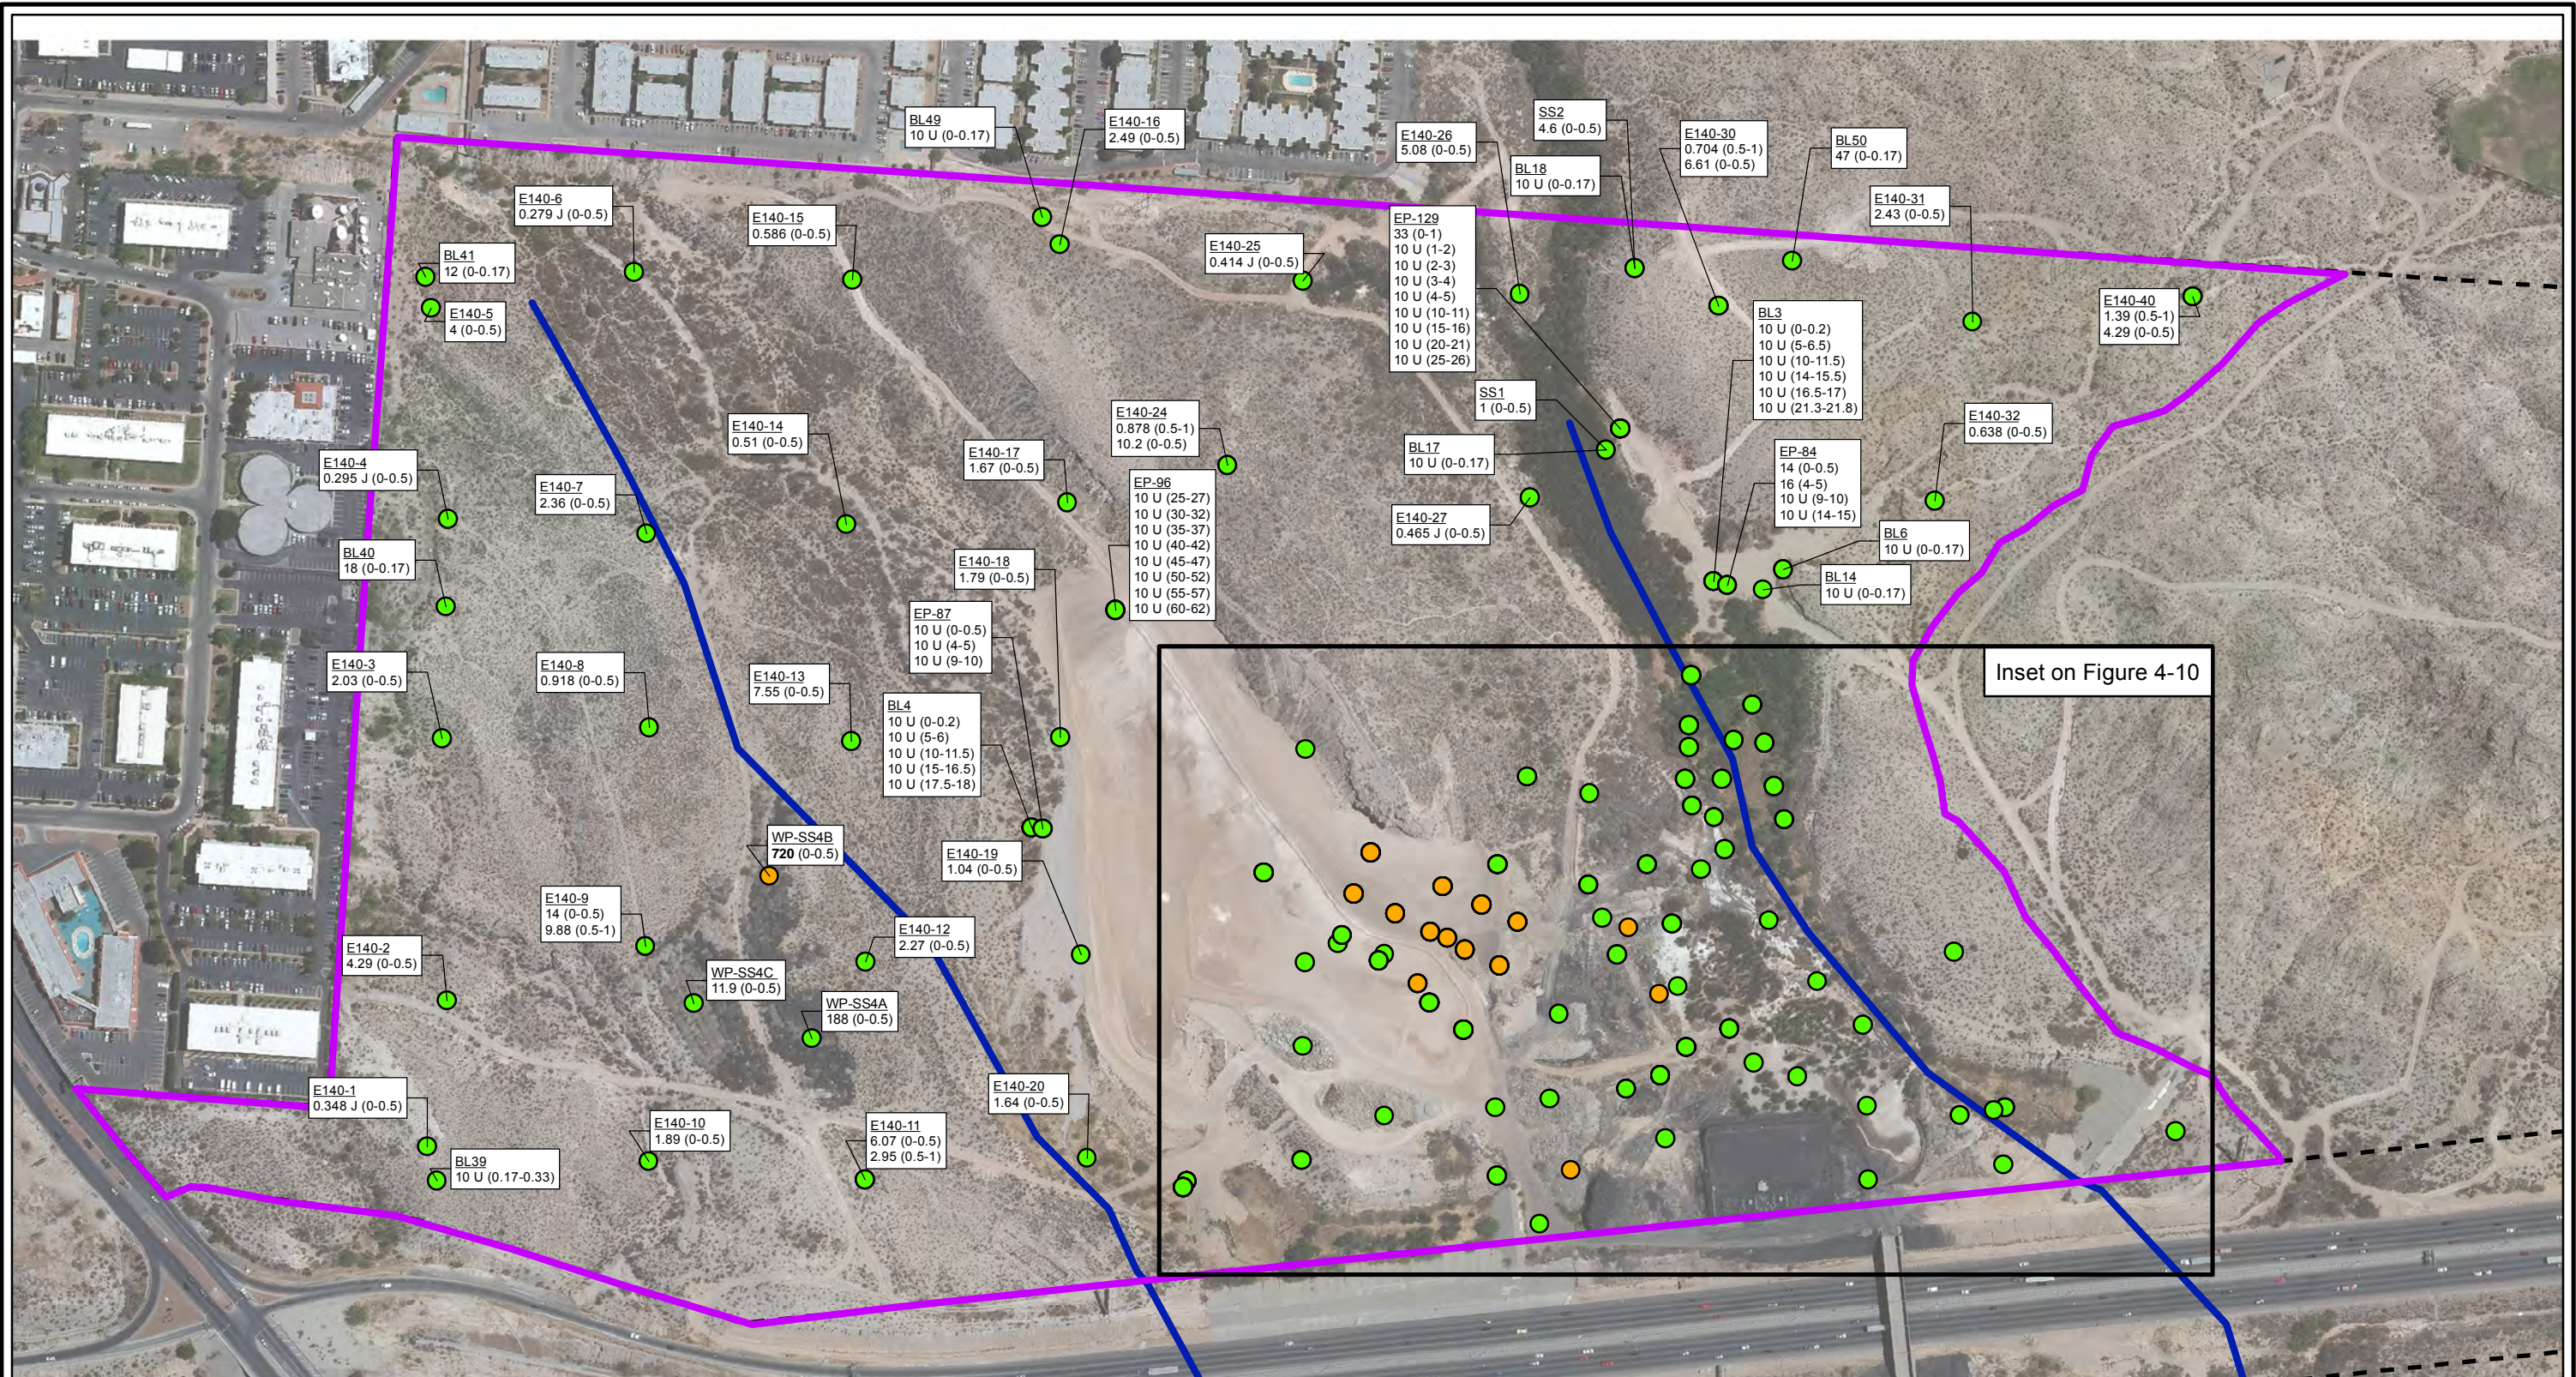
NOTE:
 Screening Level (RRR SAI-Res = 240 mg/kg)
Bolded Value exceeds screening level
 J = Estimated Value
 U = Not detected at or above reporting limit
 Date of Aerial Photo: 2009
