FORMER EL PASO SMELTER SITE  
EL PASO, TEXAS

**COPPER DISTRIBUTION IN SOIL  
EAST PROPERTY**

**FIGURE  
4-11**

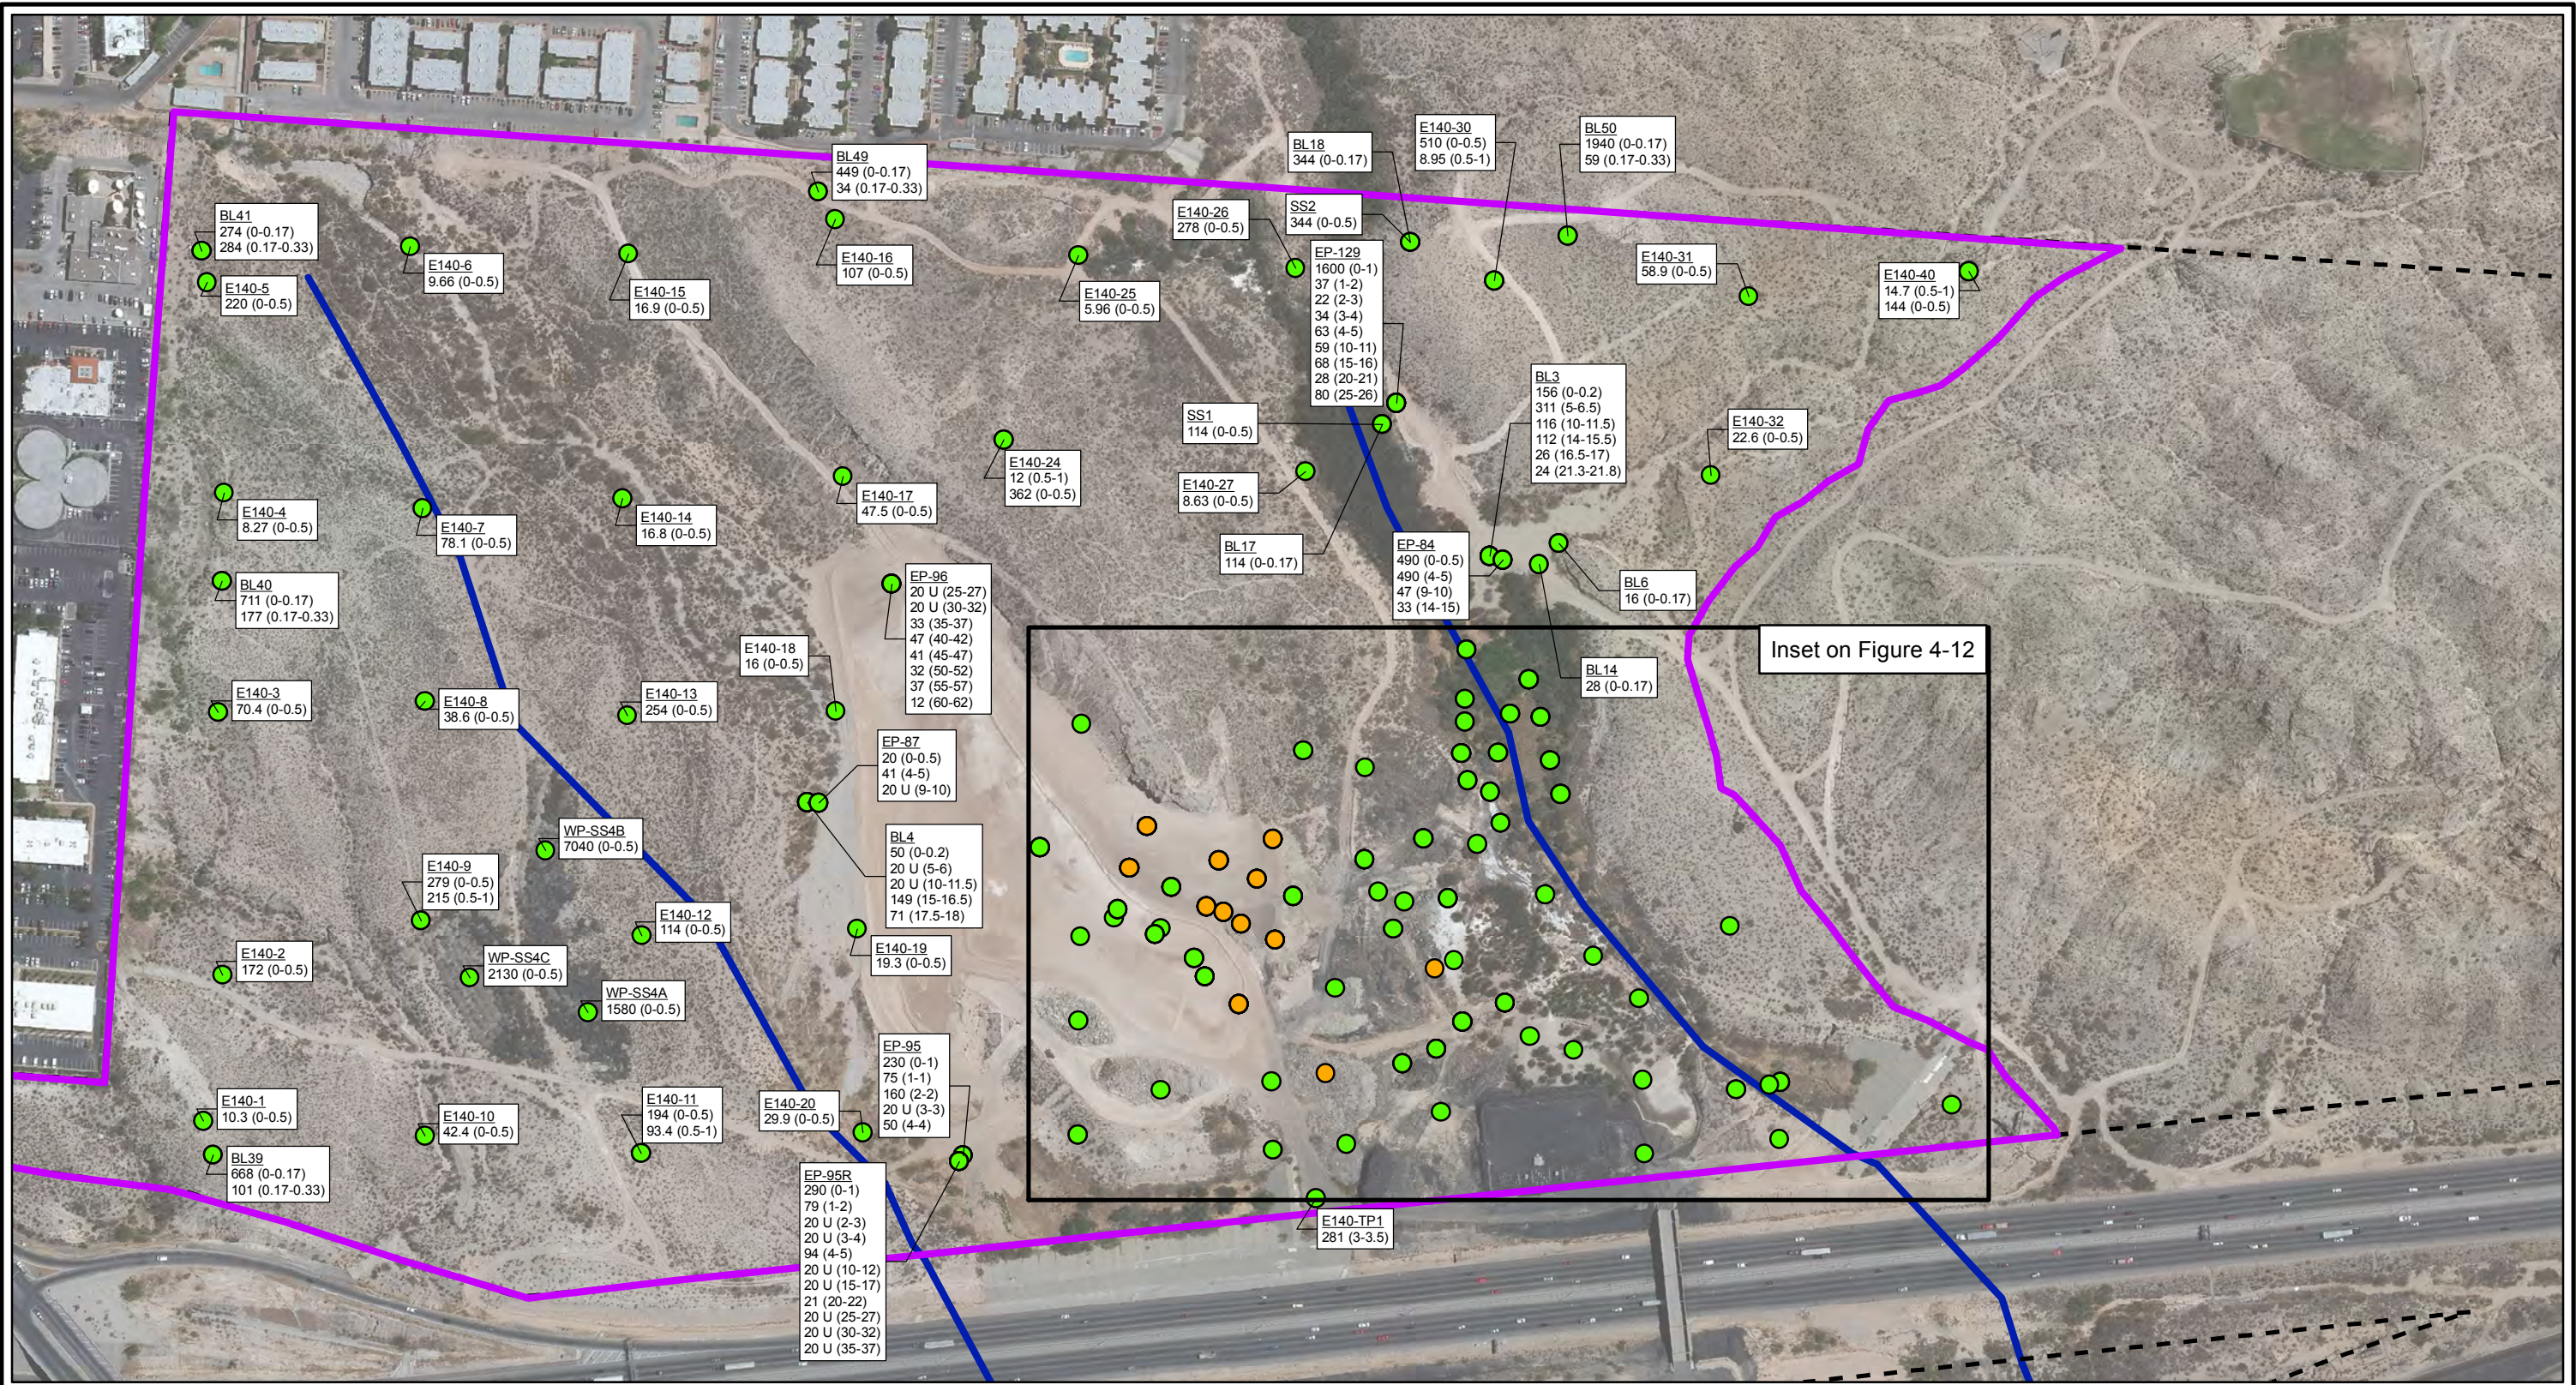
**NOTE:**  
 Screening Level (RRR SAI-Res = 10000 mg/kg)  
**Bolded** Value exceeds screening level  
*Italics* Depth below groundwater  
 J = Estimated Value  
 U = Not detected at or above reporting limit  
 Date of Aerial Photo: 2009
