FORMER EL PASO SMELTER SITE
 EL PASO, TEXAS

**COPPER DISTRIBUTION IN SOIL
 EAST PROPERTY**

**FIGURE
 4-12**

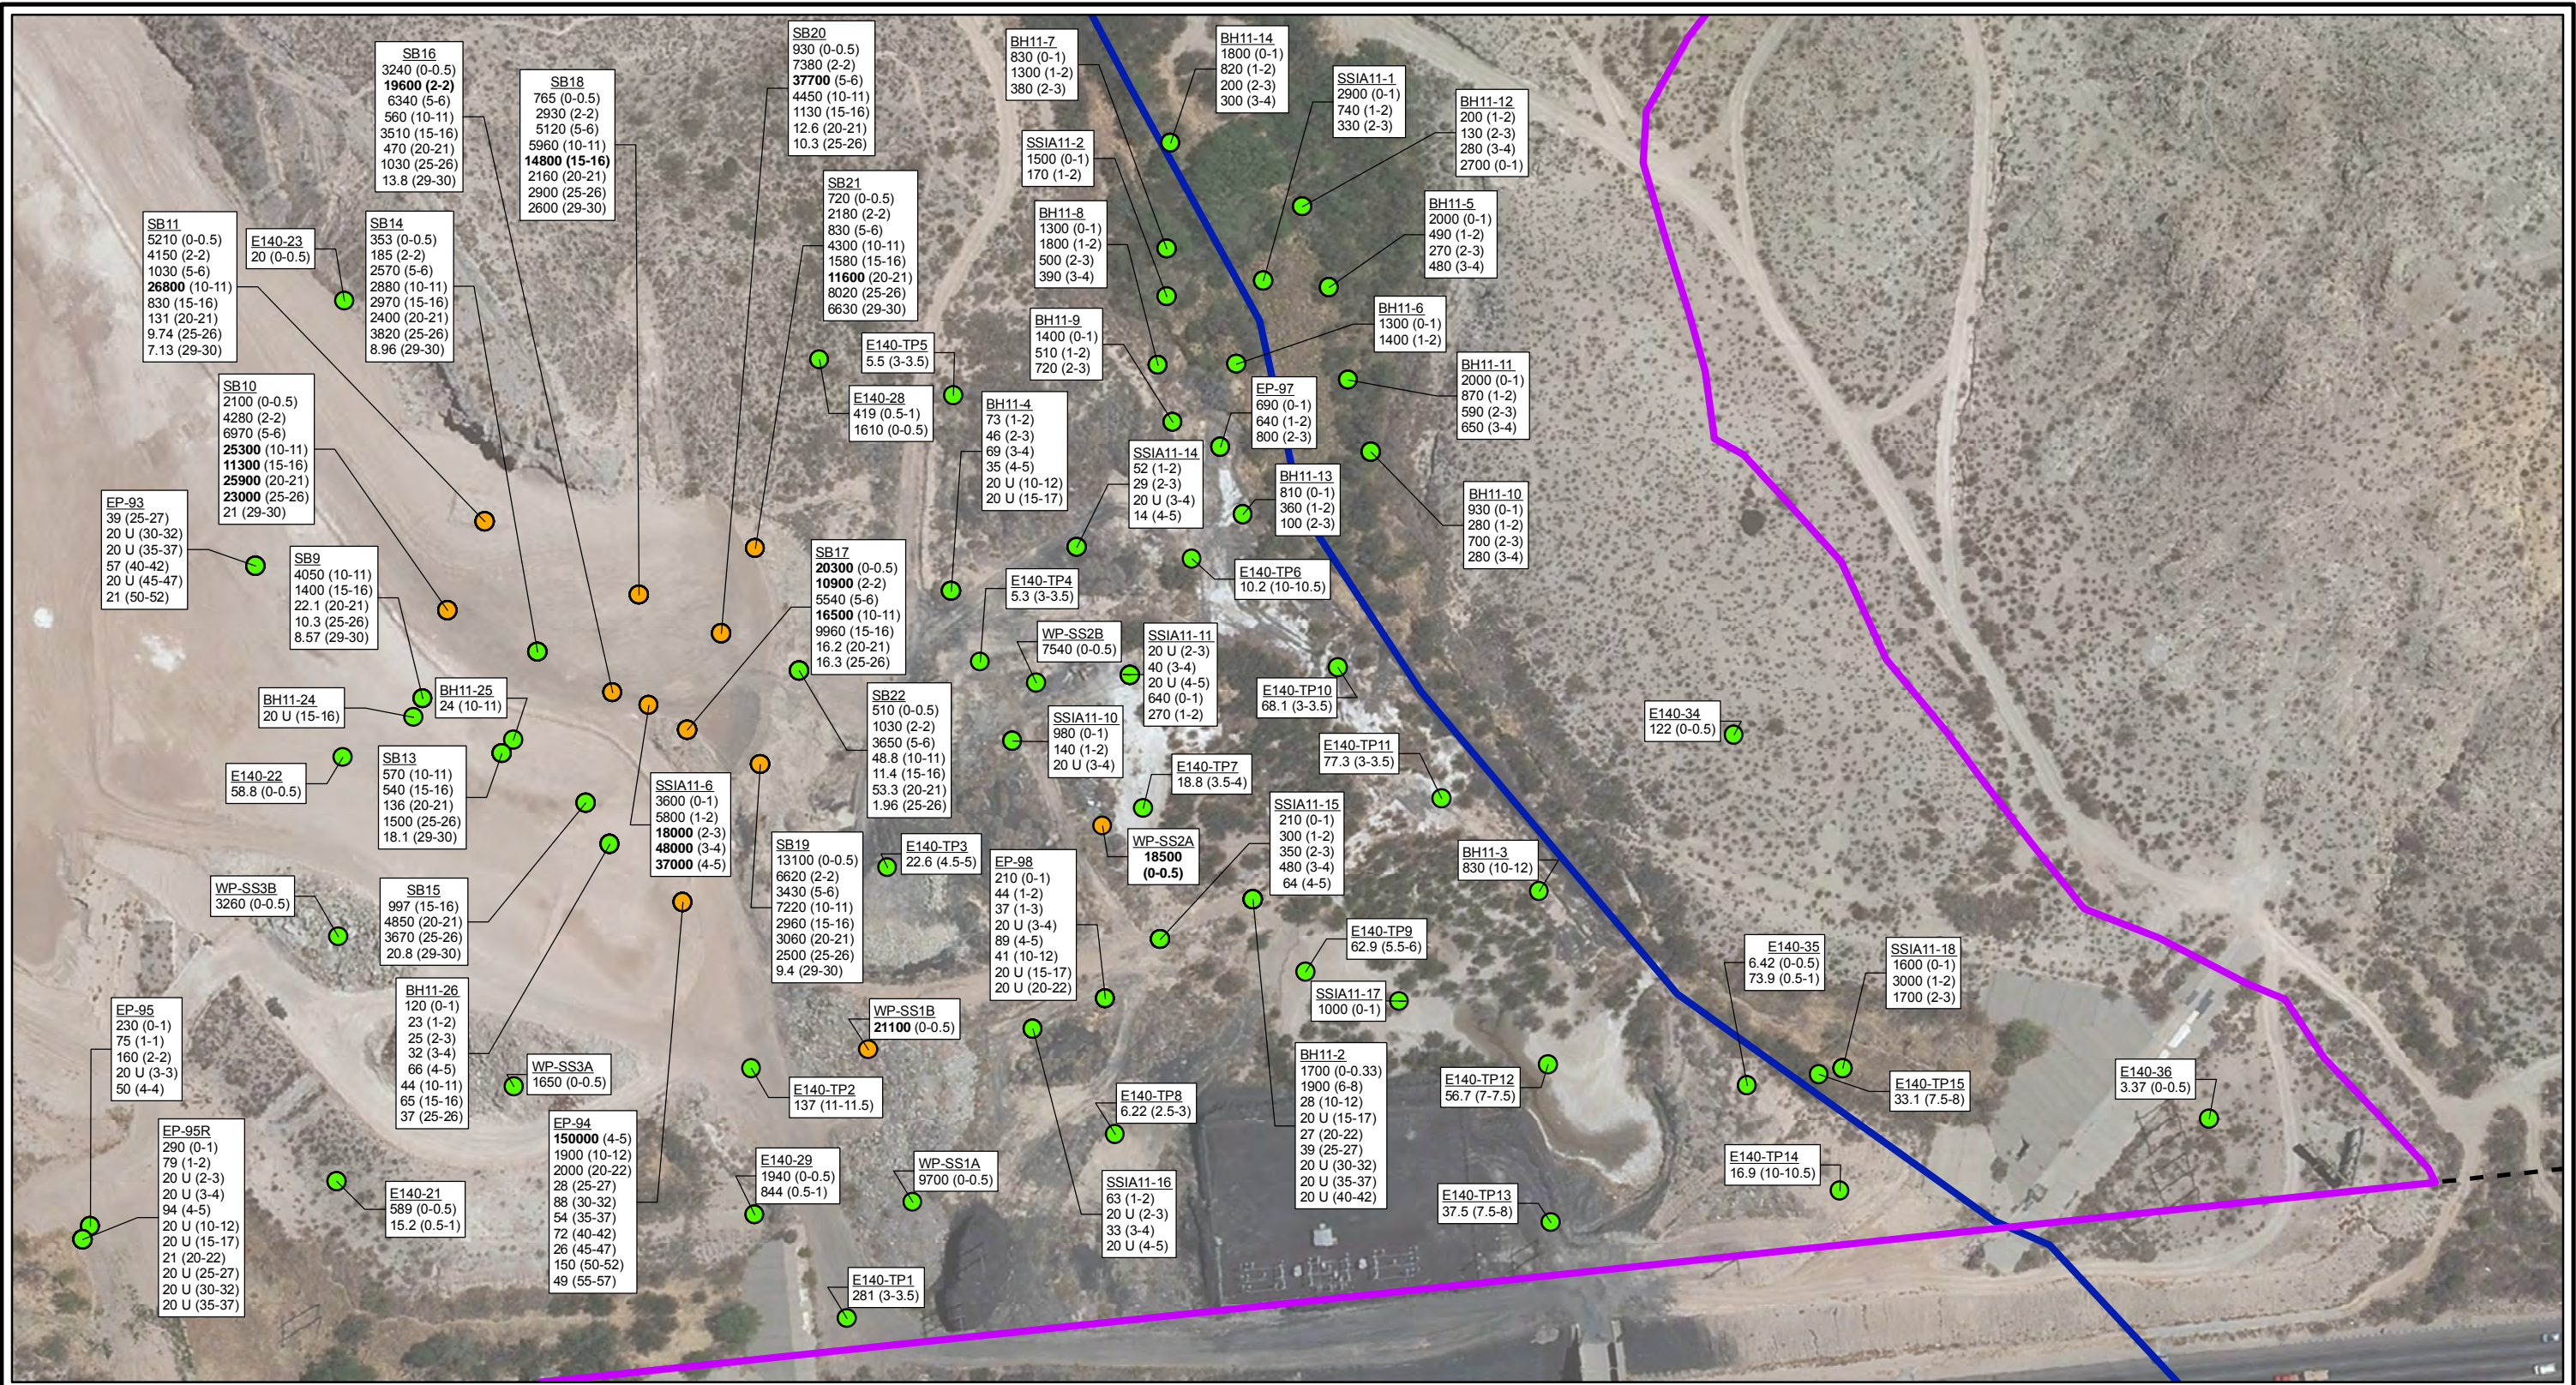
NOTE:
 Screening Level (RRR SAI-Res = 10000 mg/kg)
