FORMER EL PASO SMELTER SITE
EL PASO, TEXAS

**ANTIMONY DISTRIBUTION IN SOIL
PARKER BROTHERS ARROYO/FINES PILE**

**FIGURE
4-18**

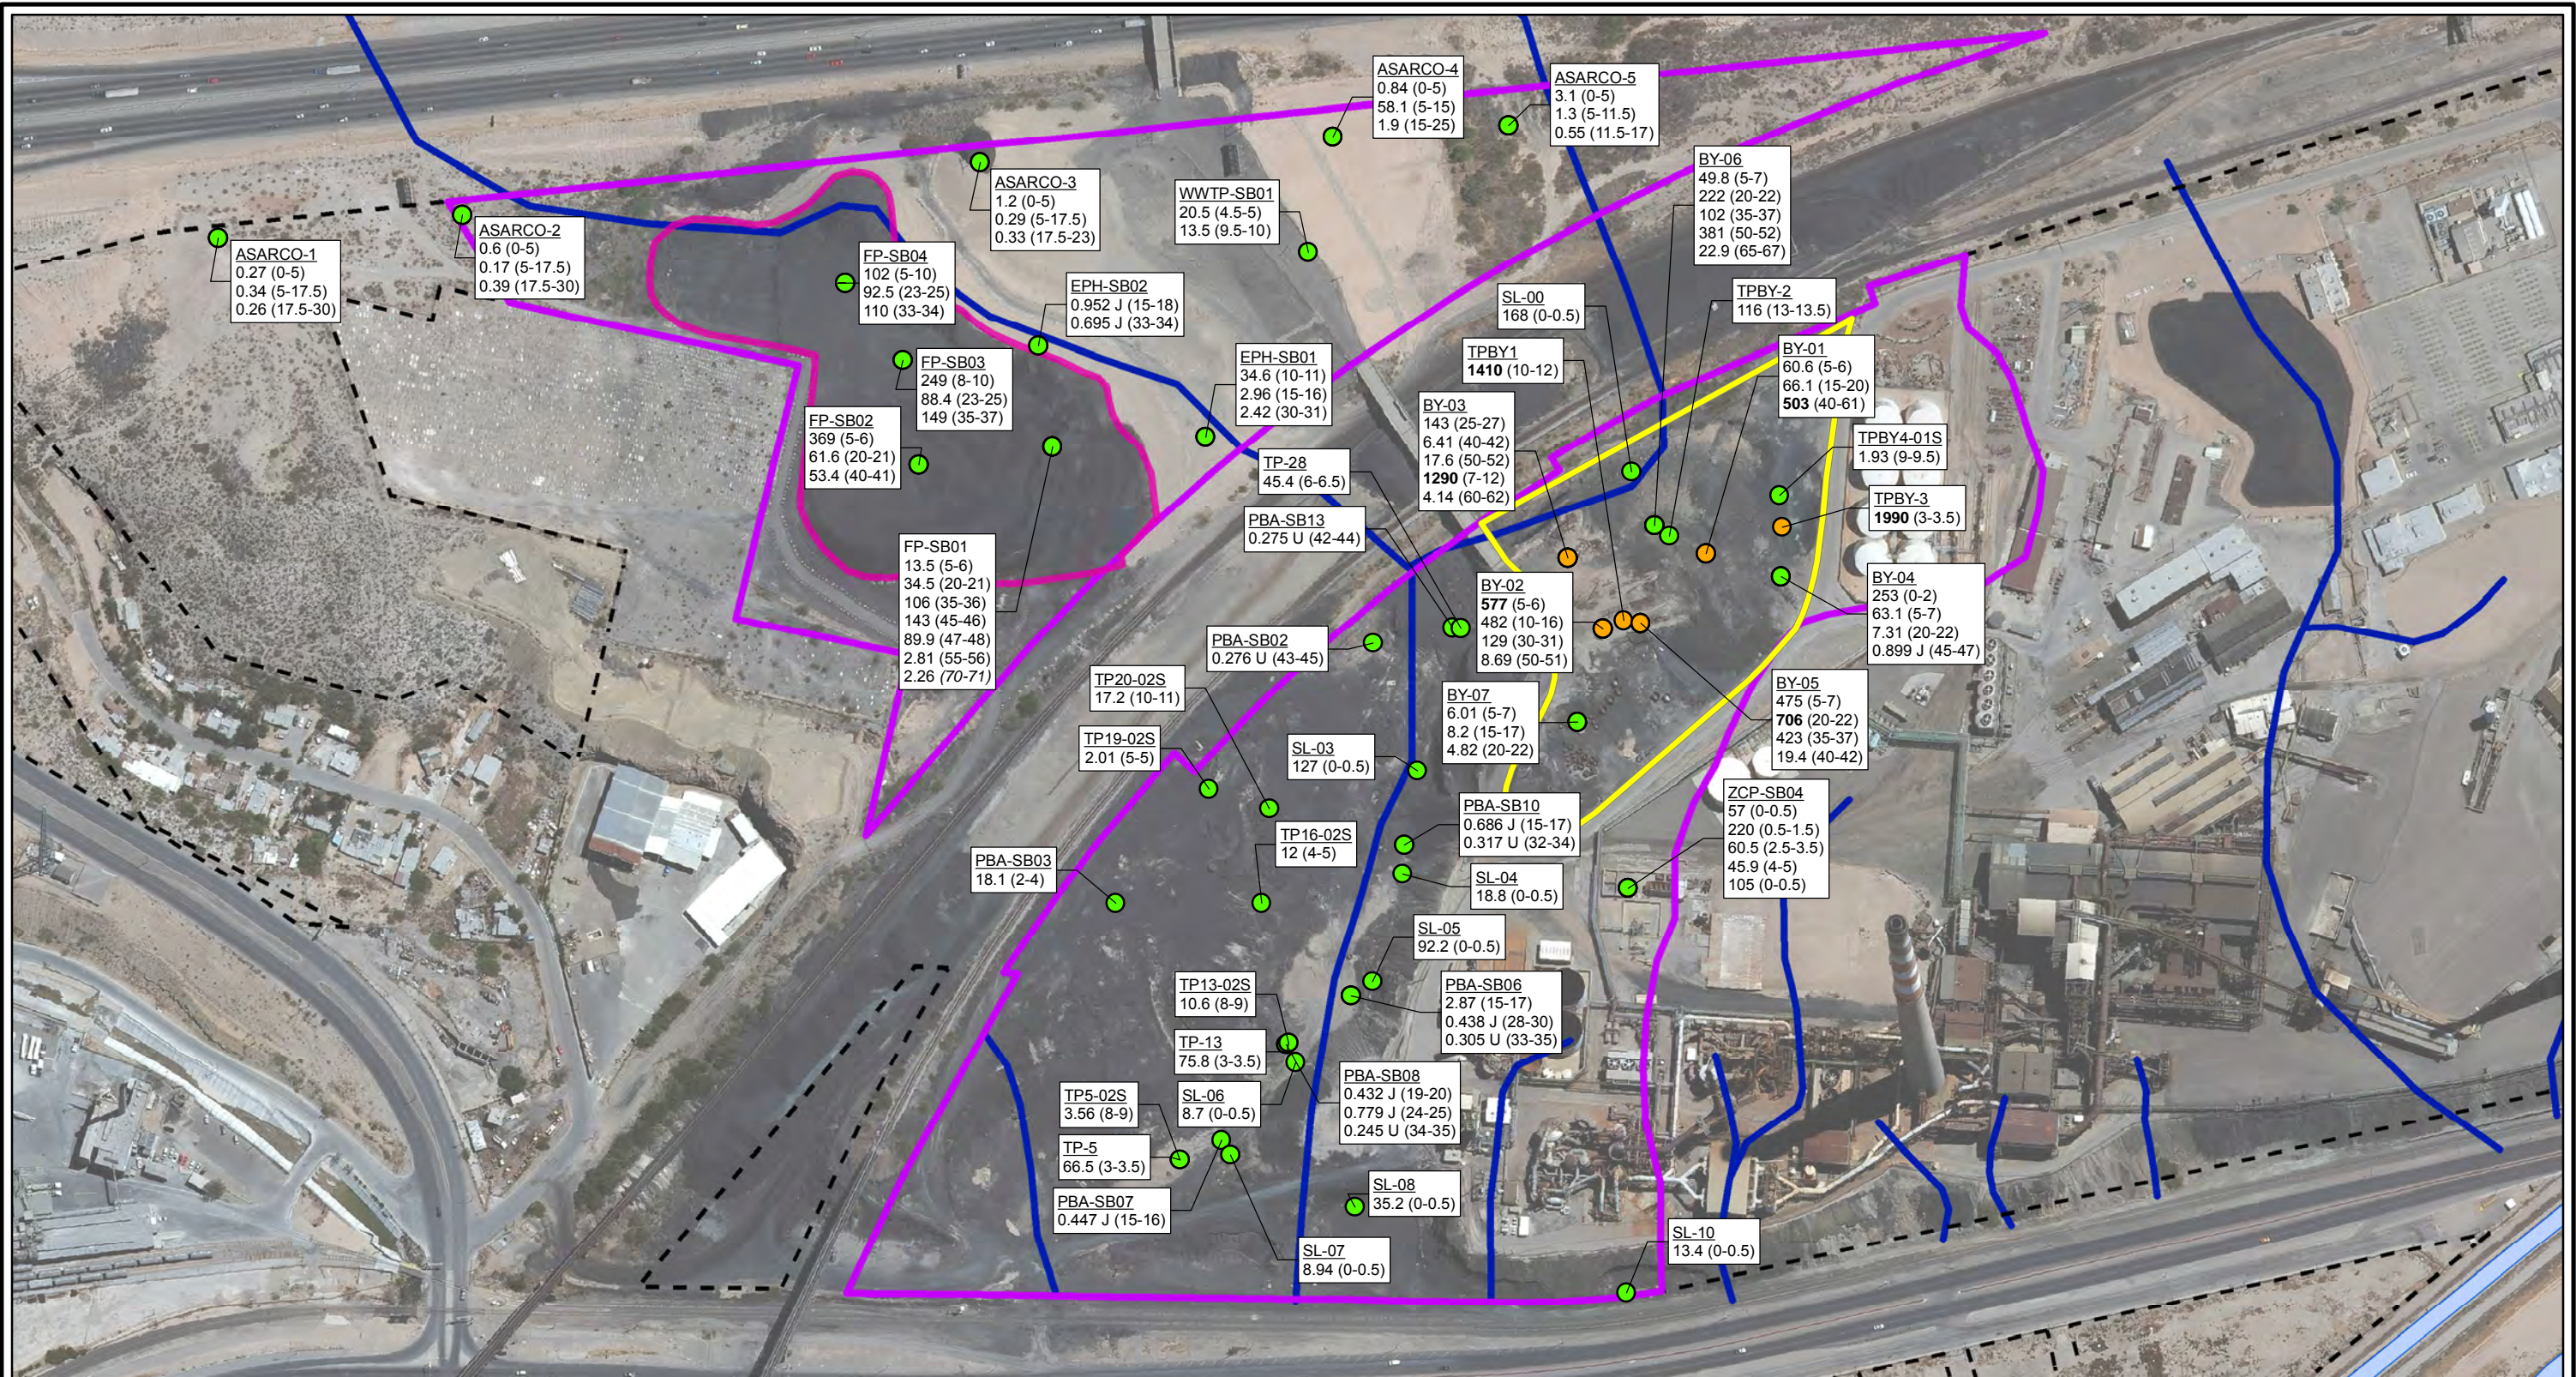
NOTE:
 Screening Level (RRR SAI-Ind = 490 mg/kg)

Bolded Value exceeds screening level
