FORMER EL PASO SMELTER SITE  
EL PASO, TEXAS

**CADMIUM DISTRIBUTION IN SOIL  
PARKER BROTHERS ARROYO/FINES PILE**

**FIGURE  
4-21**

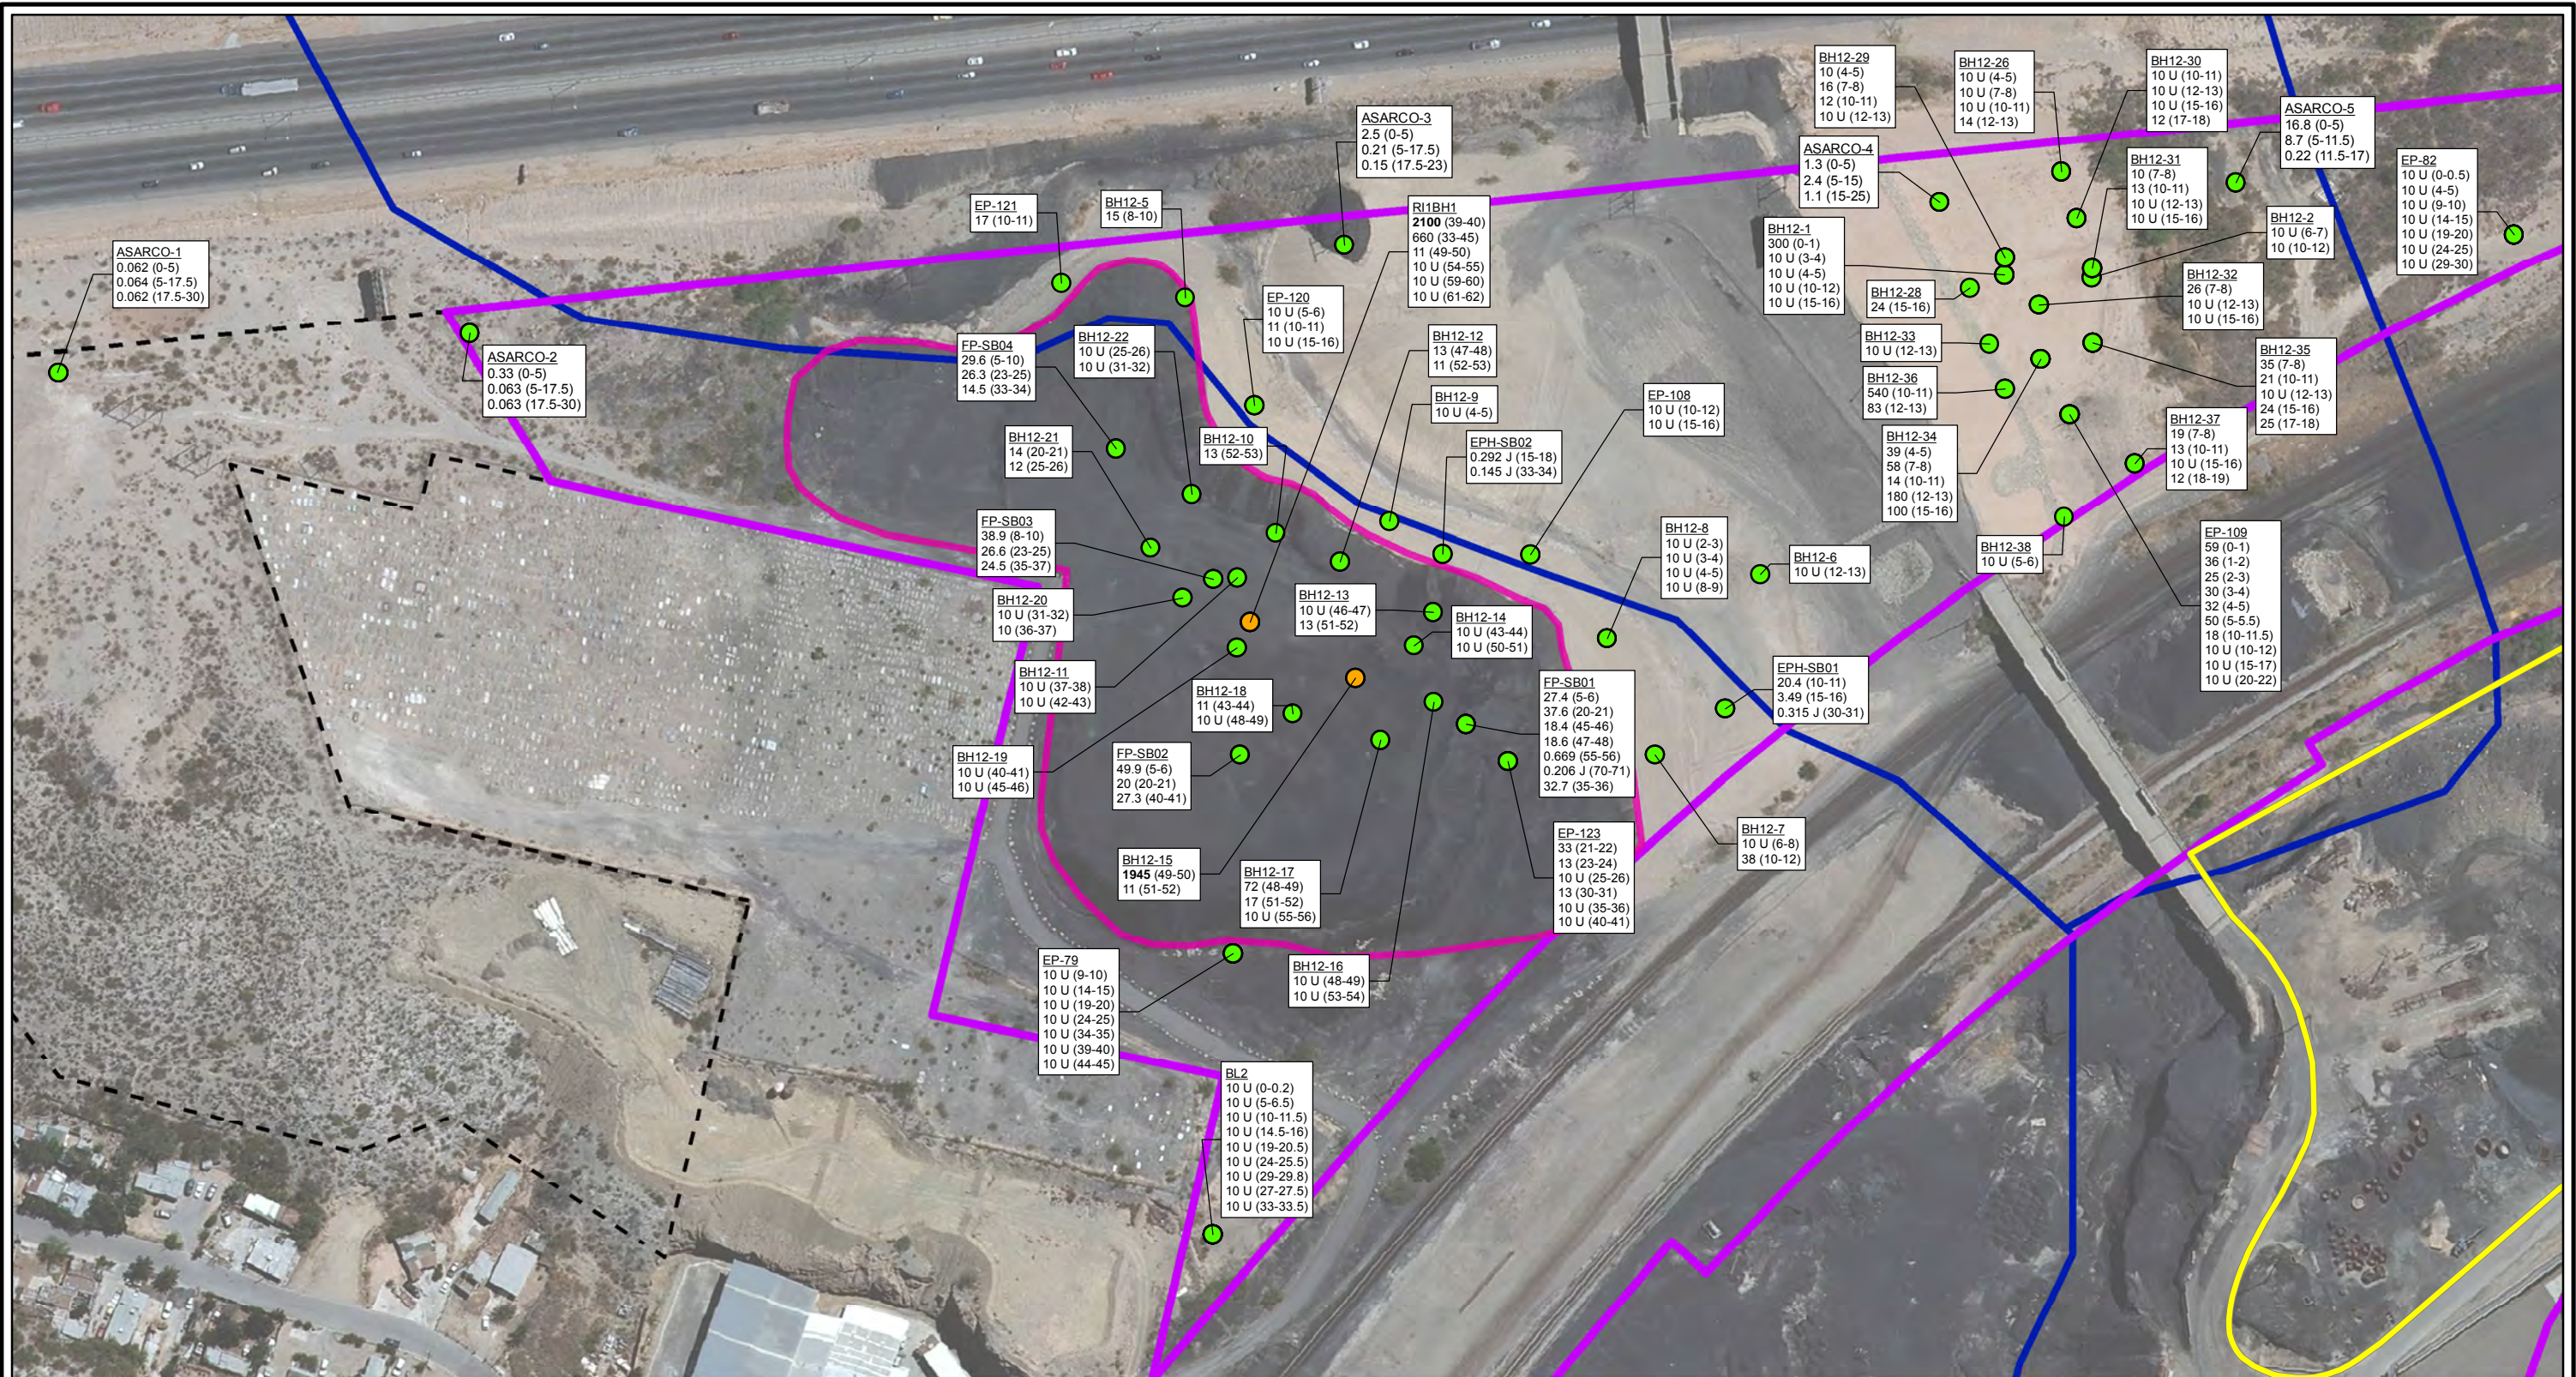
**NOTE:**  
 Screening Level (RRR SAI-Ind = 1500 mg/kg)  
**Bolded** Value exceeds screening level  
*Italics* indicate below the water table  
 J = Estimated Value  
 U = Not detected at or above reporting limit  
 Date of Aerial Photo: 2009
