FORMER EL PASO SMELTER SITE
 EL PASO, TEXAS

**CADMIUM DISTRIBUTION IN SOIL
 PARKER BROTHERS ARROYO/BONEYARD**

**FIGURE
 4-22**

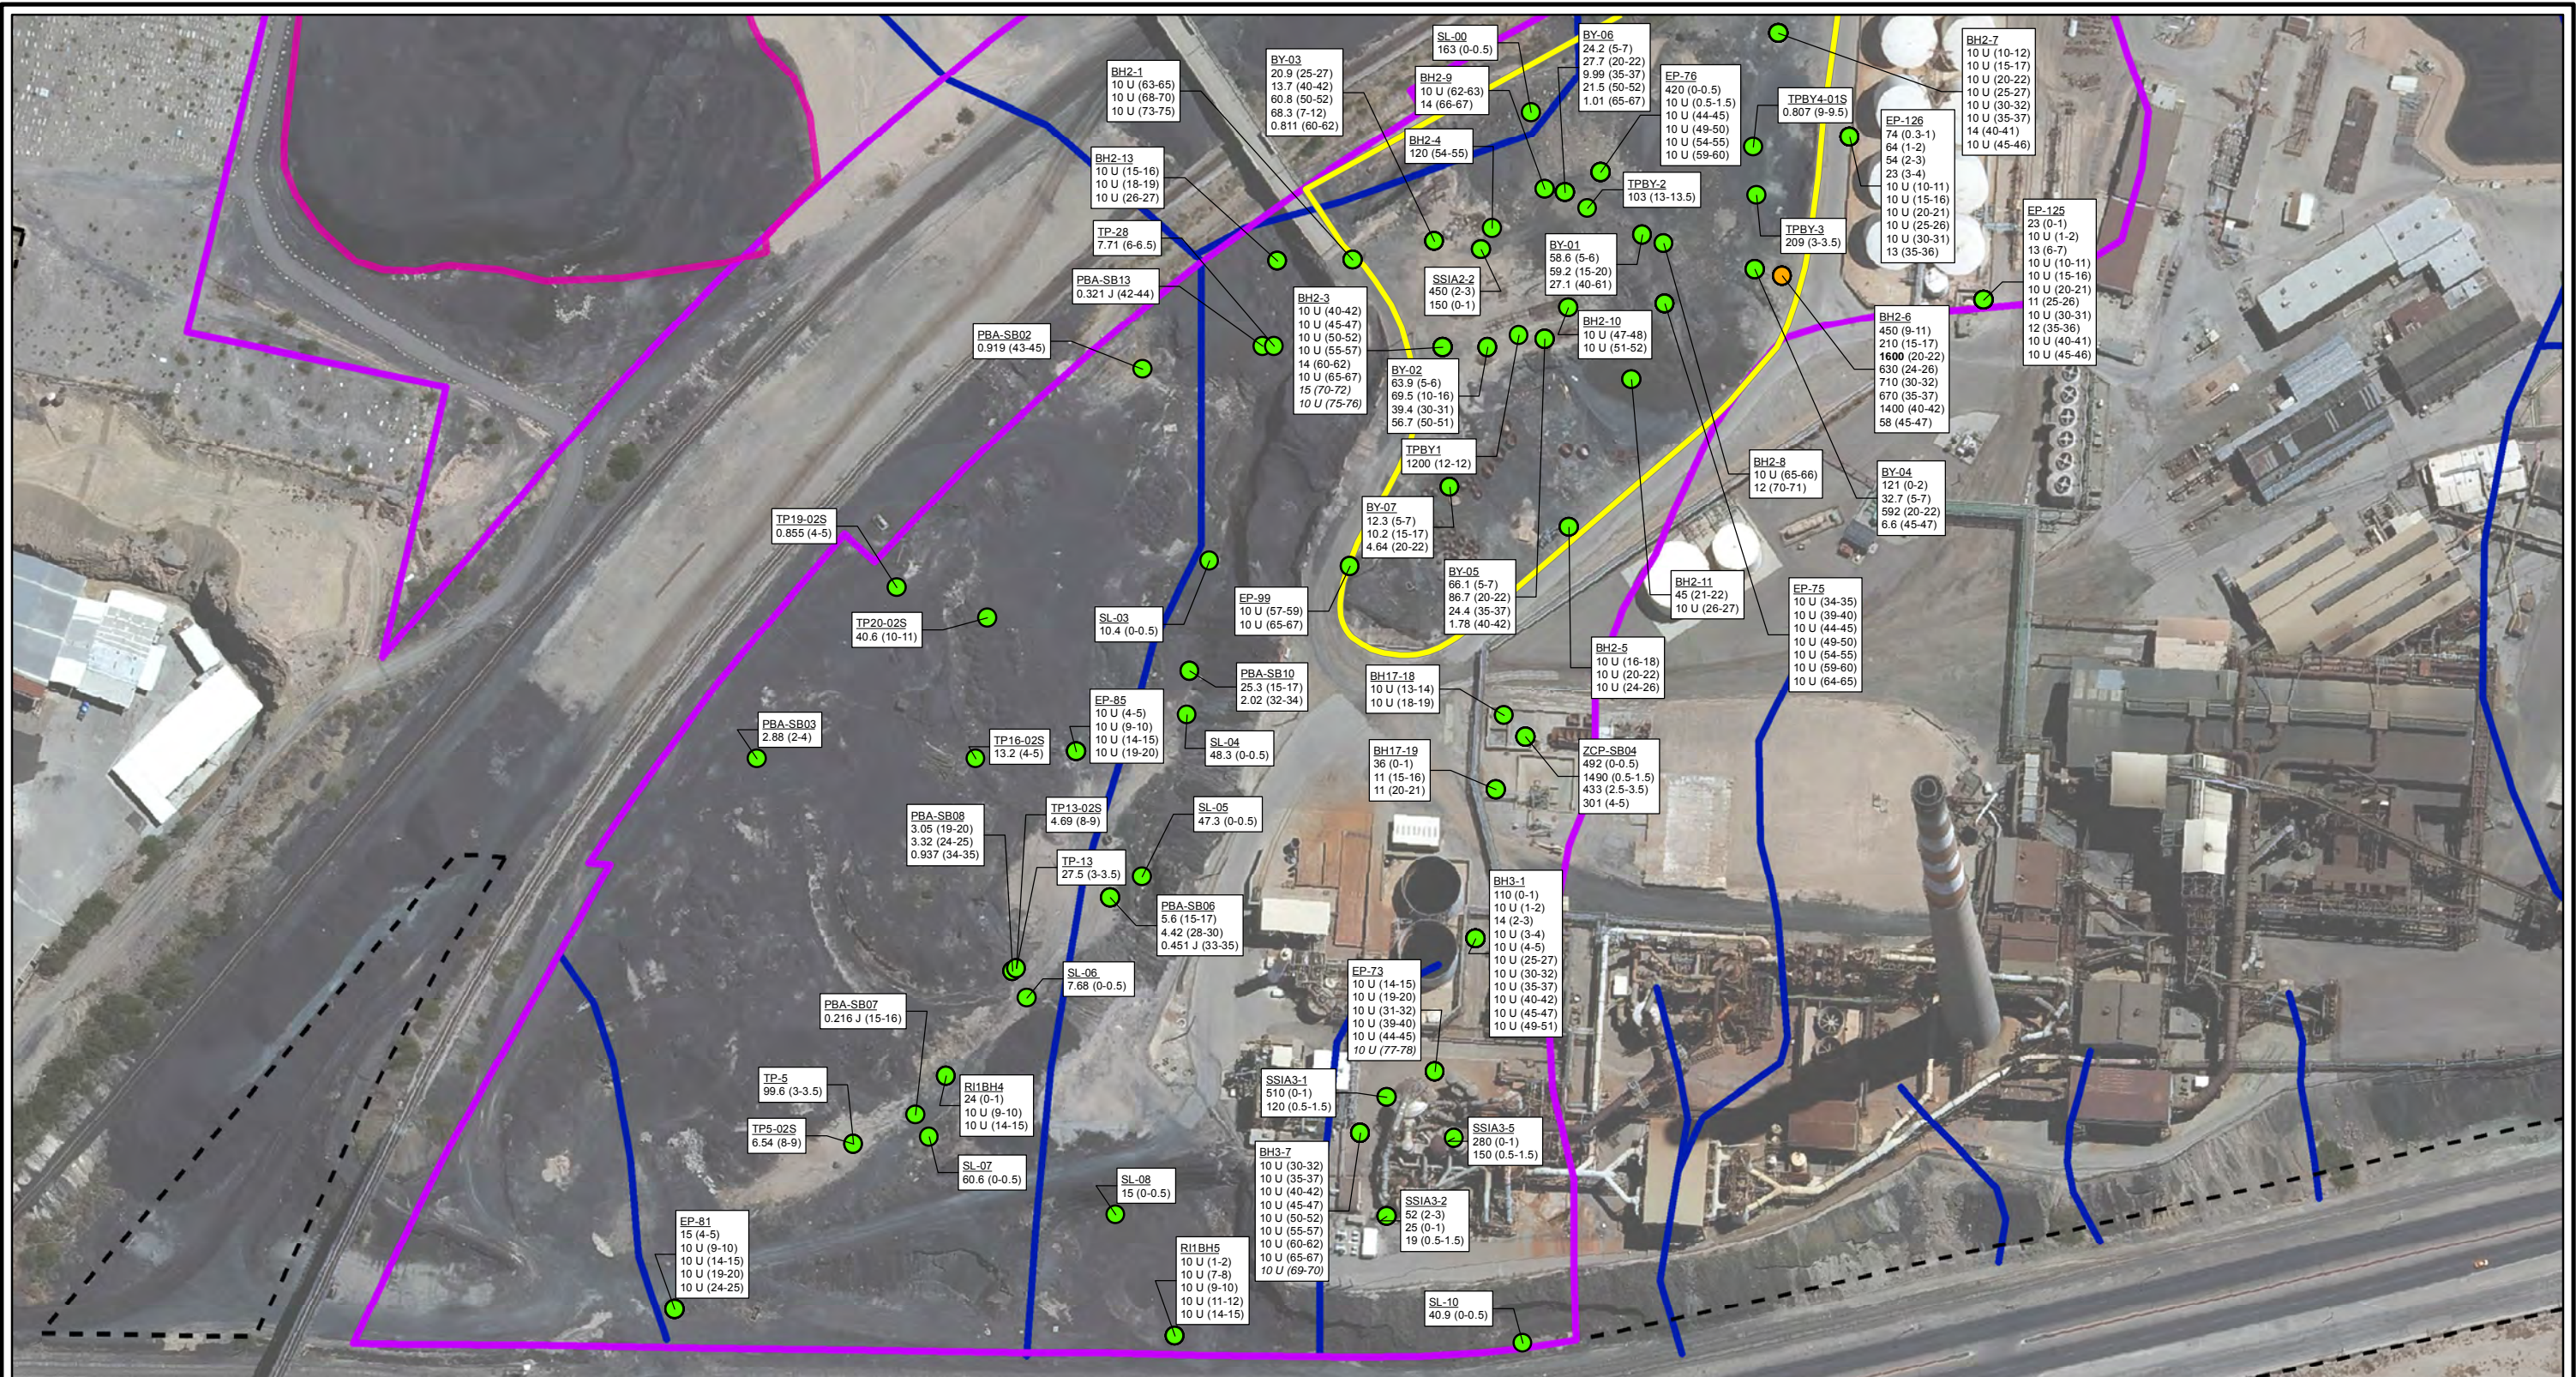
Sample ID
 SL-07
 60.6 (0-0.5)
 Depth (ft bgs)
 Cadmium Concentration in mg/kg
