FORMER EL PASO SMELTER SITE
 EL PASO, TEXAS

**COPPER DISTRIBUTION IN SOIL
 PARKER BROTHERS ARROYO/BONEYARD**

**FIGURE
 4-24**

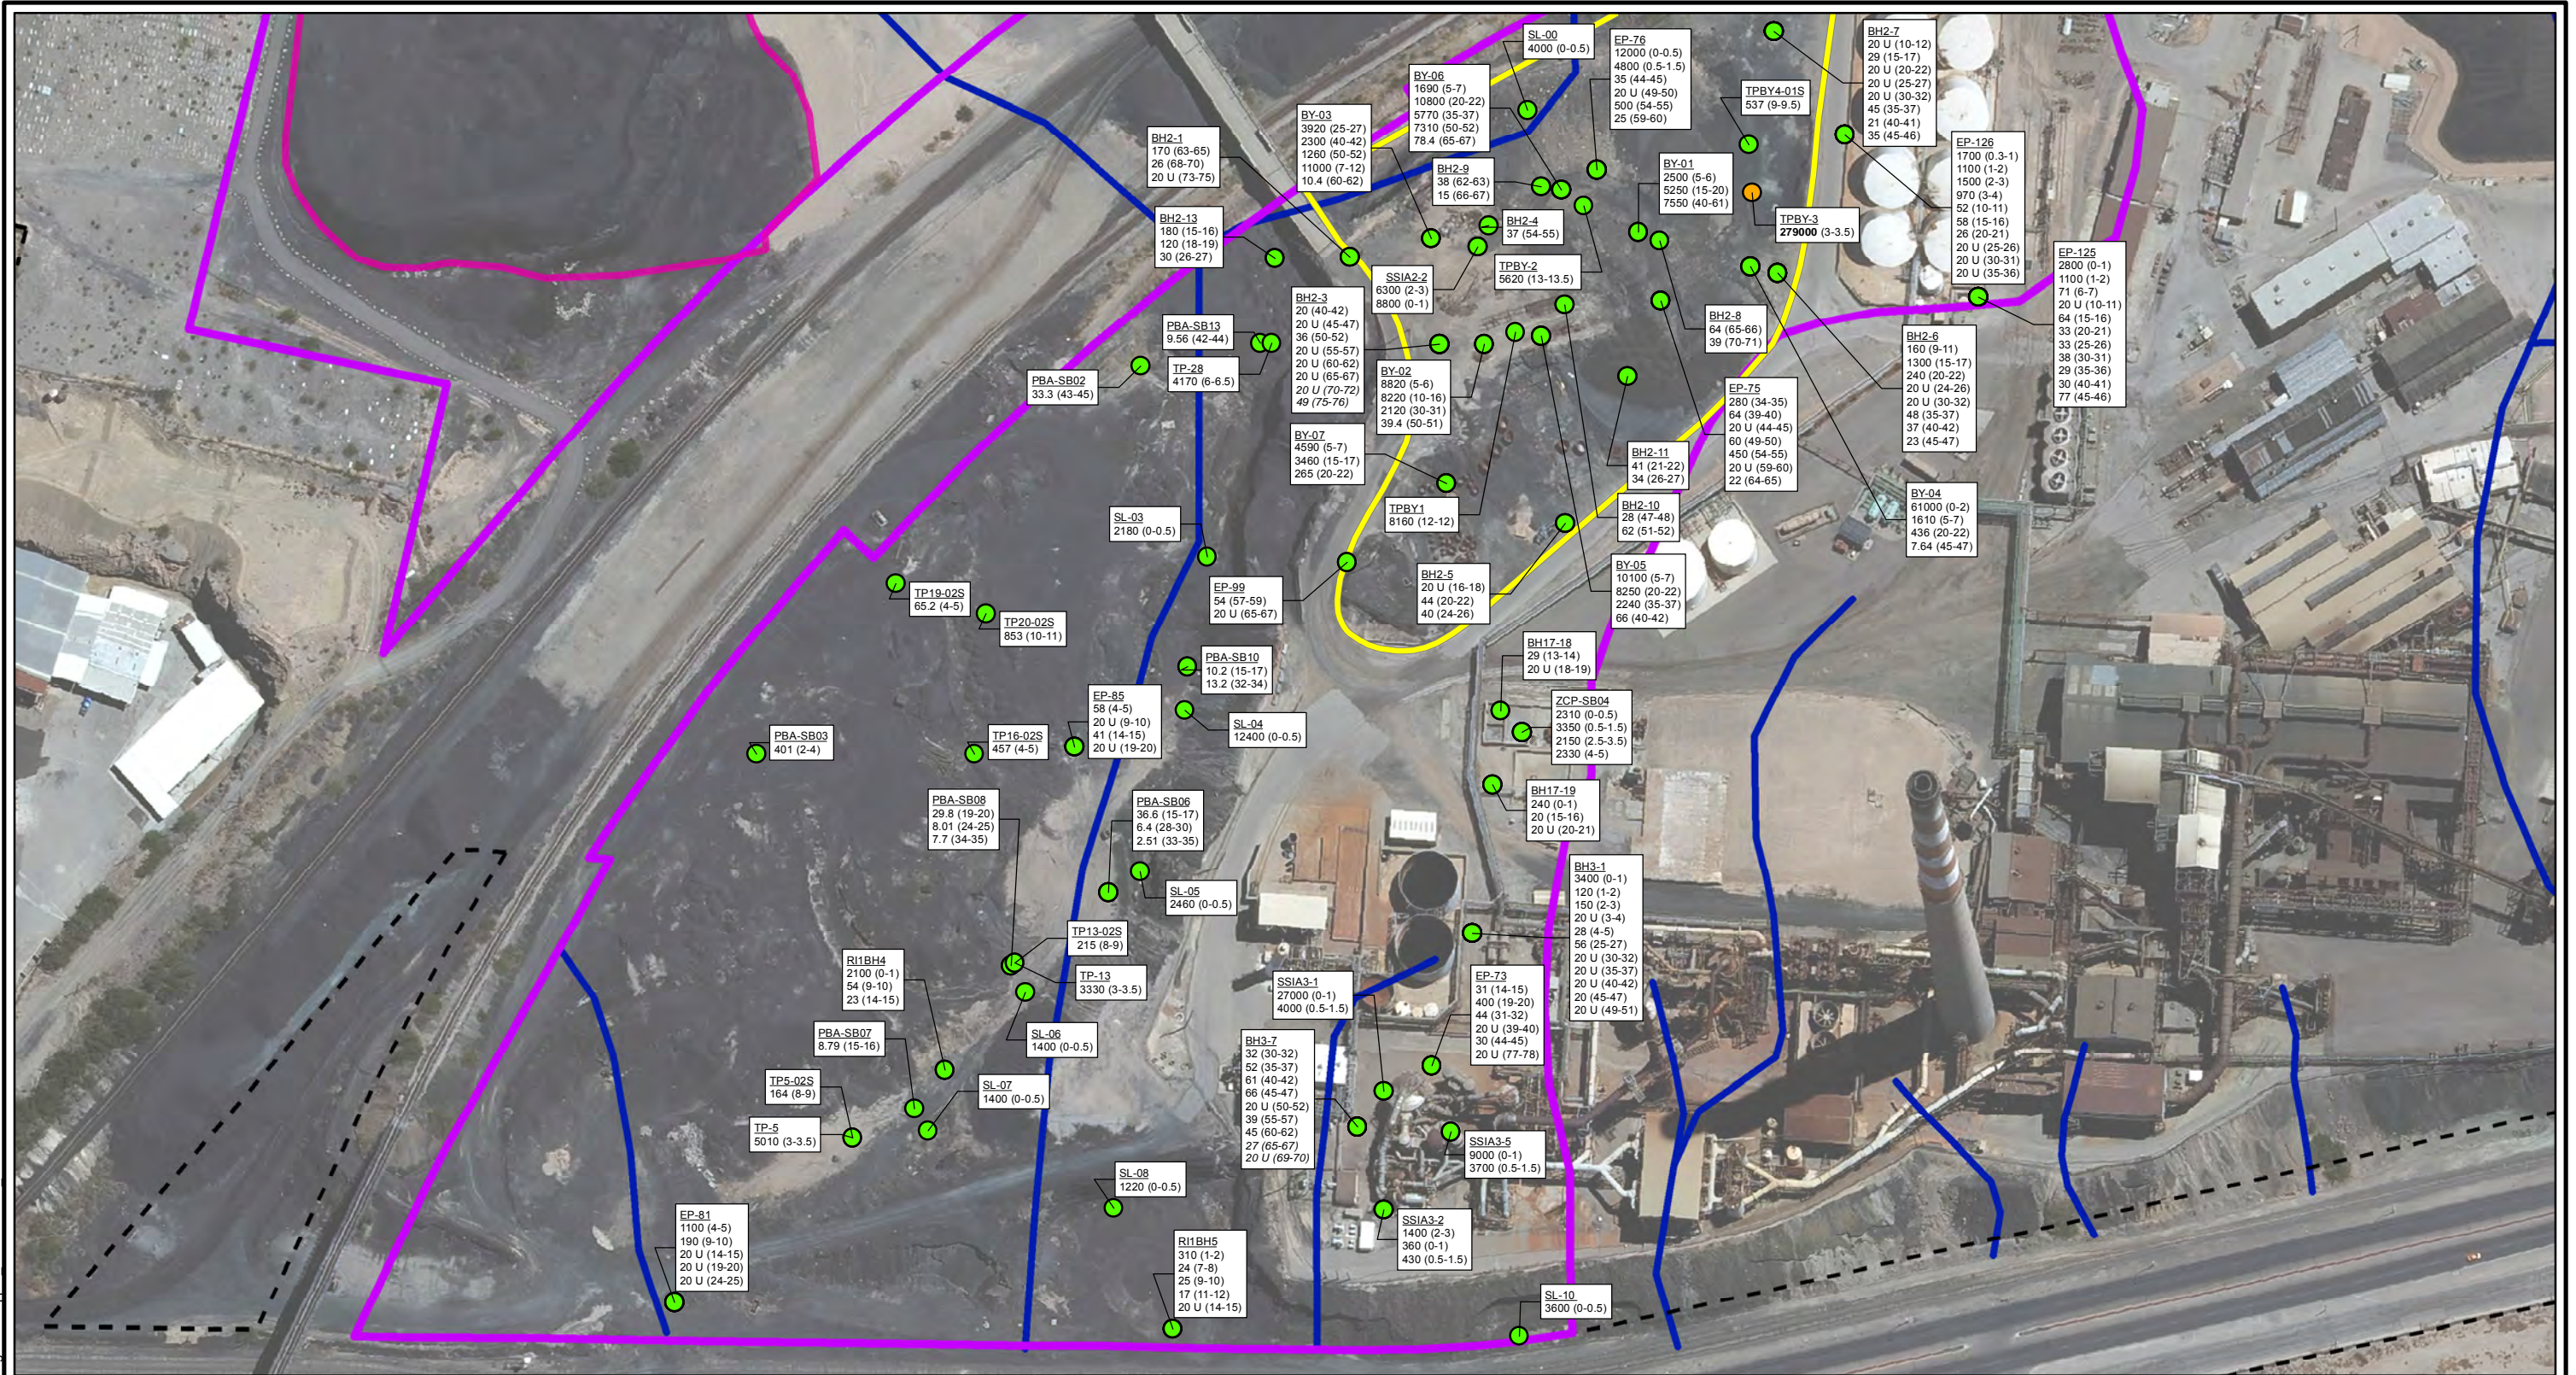
Screening Level (RRR SAI-Ind = 74000 mg/kg)

Date of Aerial Photo: 2009
