FORMER EL PASO SMELTER SITE
EL PASO, TEXAS

**LEAD DISTRIBUTION IN SOIL
PLANT ENTRANCE**

**FIGURE
4-29**

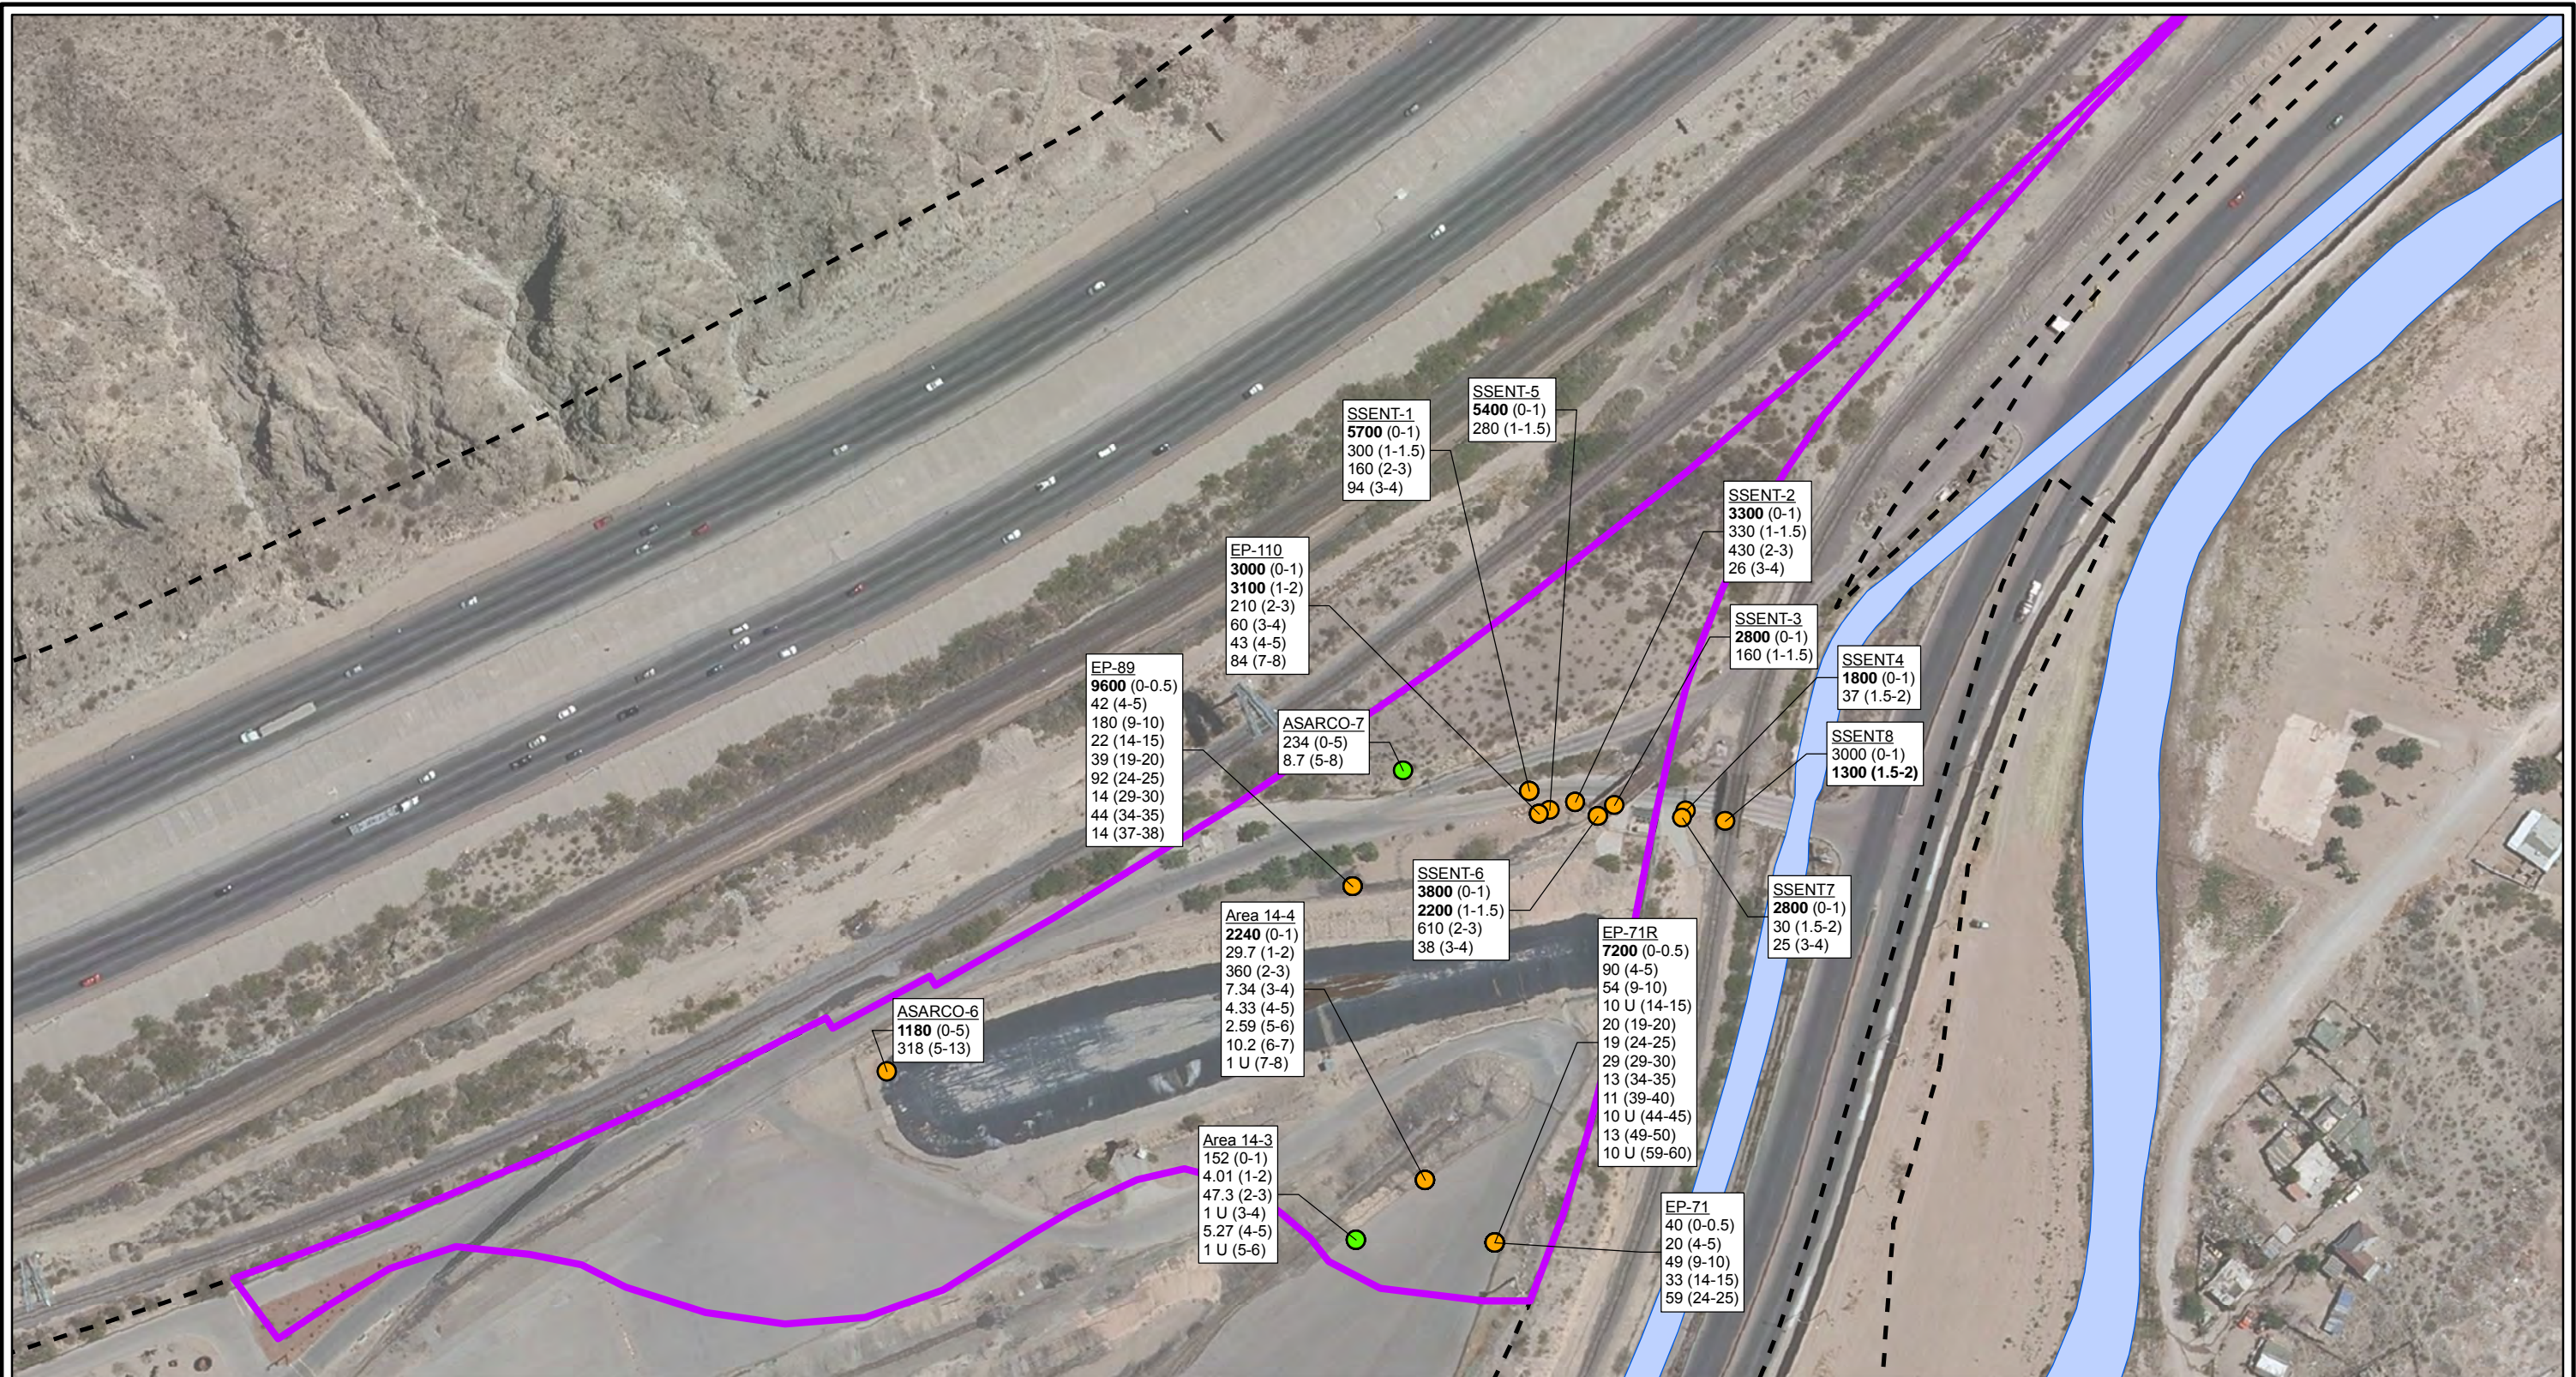
NOTE:
 Screening Level (RRR SAI-Ind = 1000 mg/kg)

Bolded Value exceeds screening level

Italics indicate below the water table
