FORMER EL PASO SMELTER SITE
EL PASO, TEXAS

**LEAD DISTRIBUTION IN SOIL
SOUTH TERRACE ARROYO**

**FIGURE
4-33**

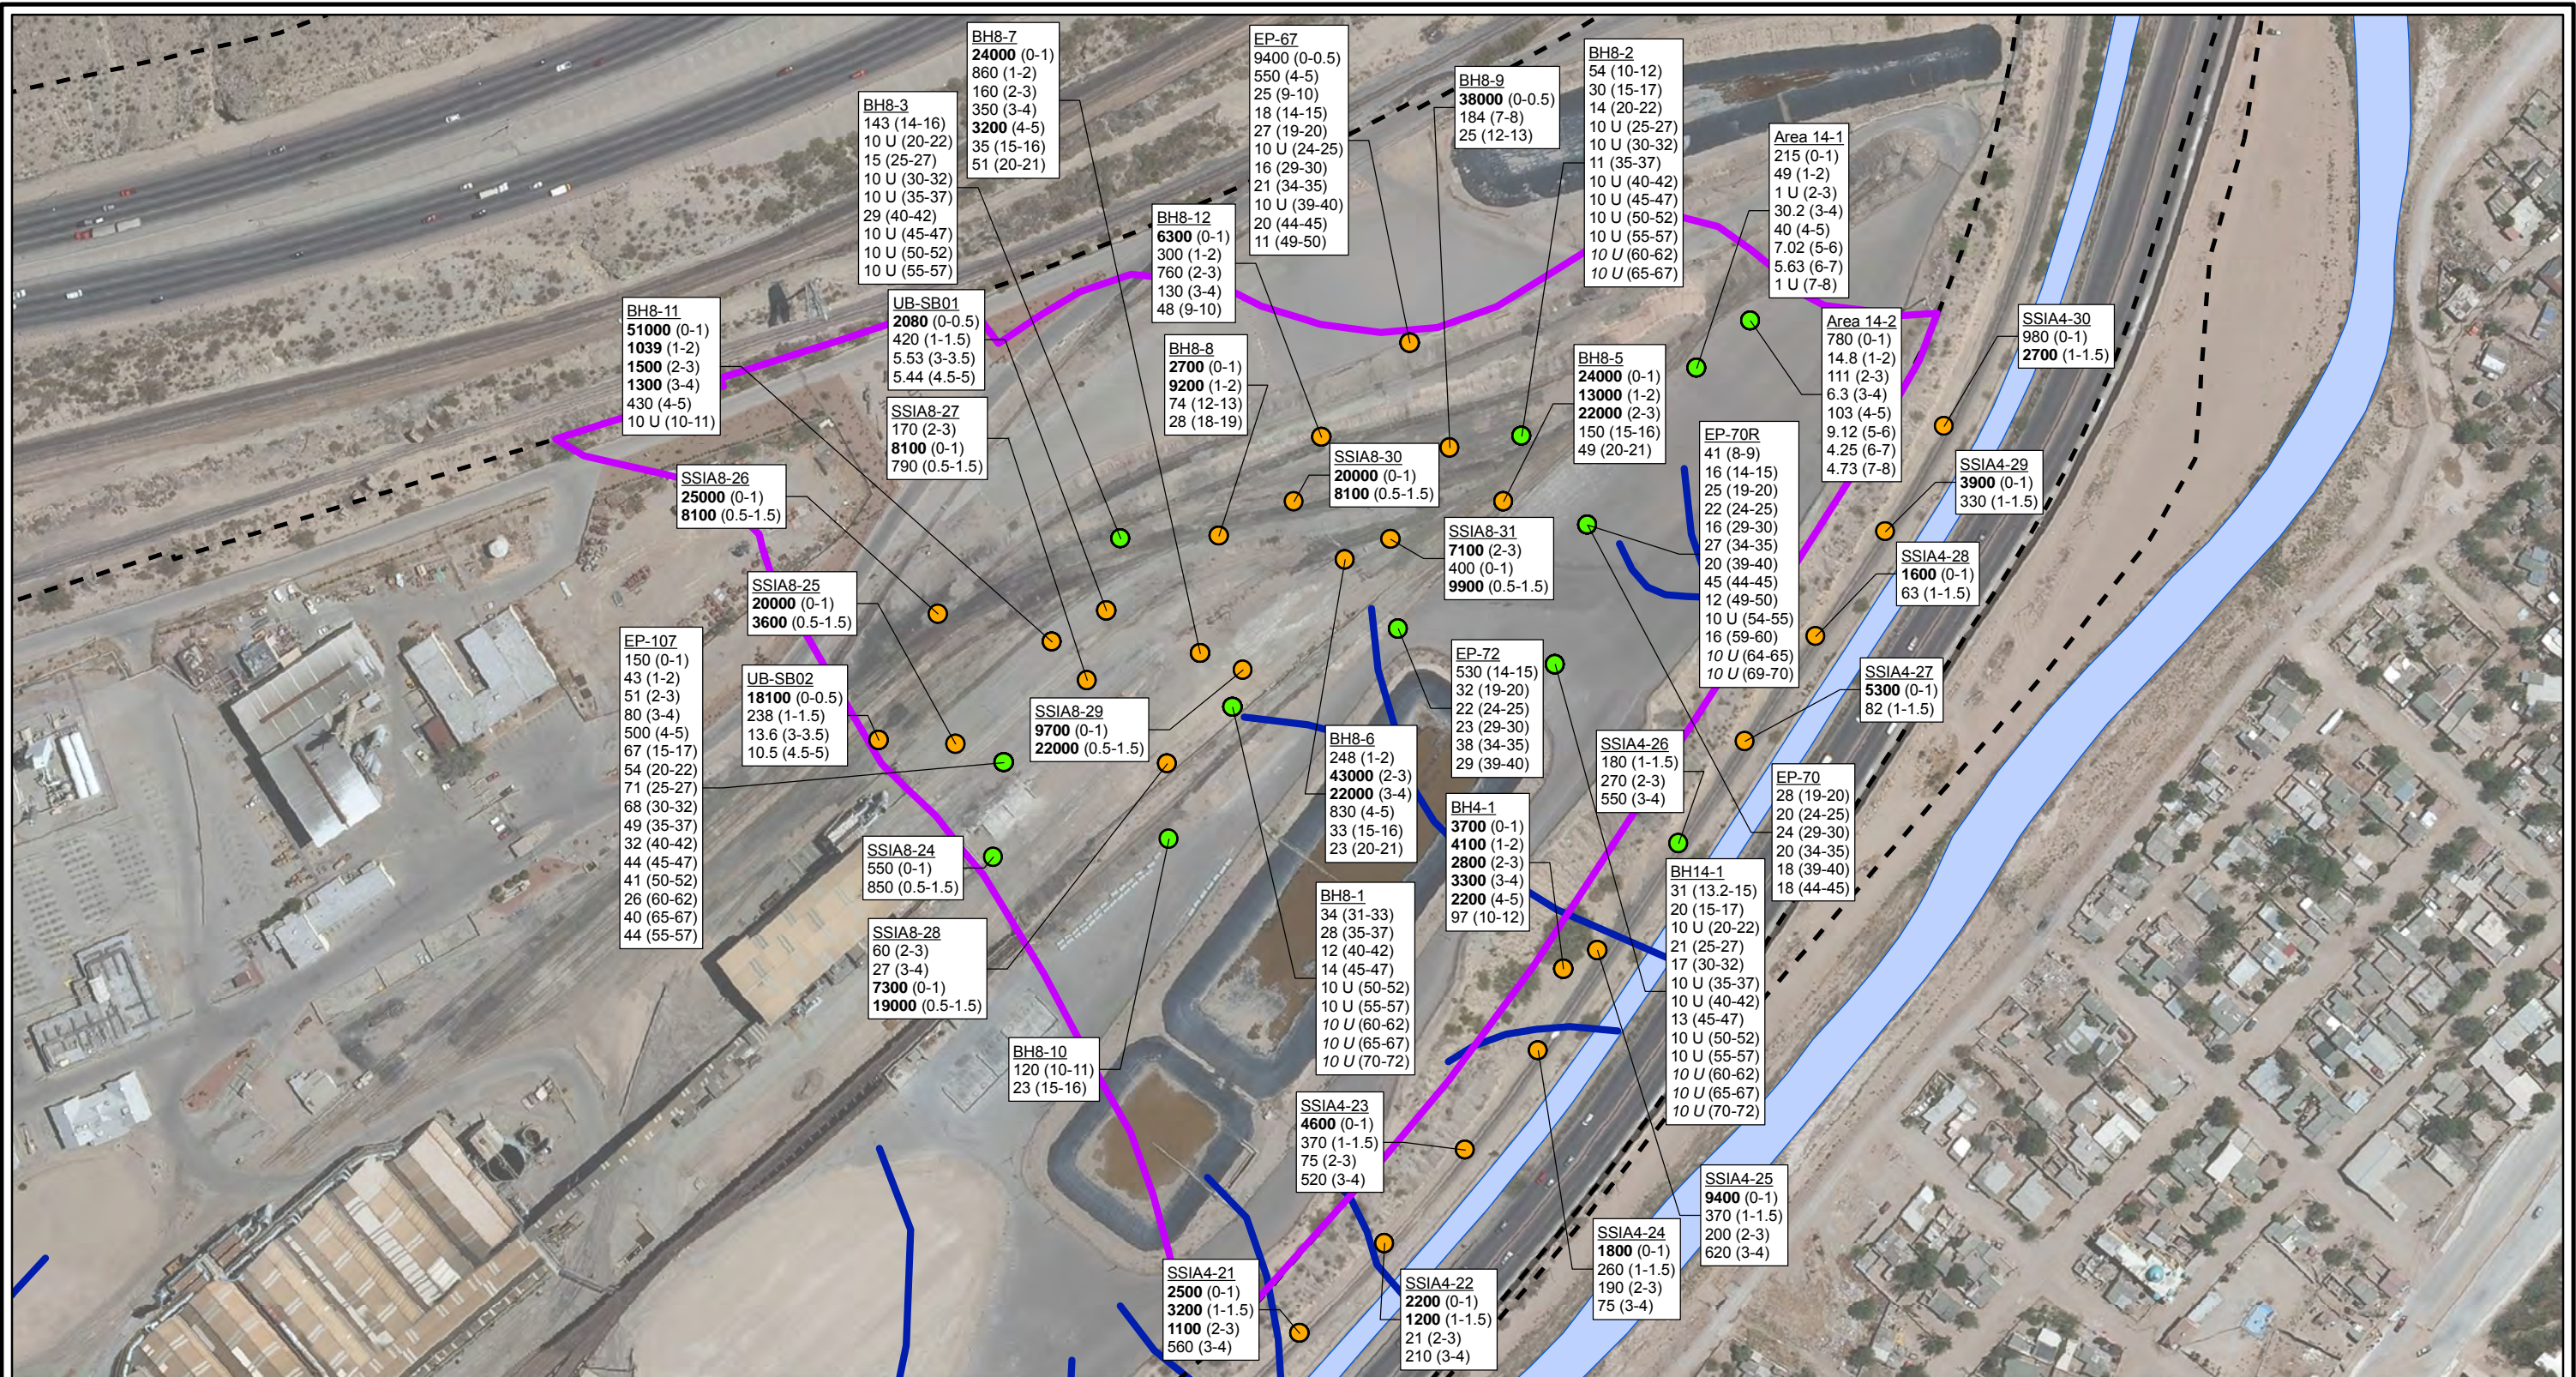
NOTE:
 Screening Level (RRR SAI-Ind = 1000 mg/kg)
Bolded Value exceeds screening level
Italics indicate below the water table
 J = Estimated Value
 U = Not detected at or above reporting limit
 Date of Aerial Photo: 2009
