FORMER EL PASO SMELTER SITE  
 EL PASO, TEXAS

**LEAD DISTRIBUTION IN SOIL  
 POND 1 ARROYO**

**FIGURE  
 4-37**

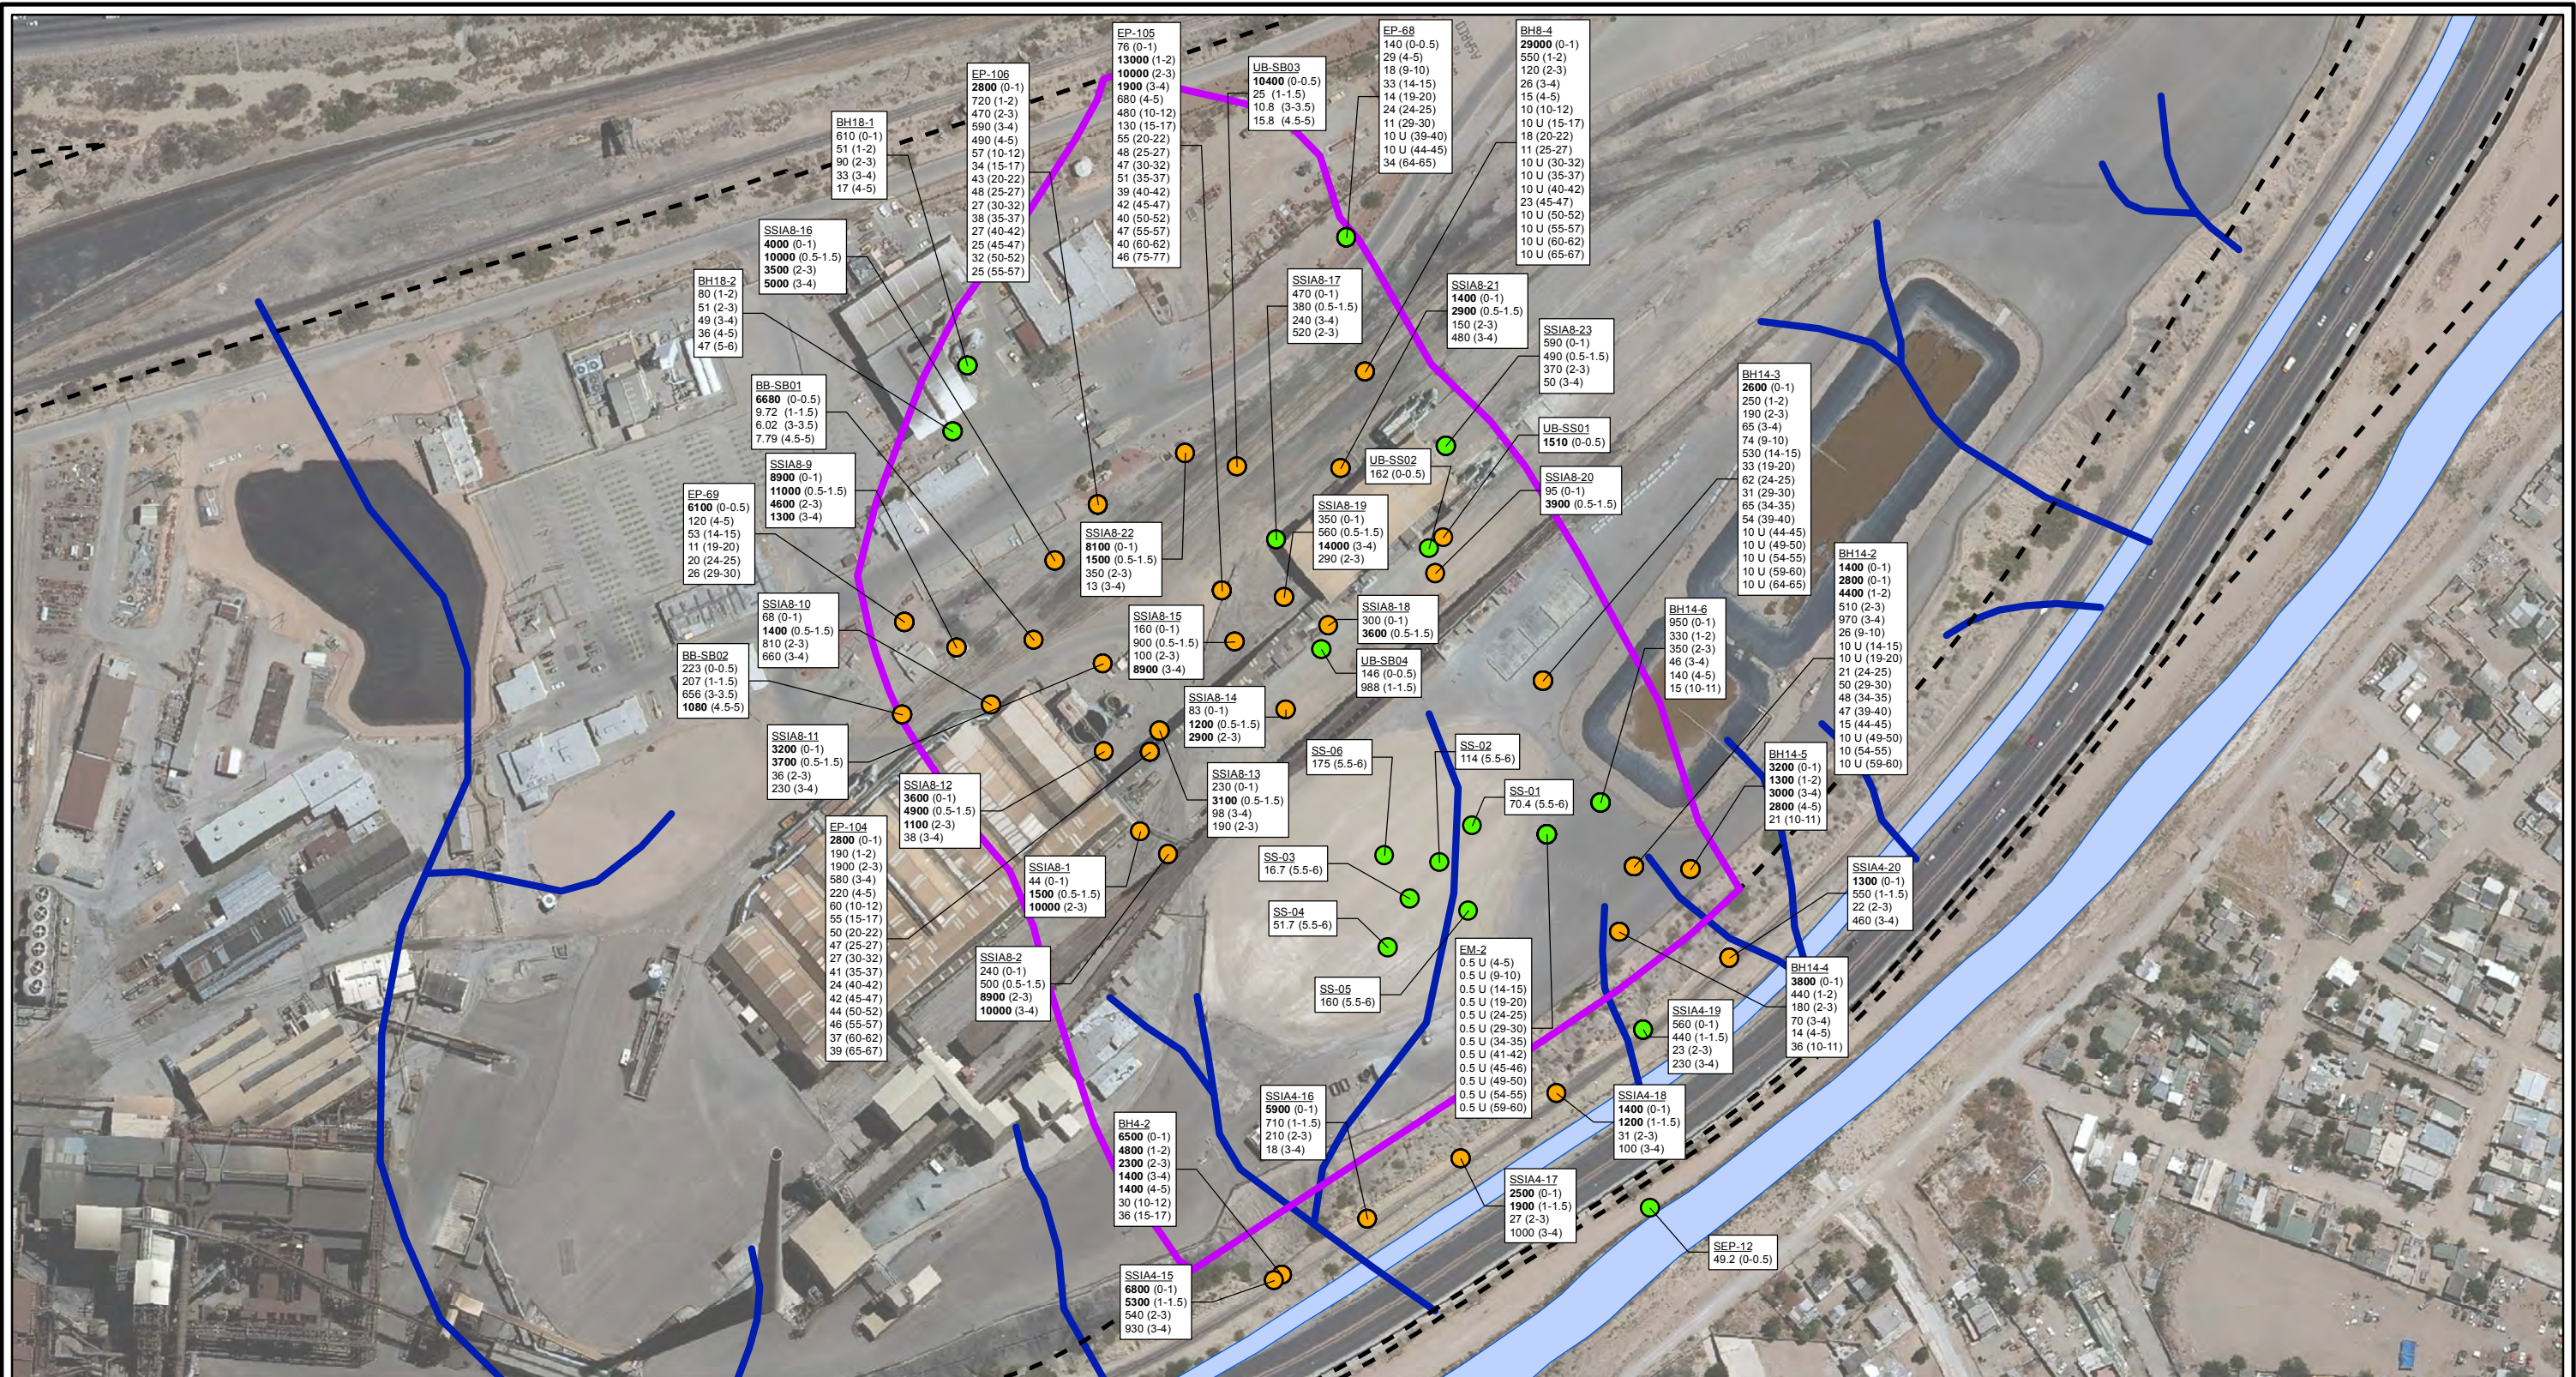
**NOTE:**  
 Screening Level (RRR SAI-Ind = 1000 mg/kg)  
**Bolded** Value exceeds screening level  
*Italics* indicate below the water table  
 J = Estimated Value  
 U = Not detected at or above reporting limit  
 Date of Aerial Photo: 2009
