FORMER EL PASO SMELTER SITE  
EL PASO, TEXAS

**ARSENIC DISTRIBUTION IN SOIL  
POND 5,6 ARROYO**

**FIGURE  
4-40**

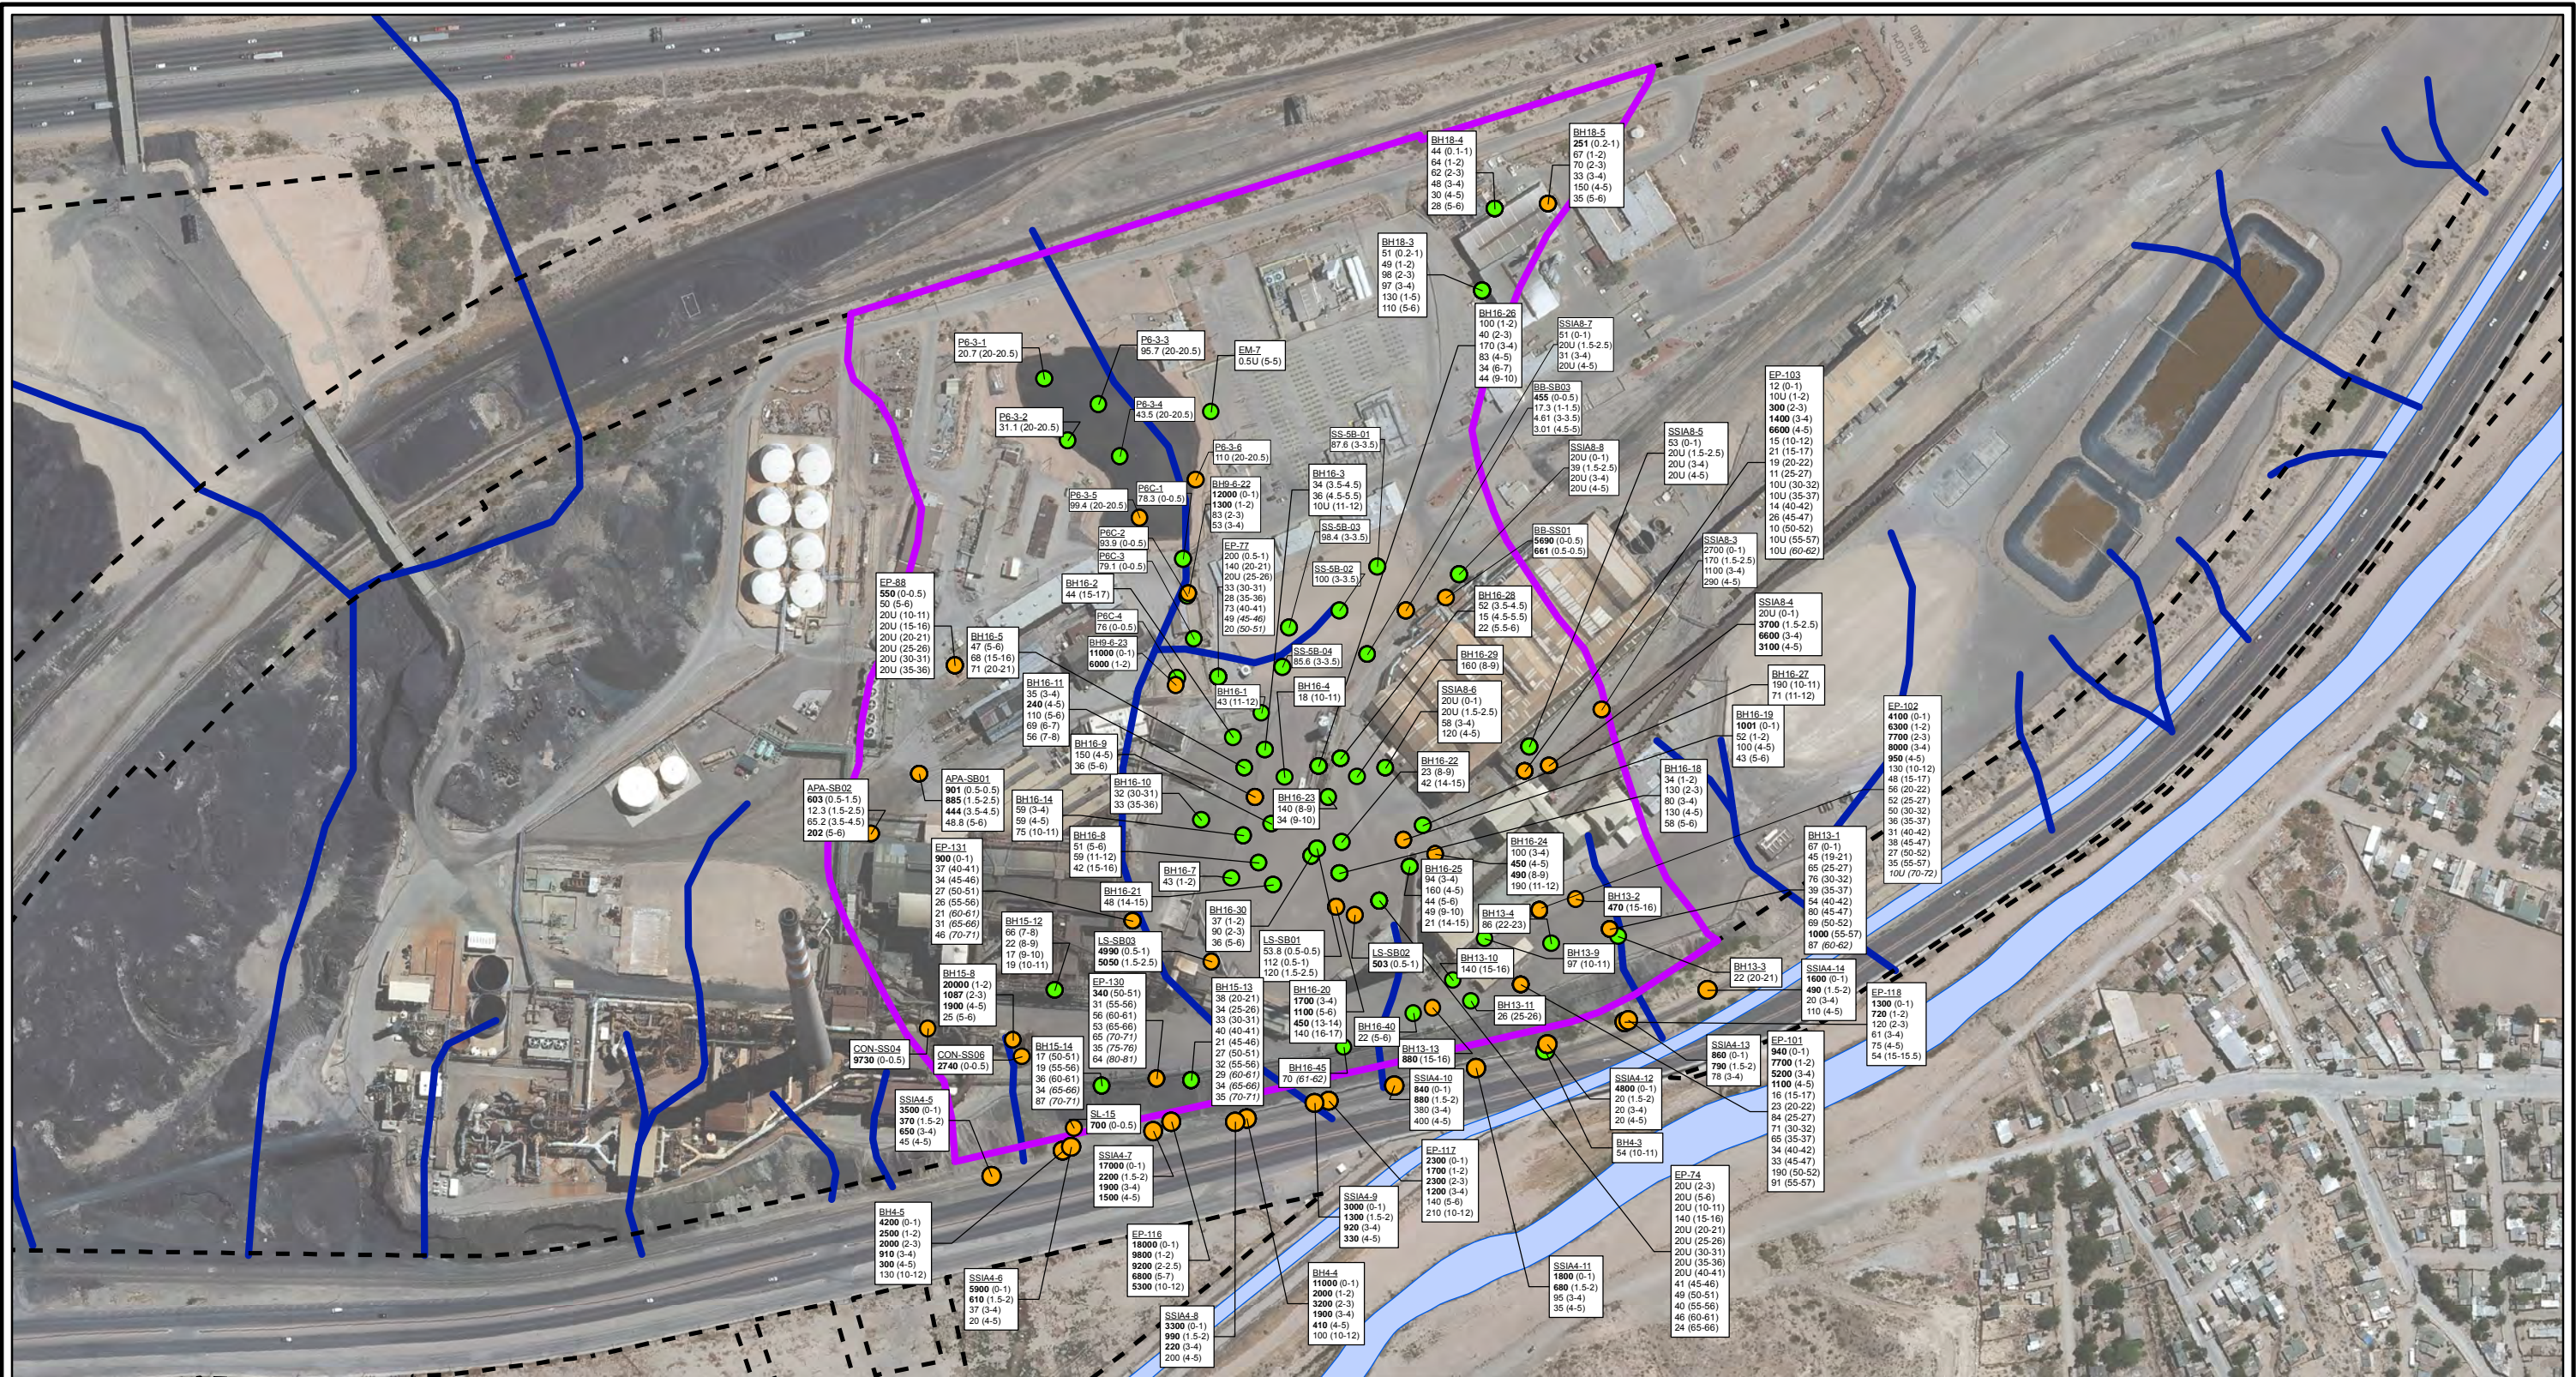
**NOTE:**  
 Screening Level (RRR SAI-Ind = 200 mg/kg)  
**Bolded** Value exceeds screening level  
*Italics* indicate below the water table  
 J = Estimated Value  
 U = Not detected at or above reporting limit  
 Date of Aerial Photo: 2009
