FORMER EL PASO SMELTER SITE  
EL PASO, TEXAS

**CADMIUM DISTRIBUTION IN SOIL  
ACID PLANT ARROYO**

**FIGURE  
4-46**

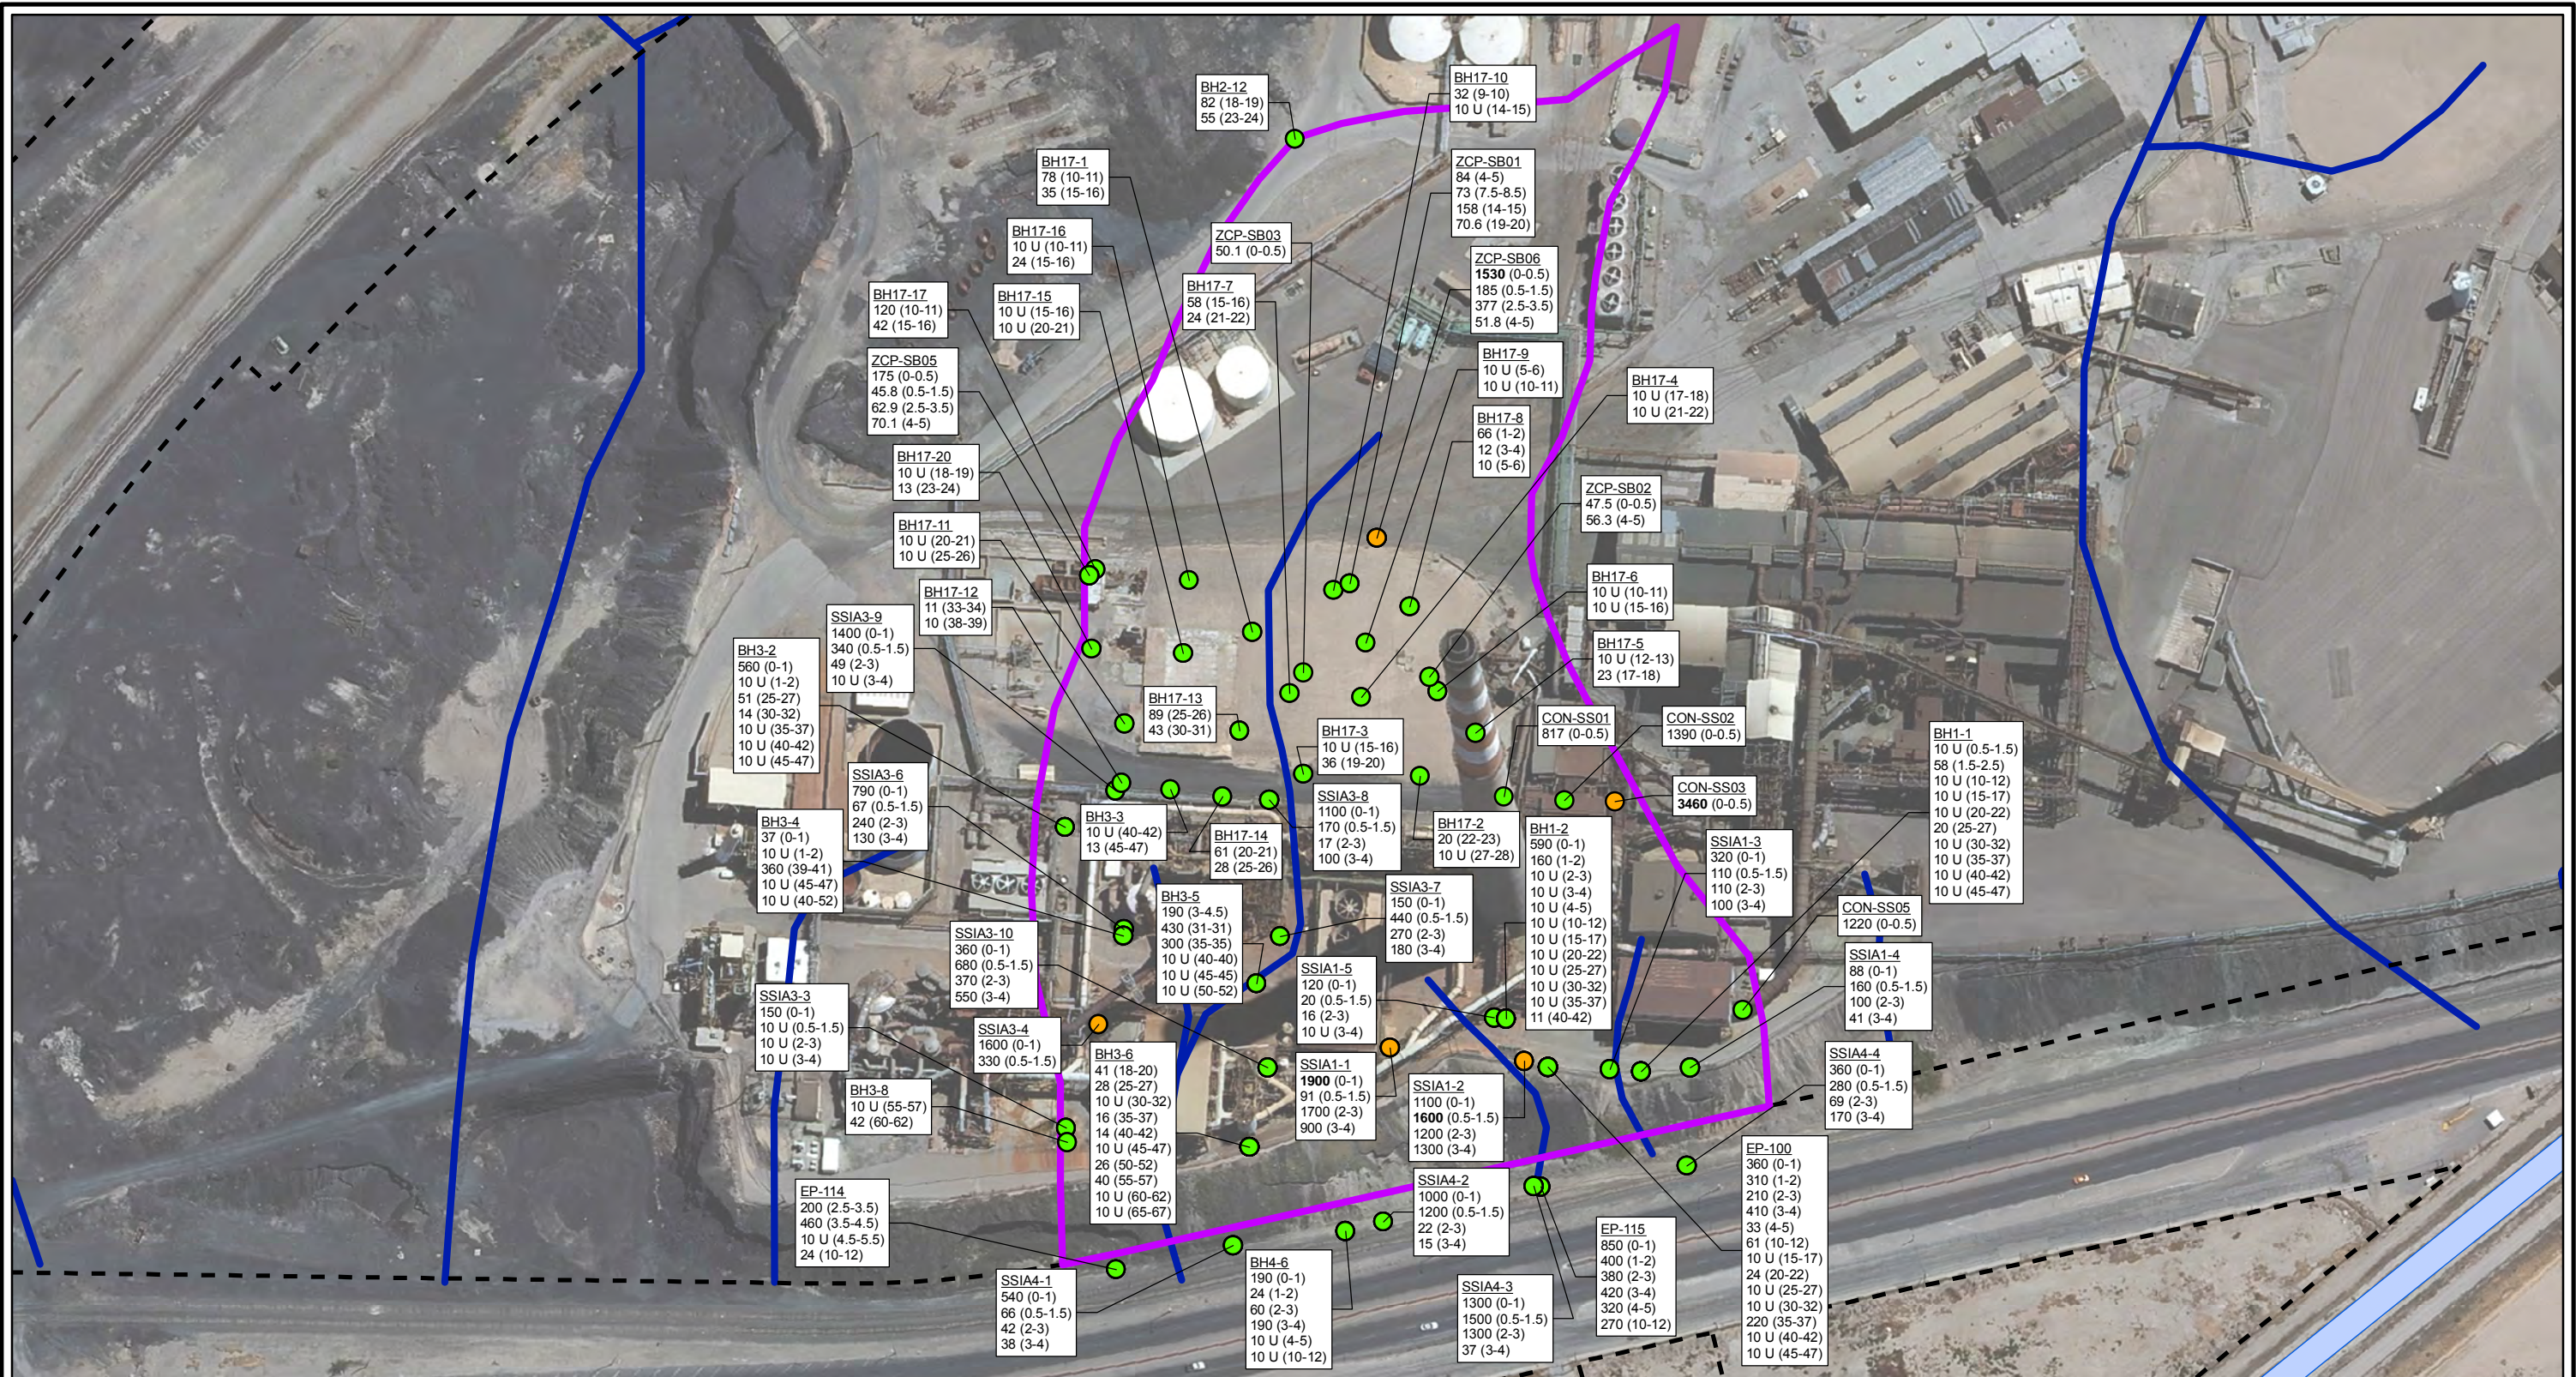
**NOTE:**  
 Screening Level (RRR SAI-Ind = 1500 mg/kg)  
**Bolded** Value exceeds screening level  
*Italics* indicate below the water table  
 J = Estimated Value  
 U = Not detected at or above reporting limit  
 Date of Aerial Photo: 2009
