| FORMER EL PASO SMELTER SITE EL PASO, TEXAS | |
| SITE-WIDE DISTRIBUTION OF COPPER | |
| | FIGURE 4-57 |

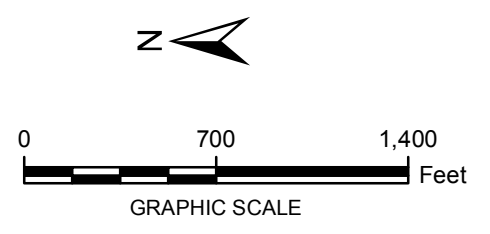
- LEGEND:
- DETECTED \leq SCREENING LEVEL
 - DETECTED $>$ SCREENING LEVEL
 - HISTORICAL ARROYO TRACE LINES
 - - - PROPERTY BOUNDARY
