FORMER EL PASO SMELTER SITE
EL PASO, TEXAS

**ANTIMONY DISTRIBUTION IN SOIL
EAST PROPERTY**

**FIGURE
4-6**

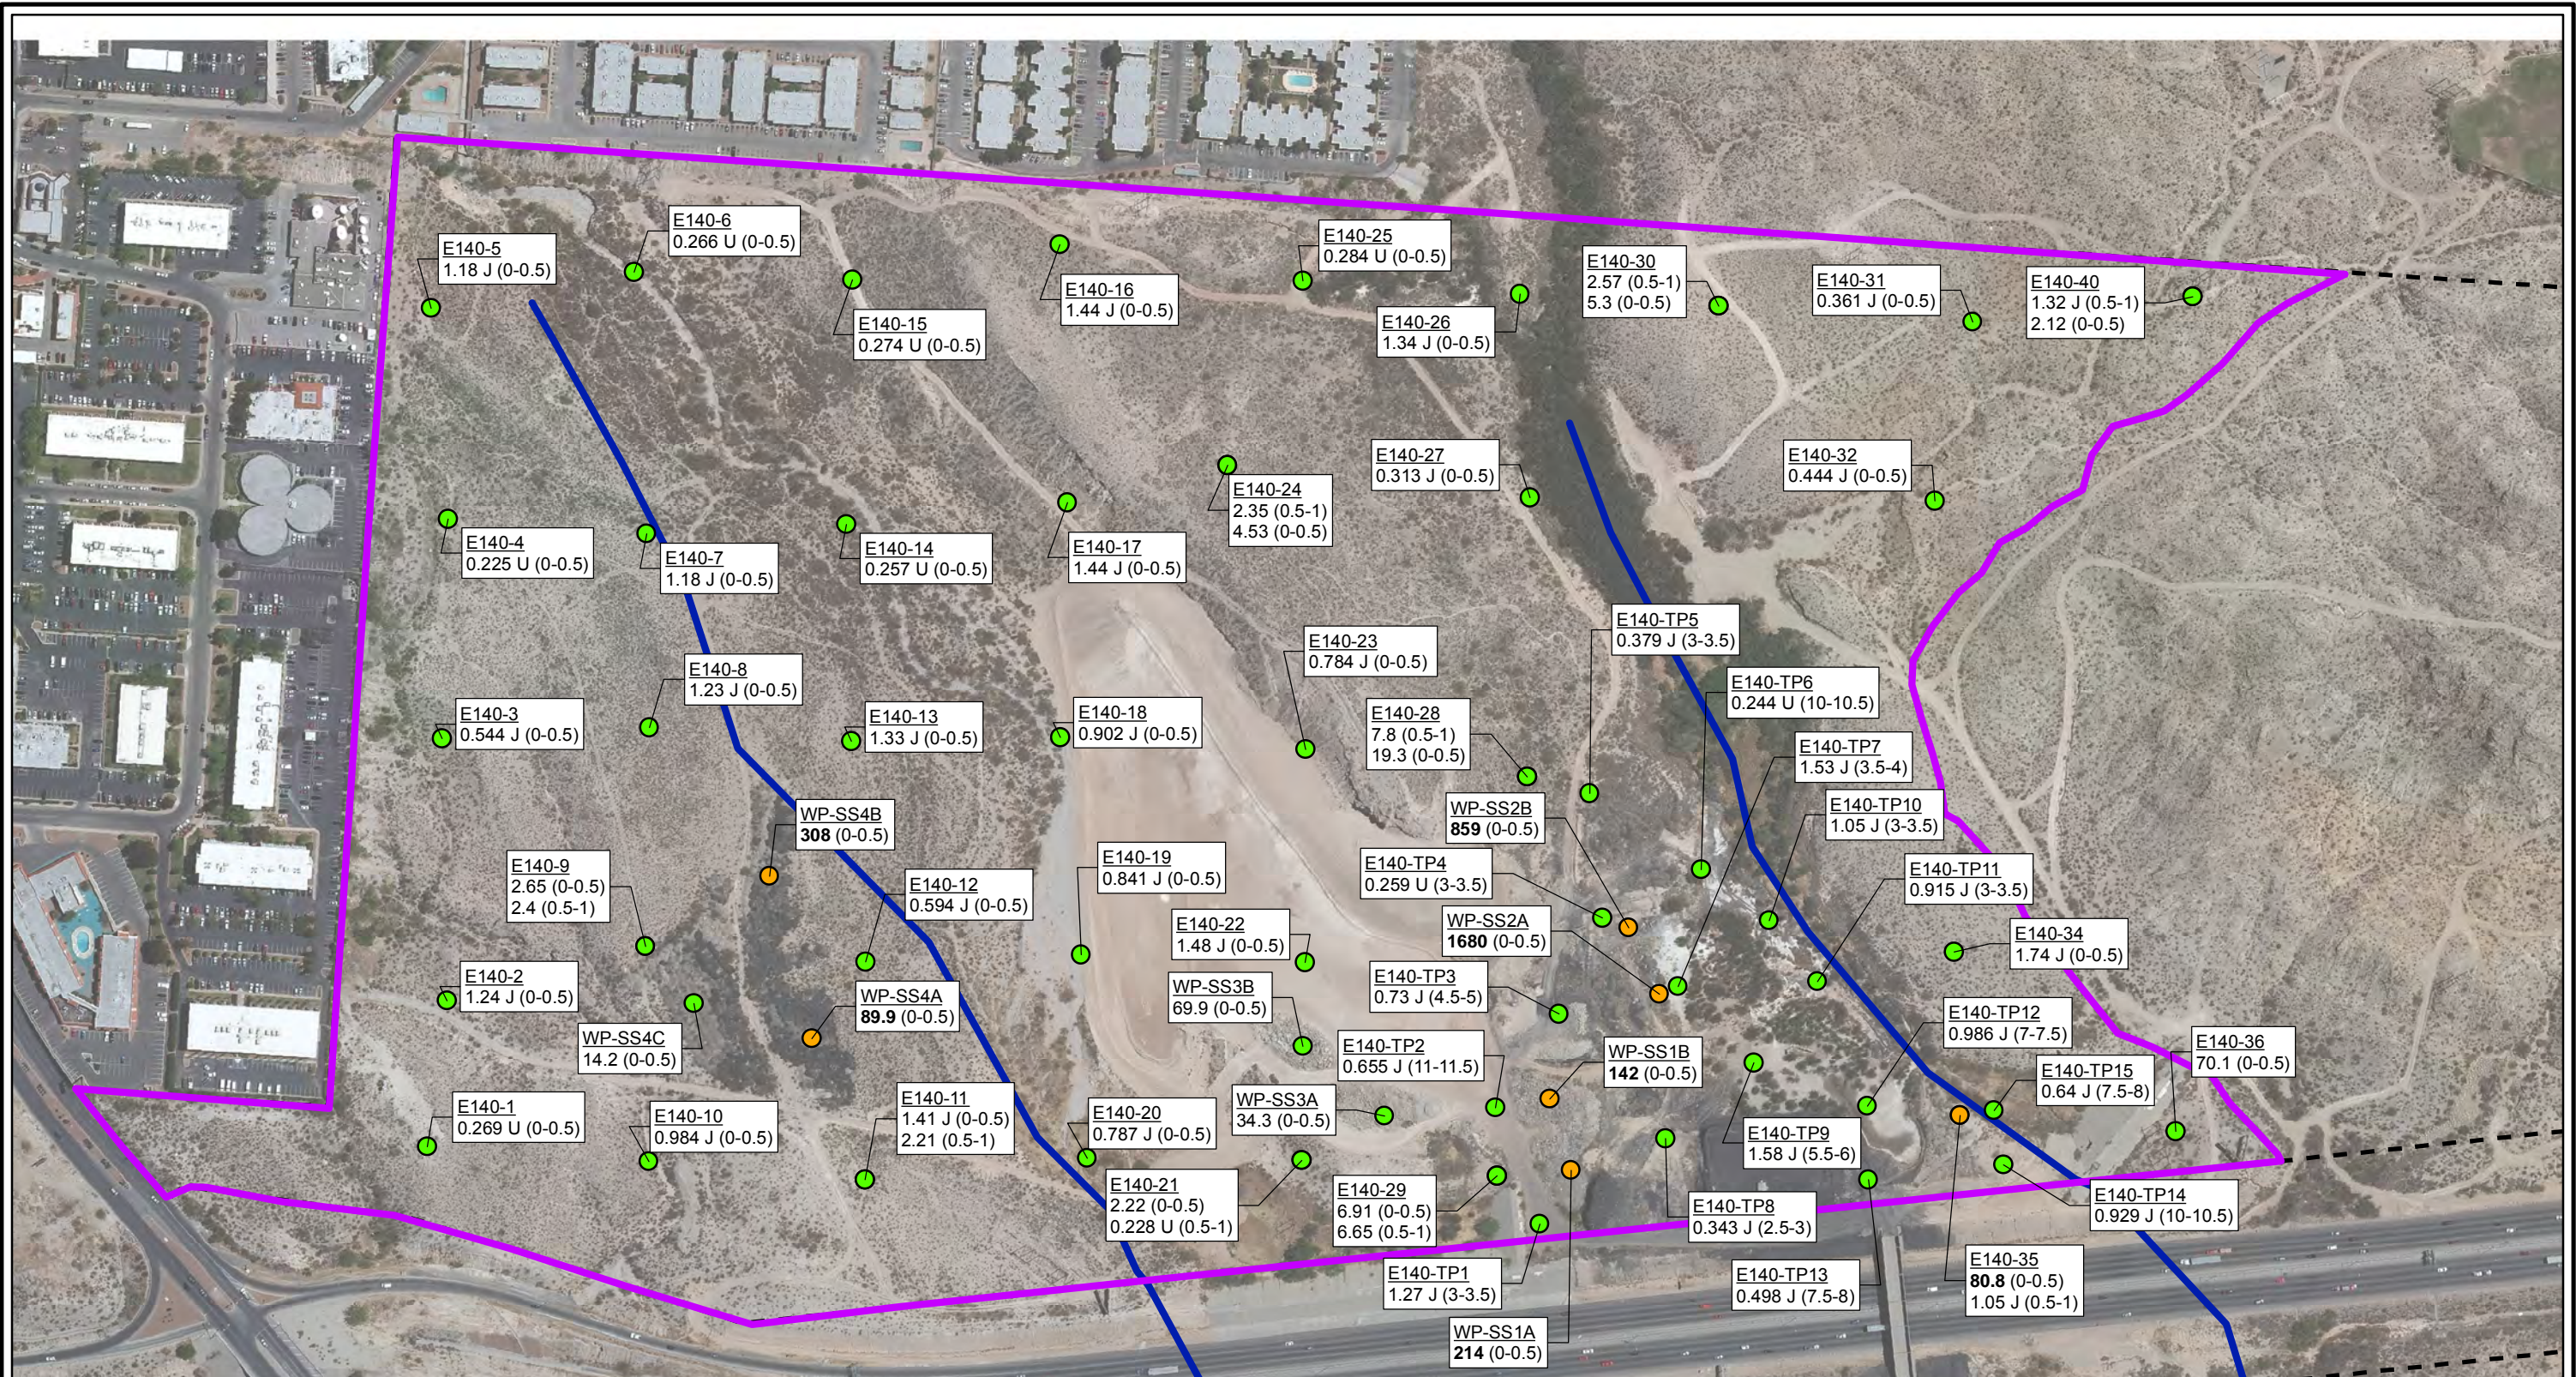
NOTE:
 Screening Level (RRR SAI-Res = 72 mg/kg)
Bolded Value exceeds screening level
 U = Not detected at or above reporting limit
 J = Estimated Value
 Date of Aerial Photo: 2009
