FORMER EL PASO SMELTER SITE
EL PASO, TEXAS

**ARSENIC DISTRIBUTION IN SOIL
EAST PROPERTY**

**FIGURE
4-7**

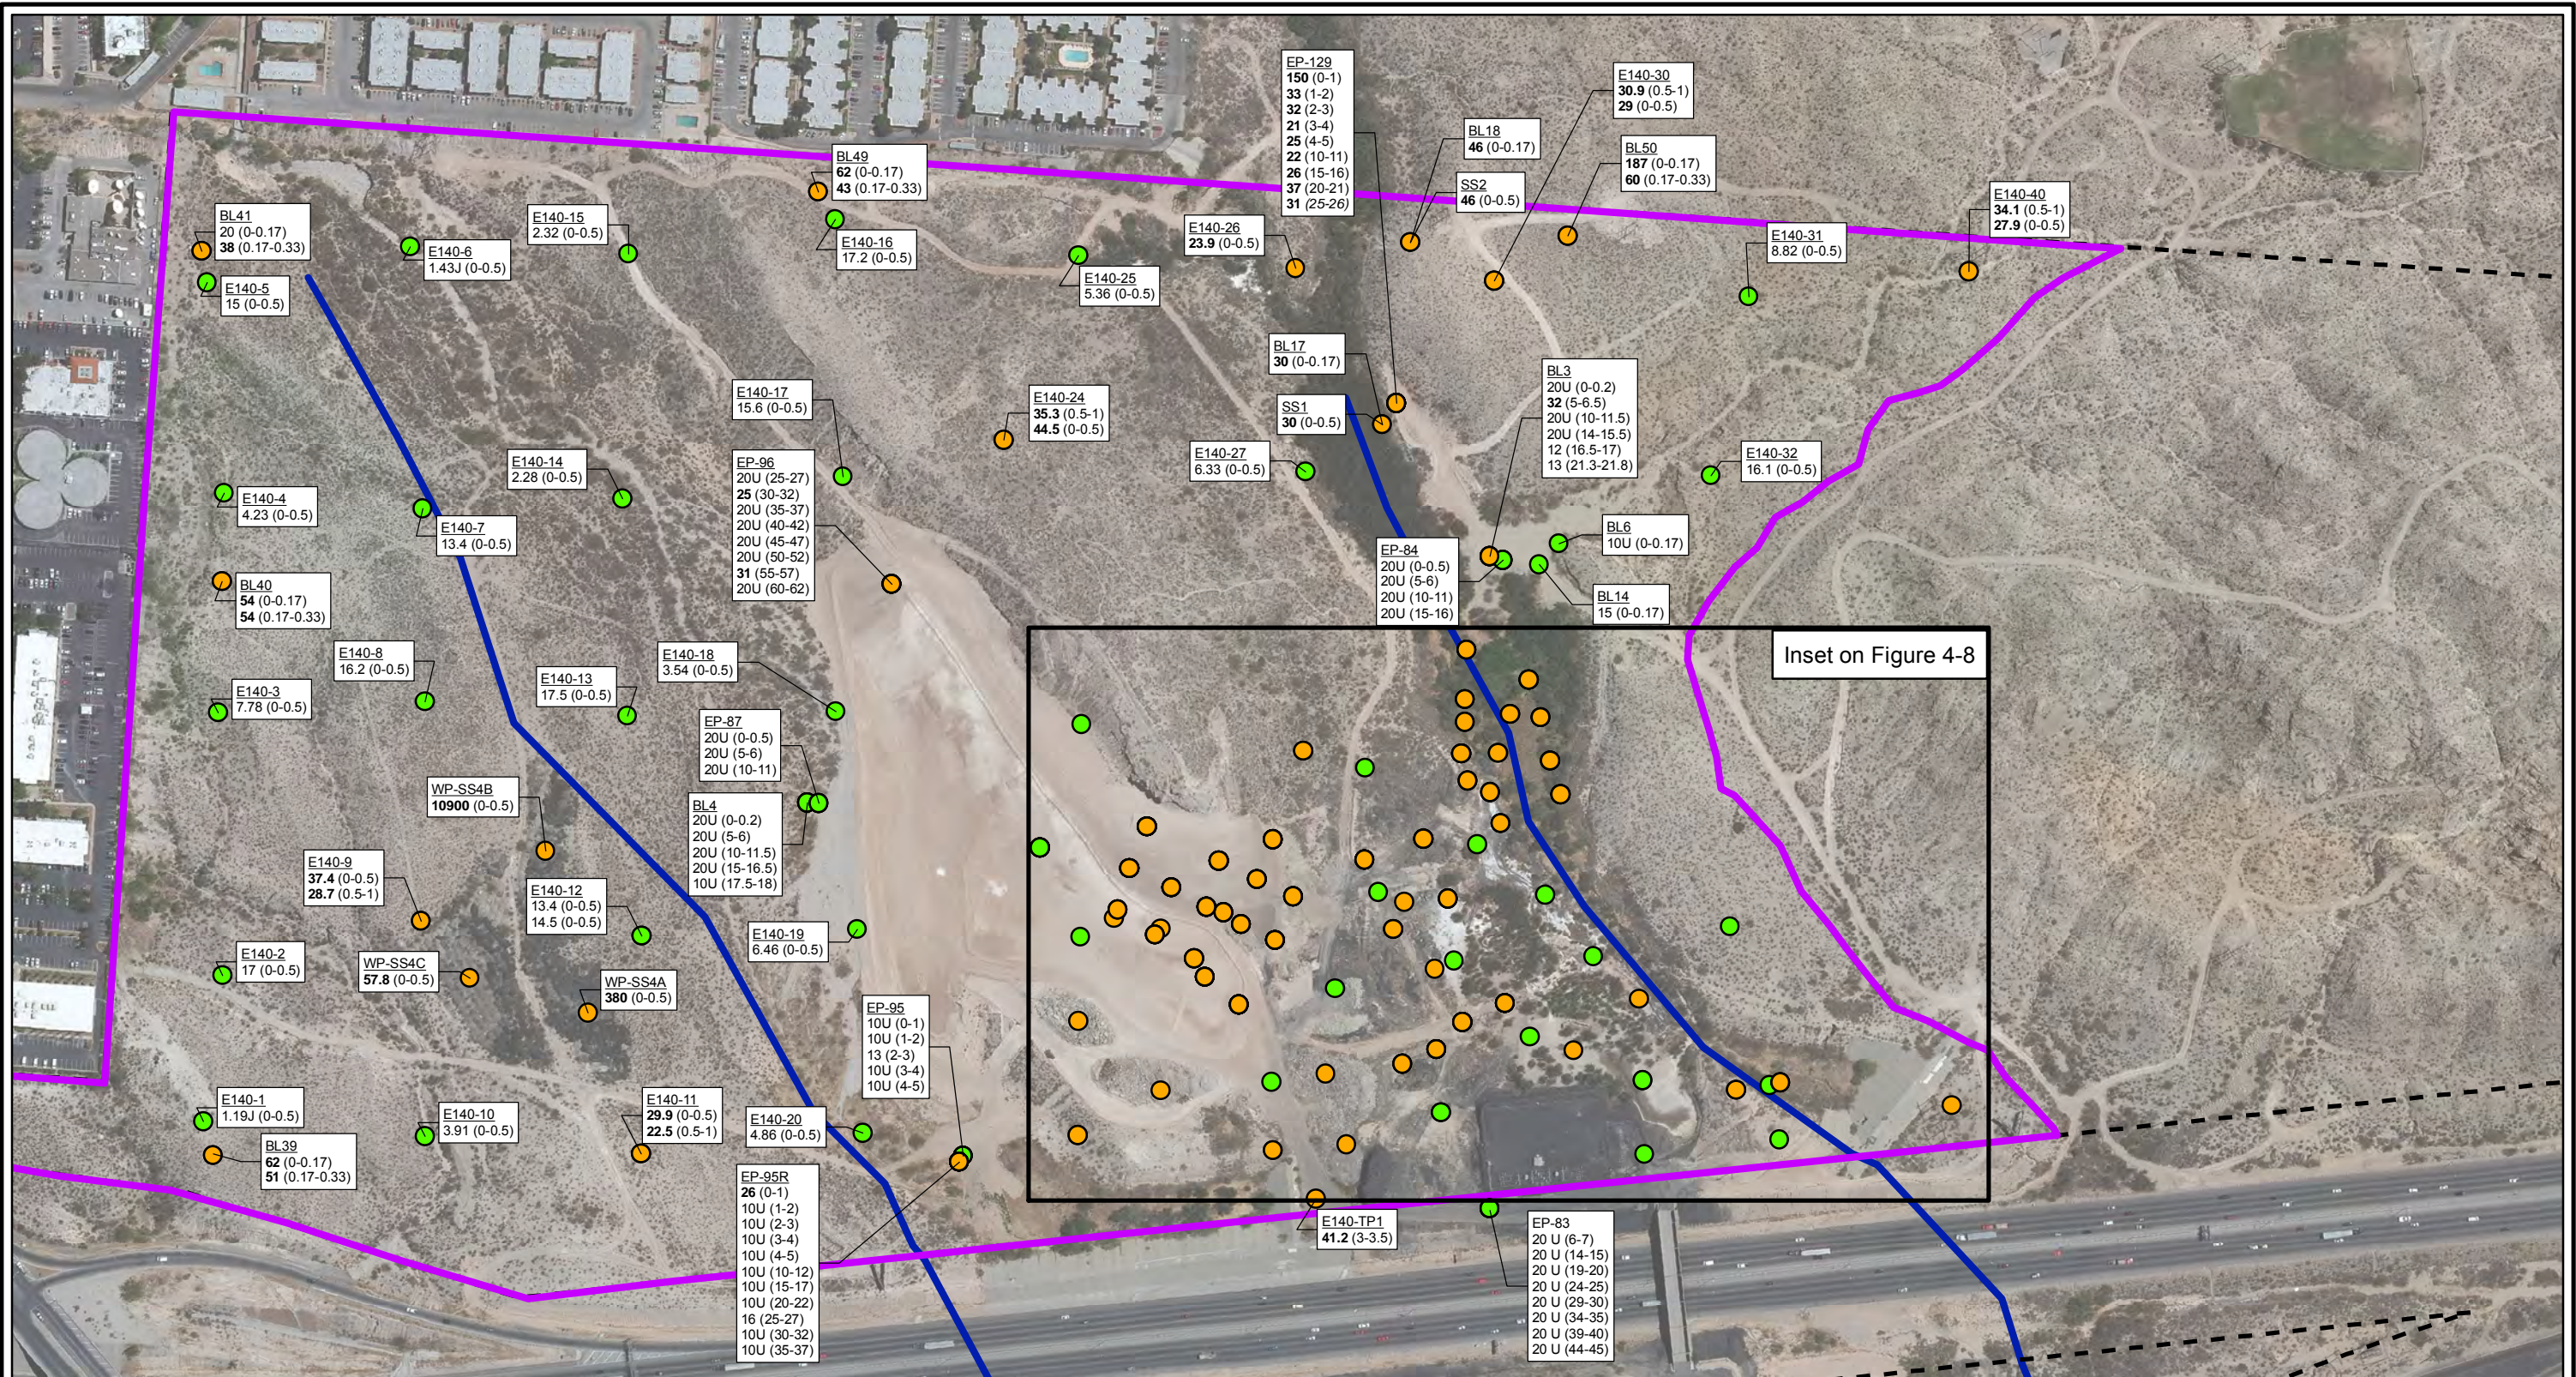
NOTE:
 Screening Level (RRR SAI-Res = 20 mg/kg)
Bolded Value exceeds screening level
Italics indicate below the water table
 J = Estimated Value
 U = Not detected at or above reporting limit
 Date of Aerial Photo: 2009
