# ATTACHMENT 1C.8.3

East Sliver, Paisano  
Floodplain Assessment Area and Paisano Drive

## East Sliver, Paisano Floodplain Assessment Area and Paisano Drive

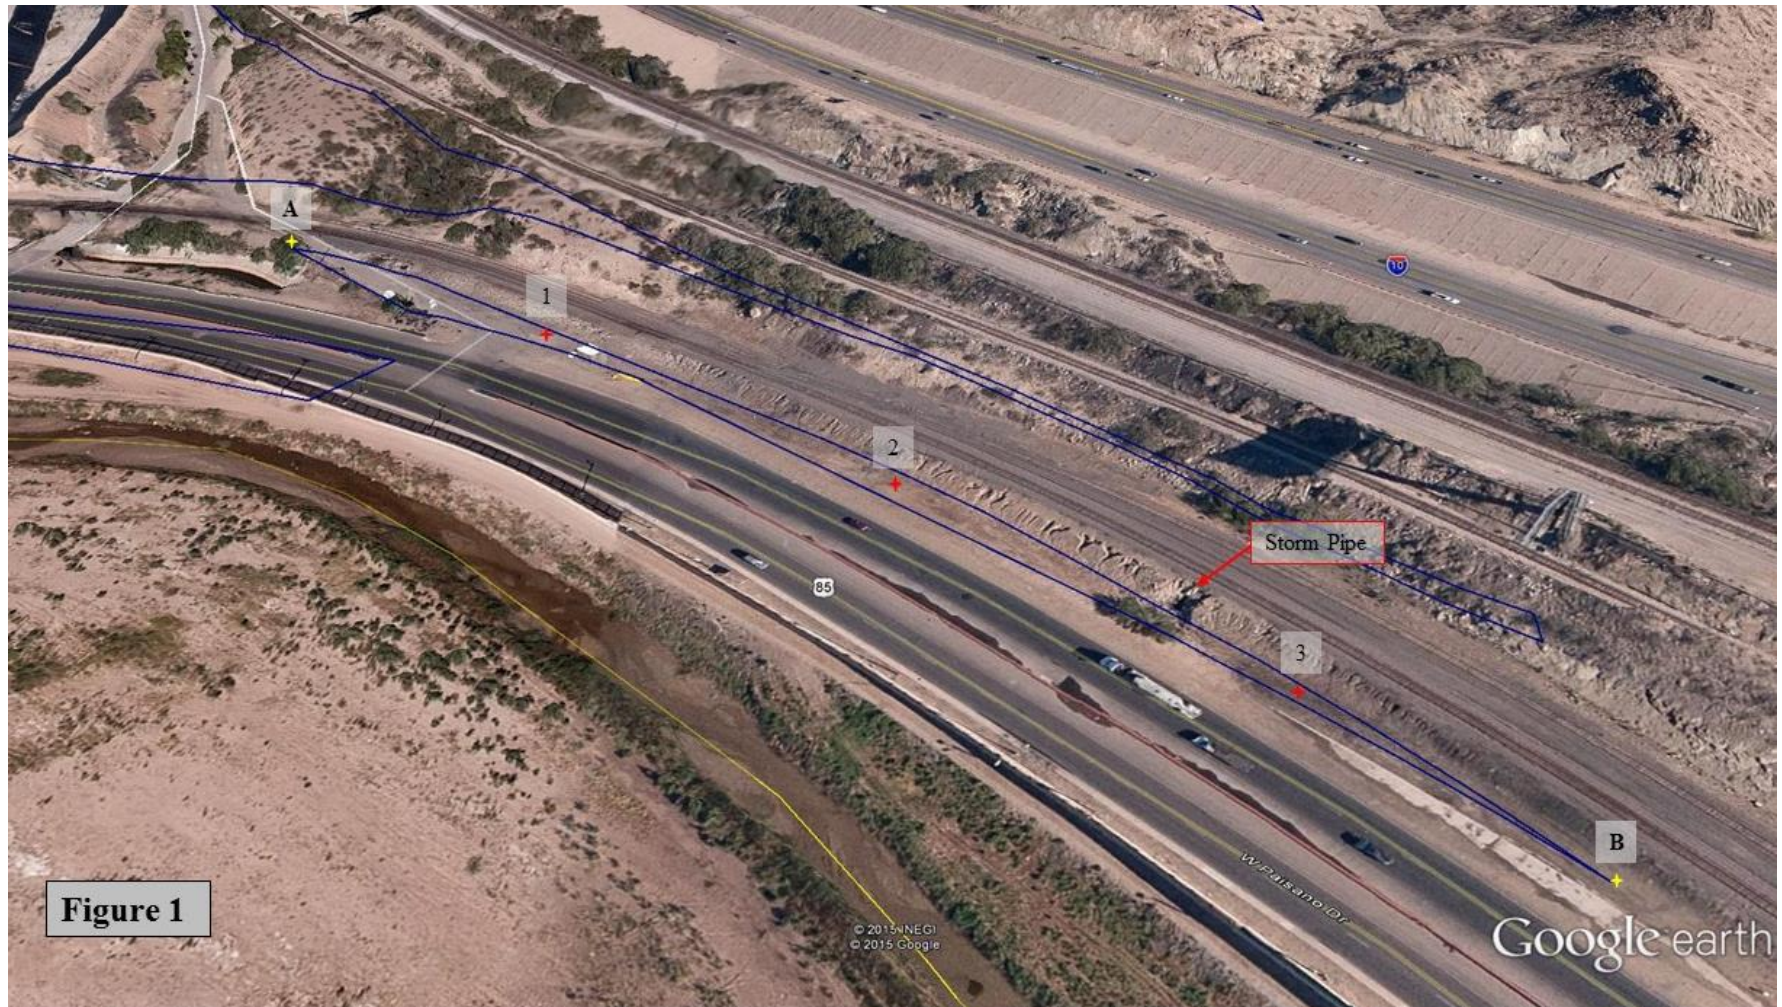
## East Sliver, Paisano

The description of the East Sliver, Paisano parcel in Appendix 2-4 of the RAP (Arcadis 2016e) presents the status of the remedial action. Soil samples were collected at locations 1 through 3 as shown on the figure included in this attachment to the Soil RACR. Concentrations of lead exceeded the C/I PCL for this area at locations 1 and 2.

In 2017, TCT will excavate a 350-ft by 20-ft by 0.5-ft area that will extend from Point A to south of location 2. Samples will be collected for XRF analysis. When XRF results are below the C/I  $T^{ot}Soil_{comb}$  PCLs, three 5-point composite confirmation samples will be collected to verify that remaining concentrations of metals in surface soil are below the respective C/I PCLs and the response action is complete.

- Figure 1 (from RAP Appendix 2-4 East Sliver Paisano)
