TEXAS CUSTODIAL TRUST
 EL PASO, TEXAS
CELL 3 COVER SYSTEM RECONSTRUCTION

CELL 3 CROSS SECTION

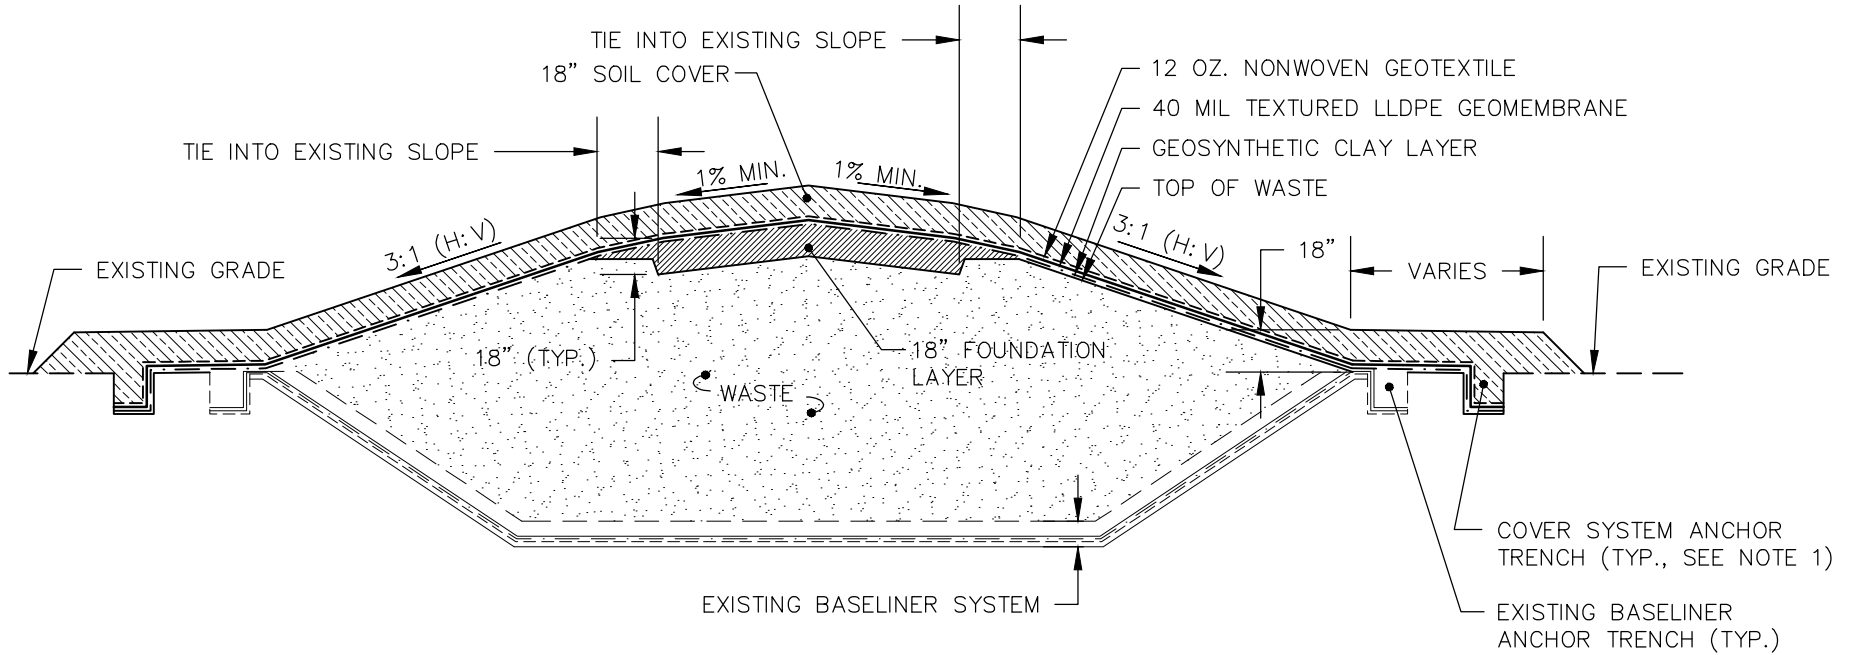
2

1. AS A RESULT OF THE EXISTING CELL 3 COVER SYSTEM GEOSYNTHETICS BEING ENTIRELY REMOVED, THE EXISTING COVER SYSTEM ANCHOR TRENCH WAS REUSED FOR THE NEW COVER SYSTEM GEOSYNTHETICS.
2. GEOSYNTHETICS ARE EXAGGERATED FOR CLARITY.
3. COVER SYSTEM CONFIGURATION IS BASED ON FIELD OBSERVATIONS.
