FORMER EL PASO SMELTER SITE
EL PASO, TEXAS

**MERCURY DISTRIBUTION IN SOIL
EAST MOUNTAIN**

**FIGURE
4-5**

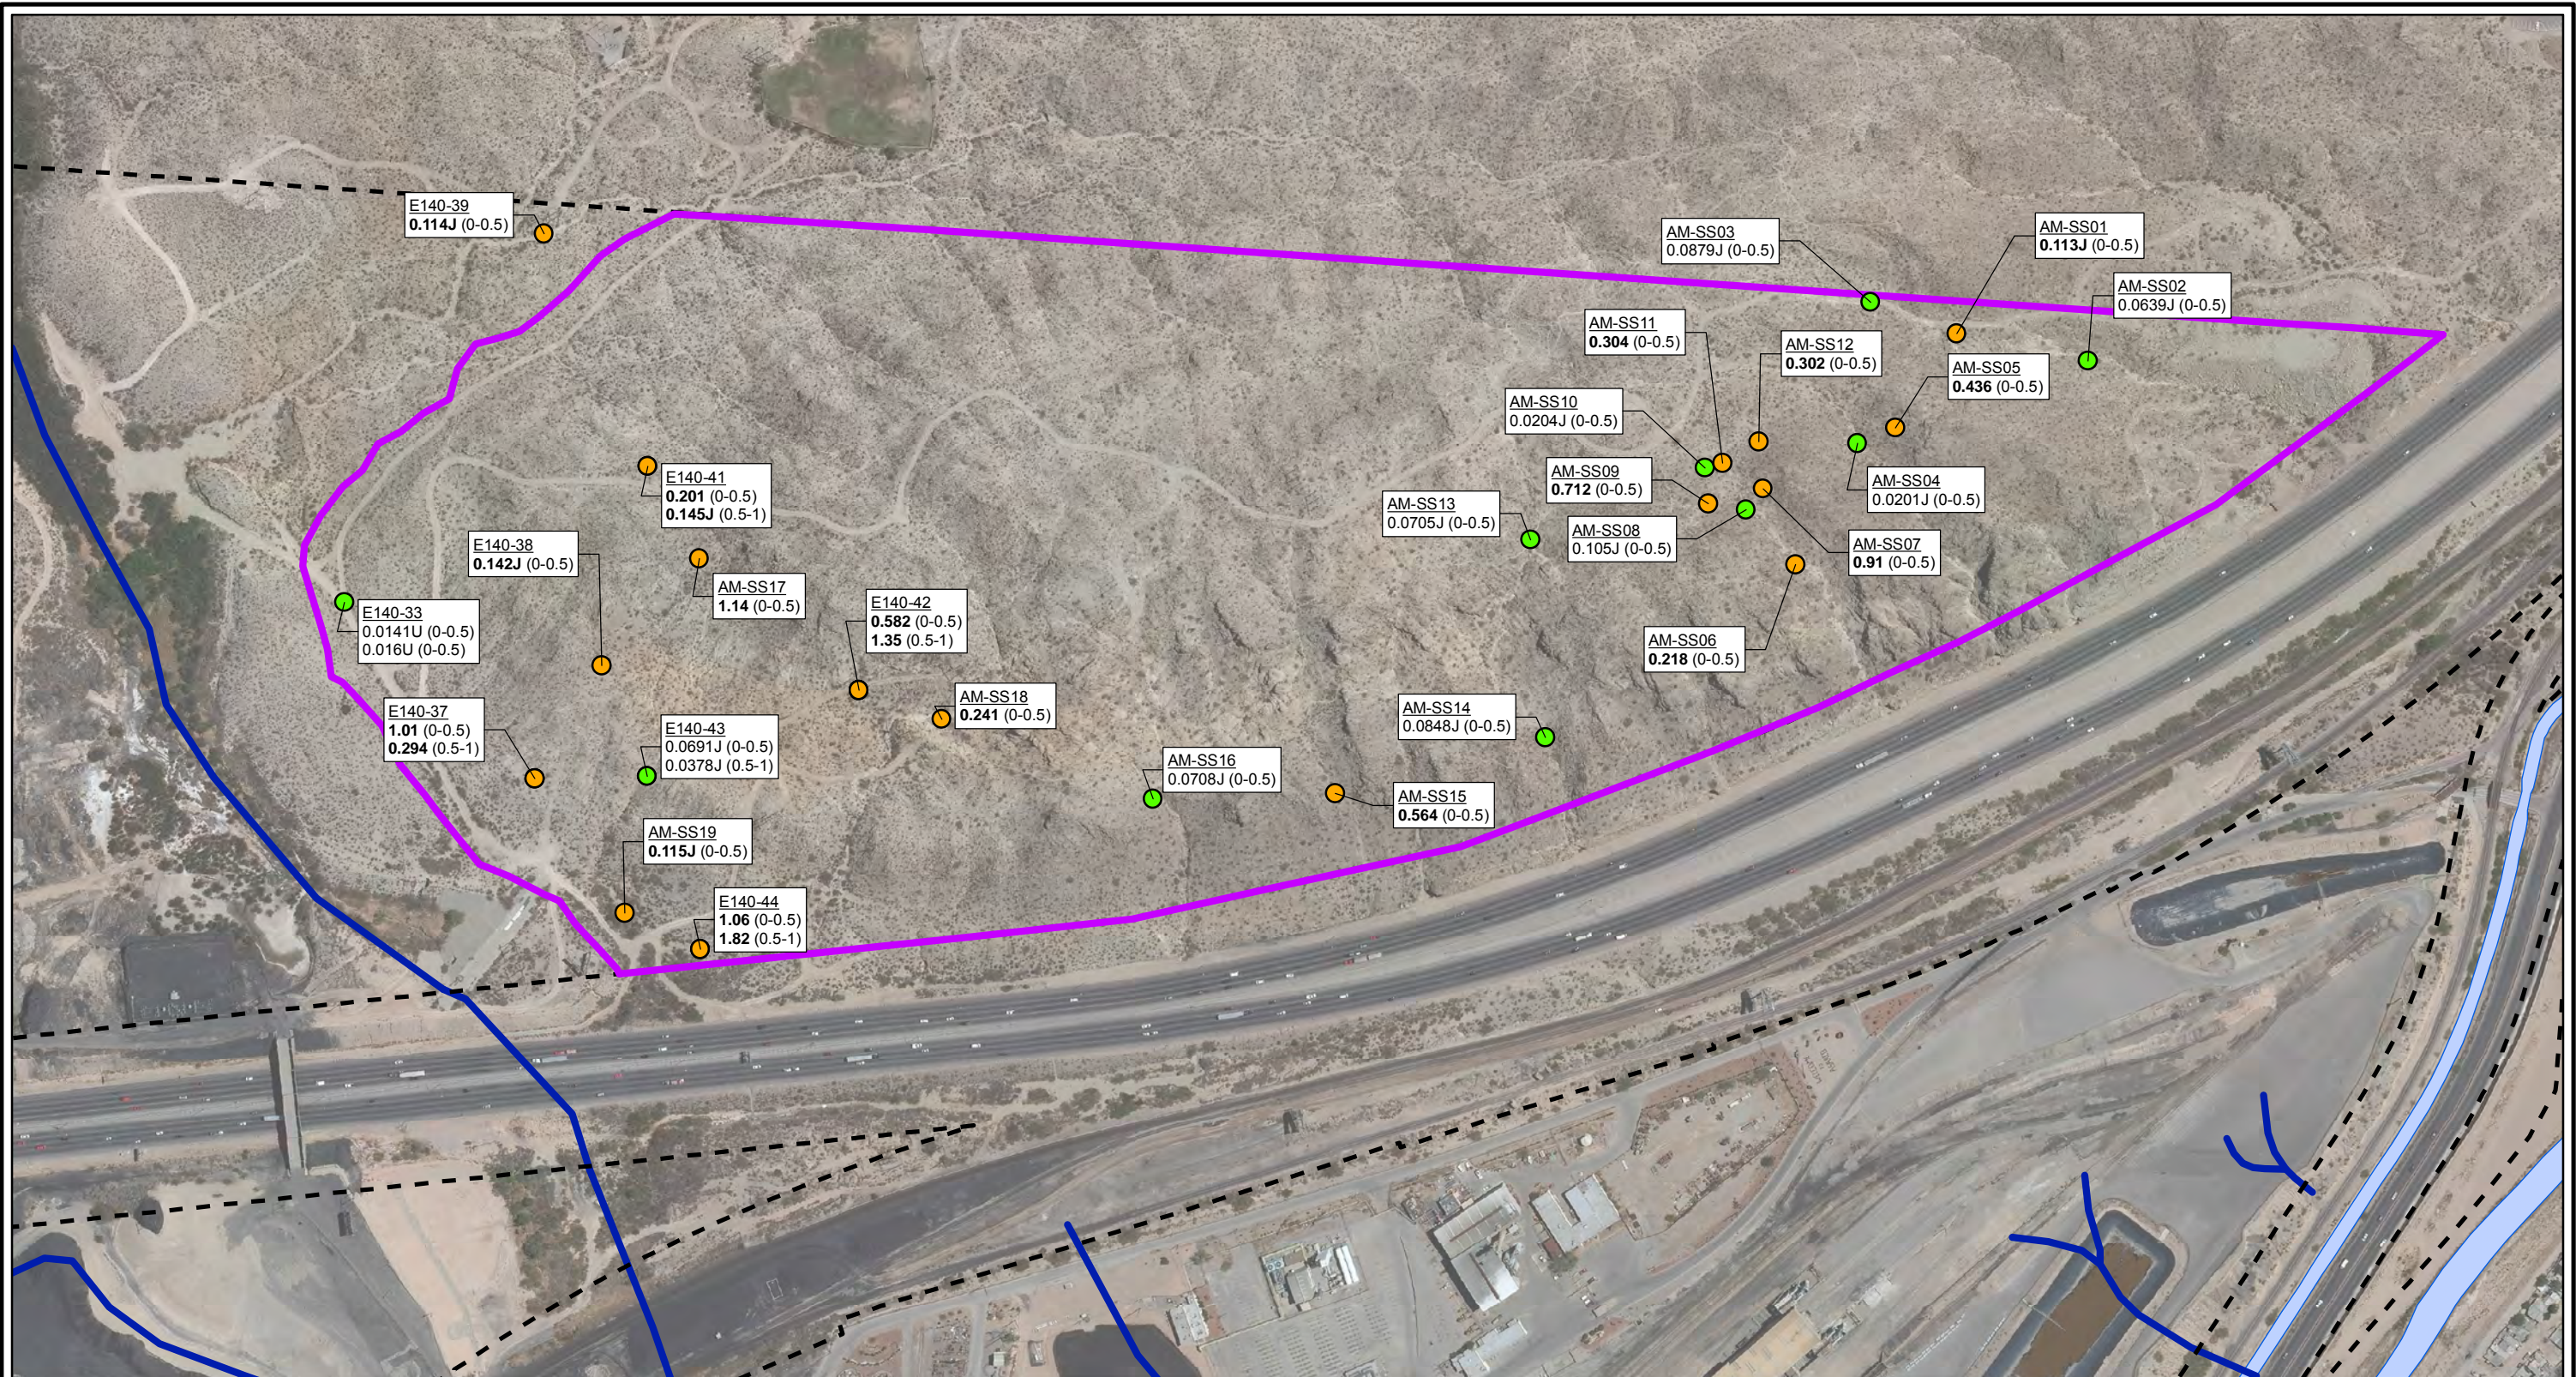
NOTE:
 Screening Level (RRR SAI-Res = 0.11 mg/kg)
Bolded Value exceeds screening level
 J = Estimated Value
 U = Not detected at or above reporting limit
 Date of Aerial Photo: 2009

Sample ID
E140-44
1.06 (0-0.5)
1.82 (0.5-1)
Depth (ft bgs)
Mercury Concentration in mg/kg
