FORMER EL PASO SMELTER SITE
EL PASO, TEXAS

**MERCURY DISTRIBUTION IN SOIL
SOUTH TERRACE ARROYO**

**FIGURE
4-34**

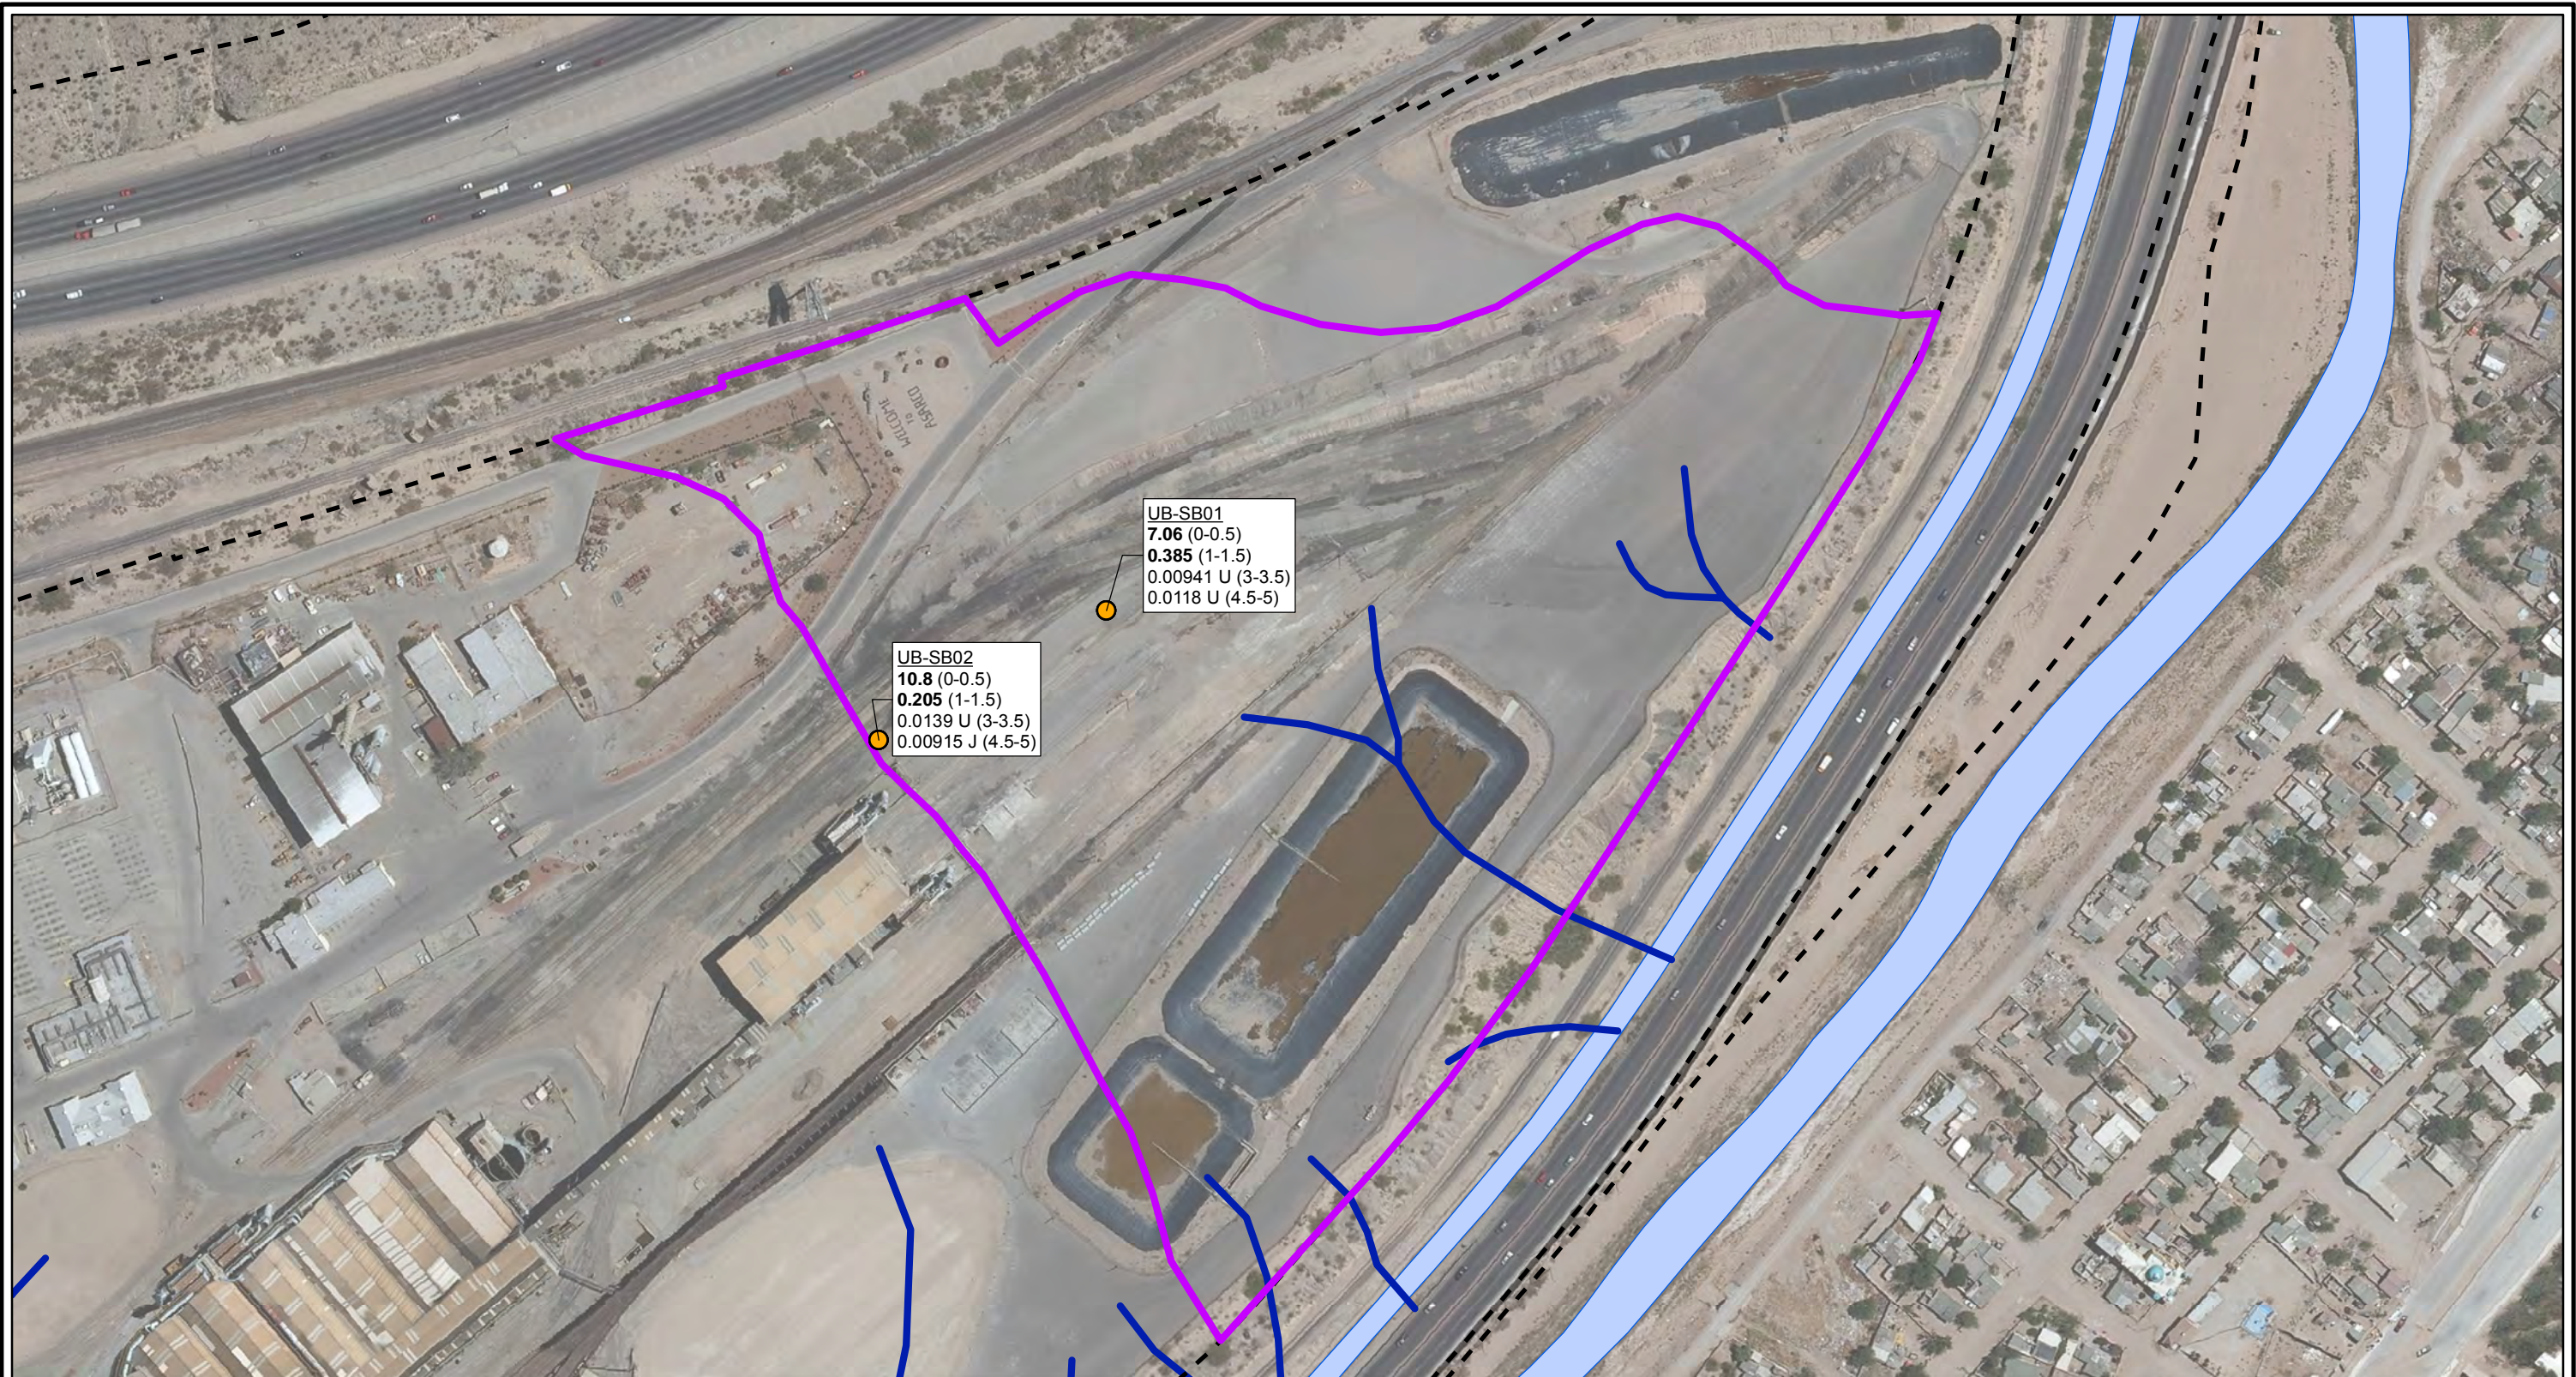
NOTE:
 Screening Level (RRR SAI-Ind = 0.15 mg/kg)

Sample ID	Depth (ft bgs)	Mercury Concentration in mg/kg
BH8-10	40 (10-11)	40
	13 (15-16)	13
