FORMER EL PASO SMELTER SITE  
EL PASO, TEXAS

**ARSENIC DISTRIBUTION IN SOIL  
LA CALAVERA**

**FIGURE  
4-49**

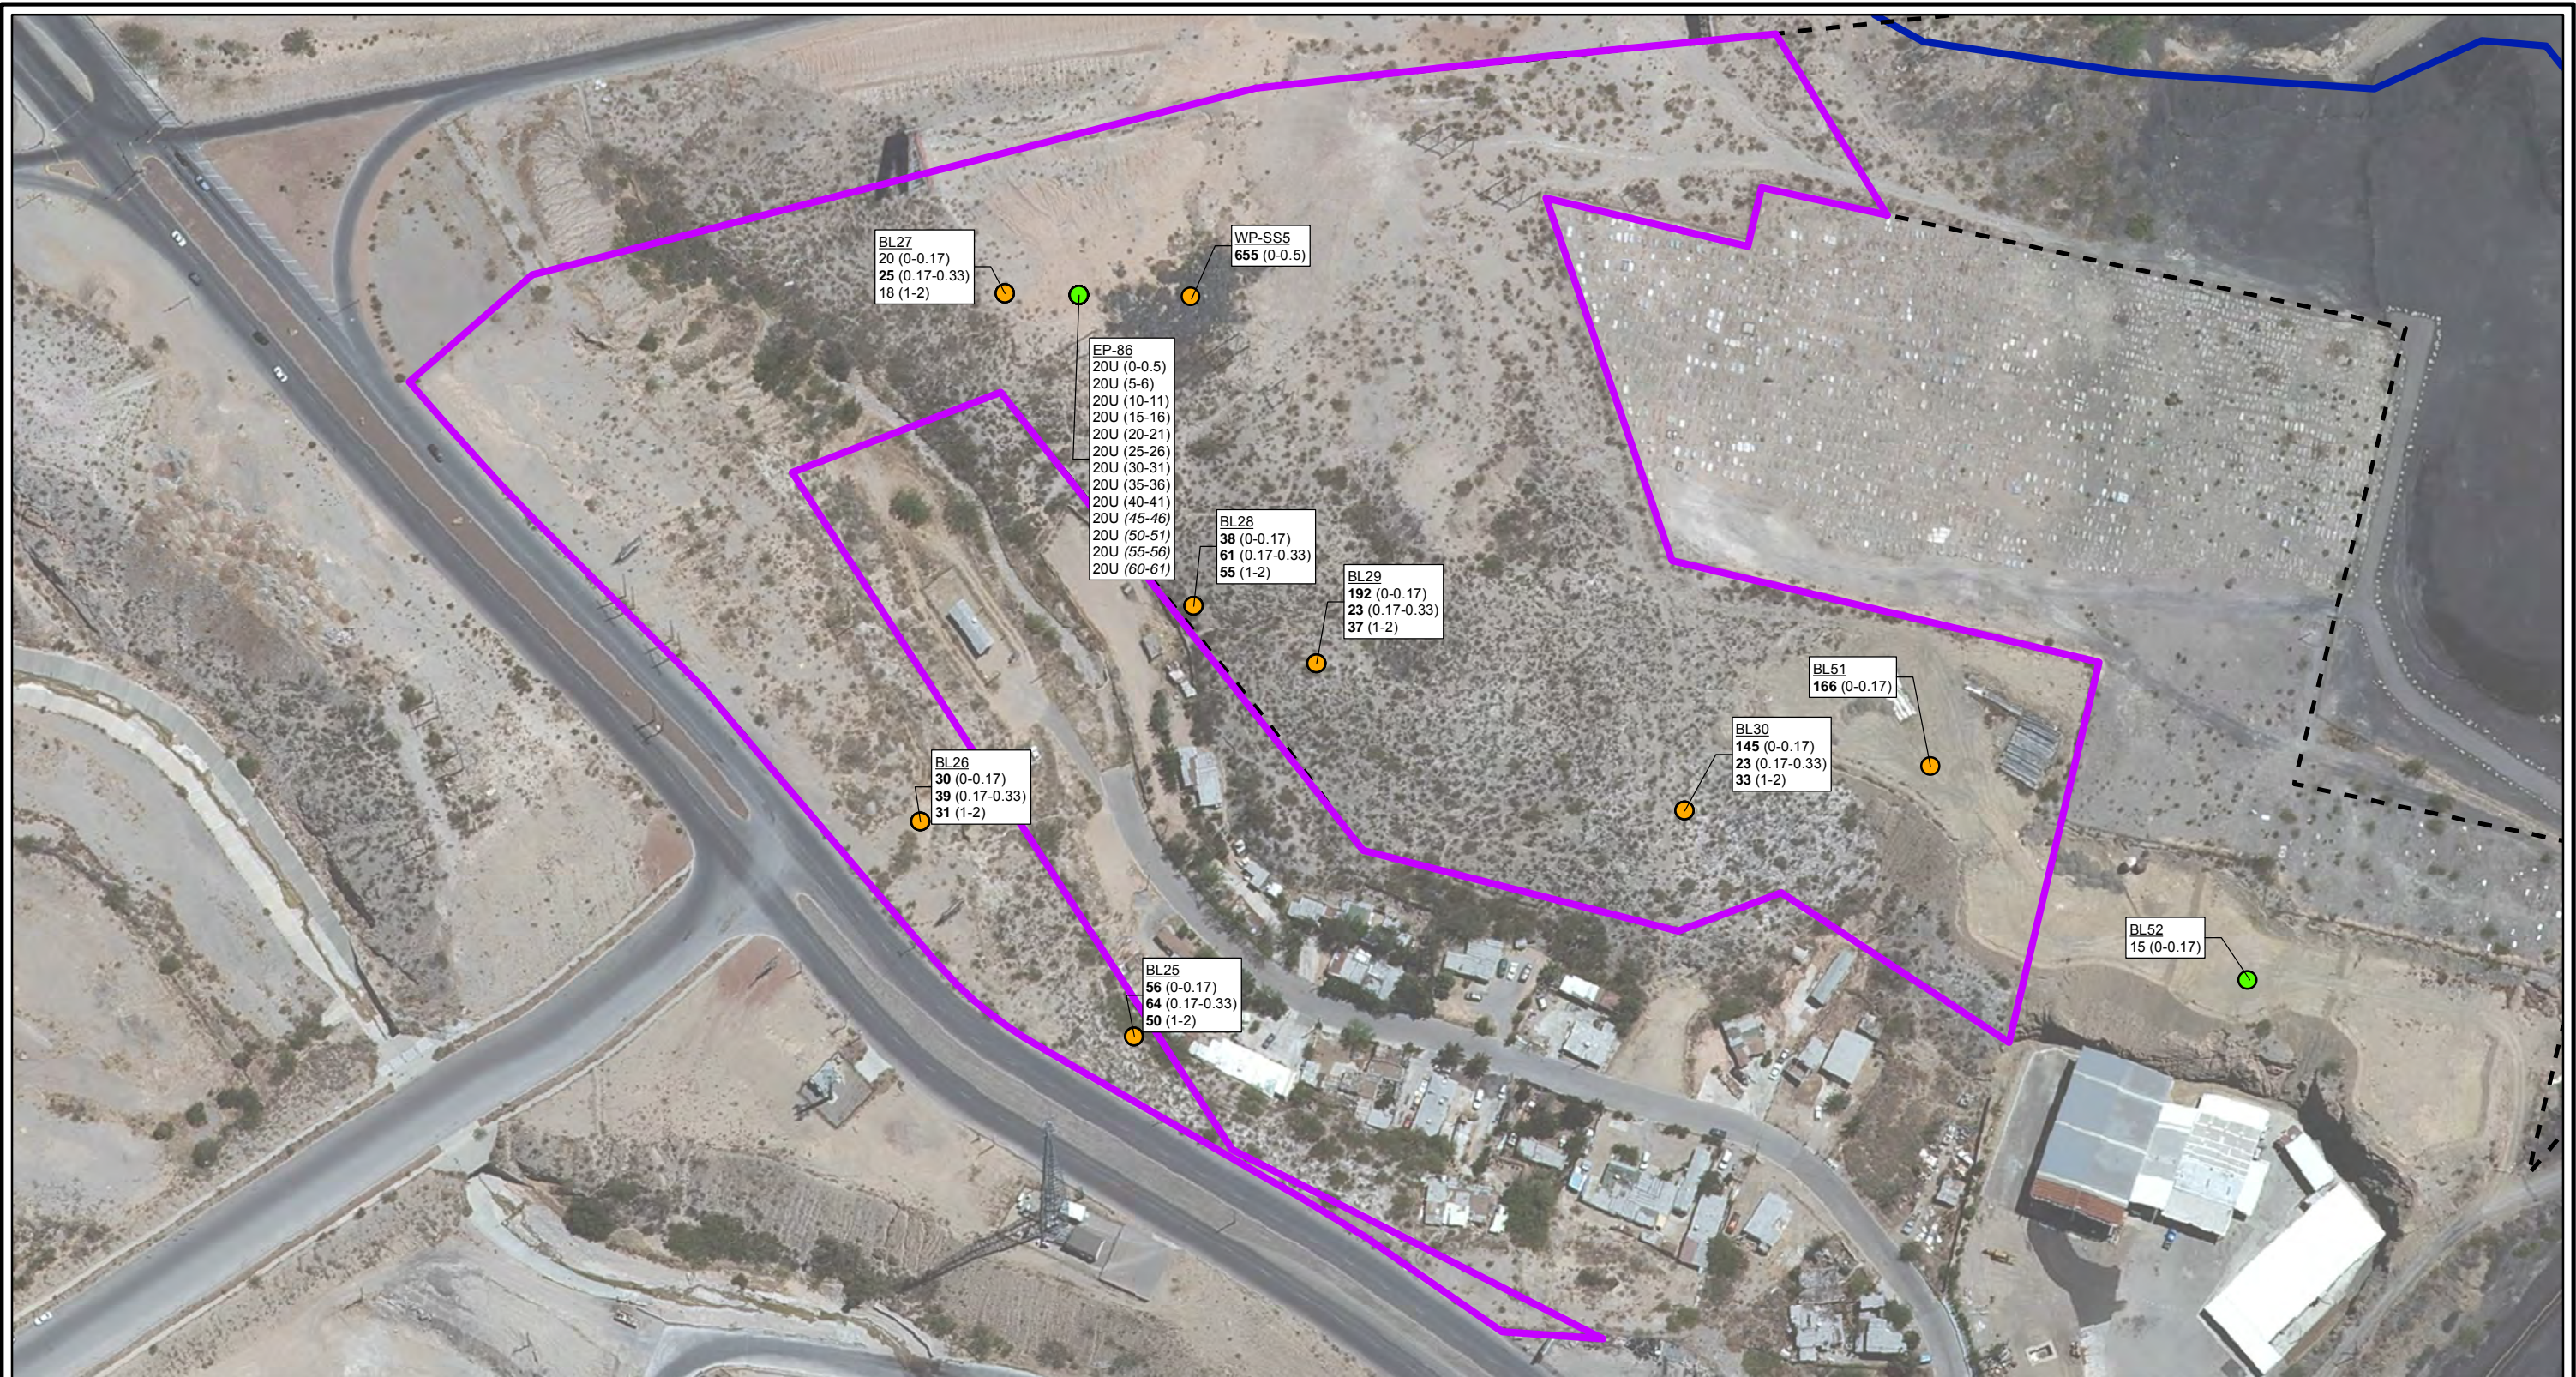
**NOTE:**  
 Screening Level (RRR SAI-Res = 20 mg/kg)  
**Bolded** Value exceeds screening level  
*Italics* indicate below the water table  
 J = Estimated Value  
 U = Not detected at or above reporting limit  
 Date of Aerial Photo: 2009
