FORMER EL PASO SMELTER SITE
 EL PASO, TEXAS

**ZINC DISTRIBUTION IN GROUNDWATER
 FALL 2012**

**FIGURE
 4-76**

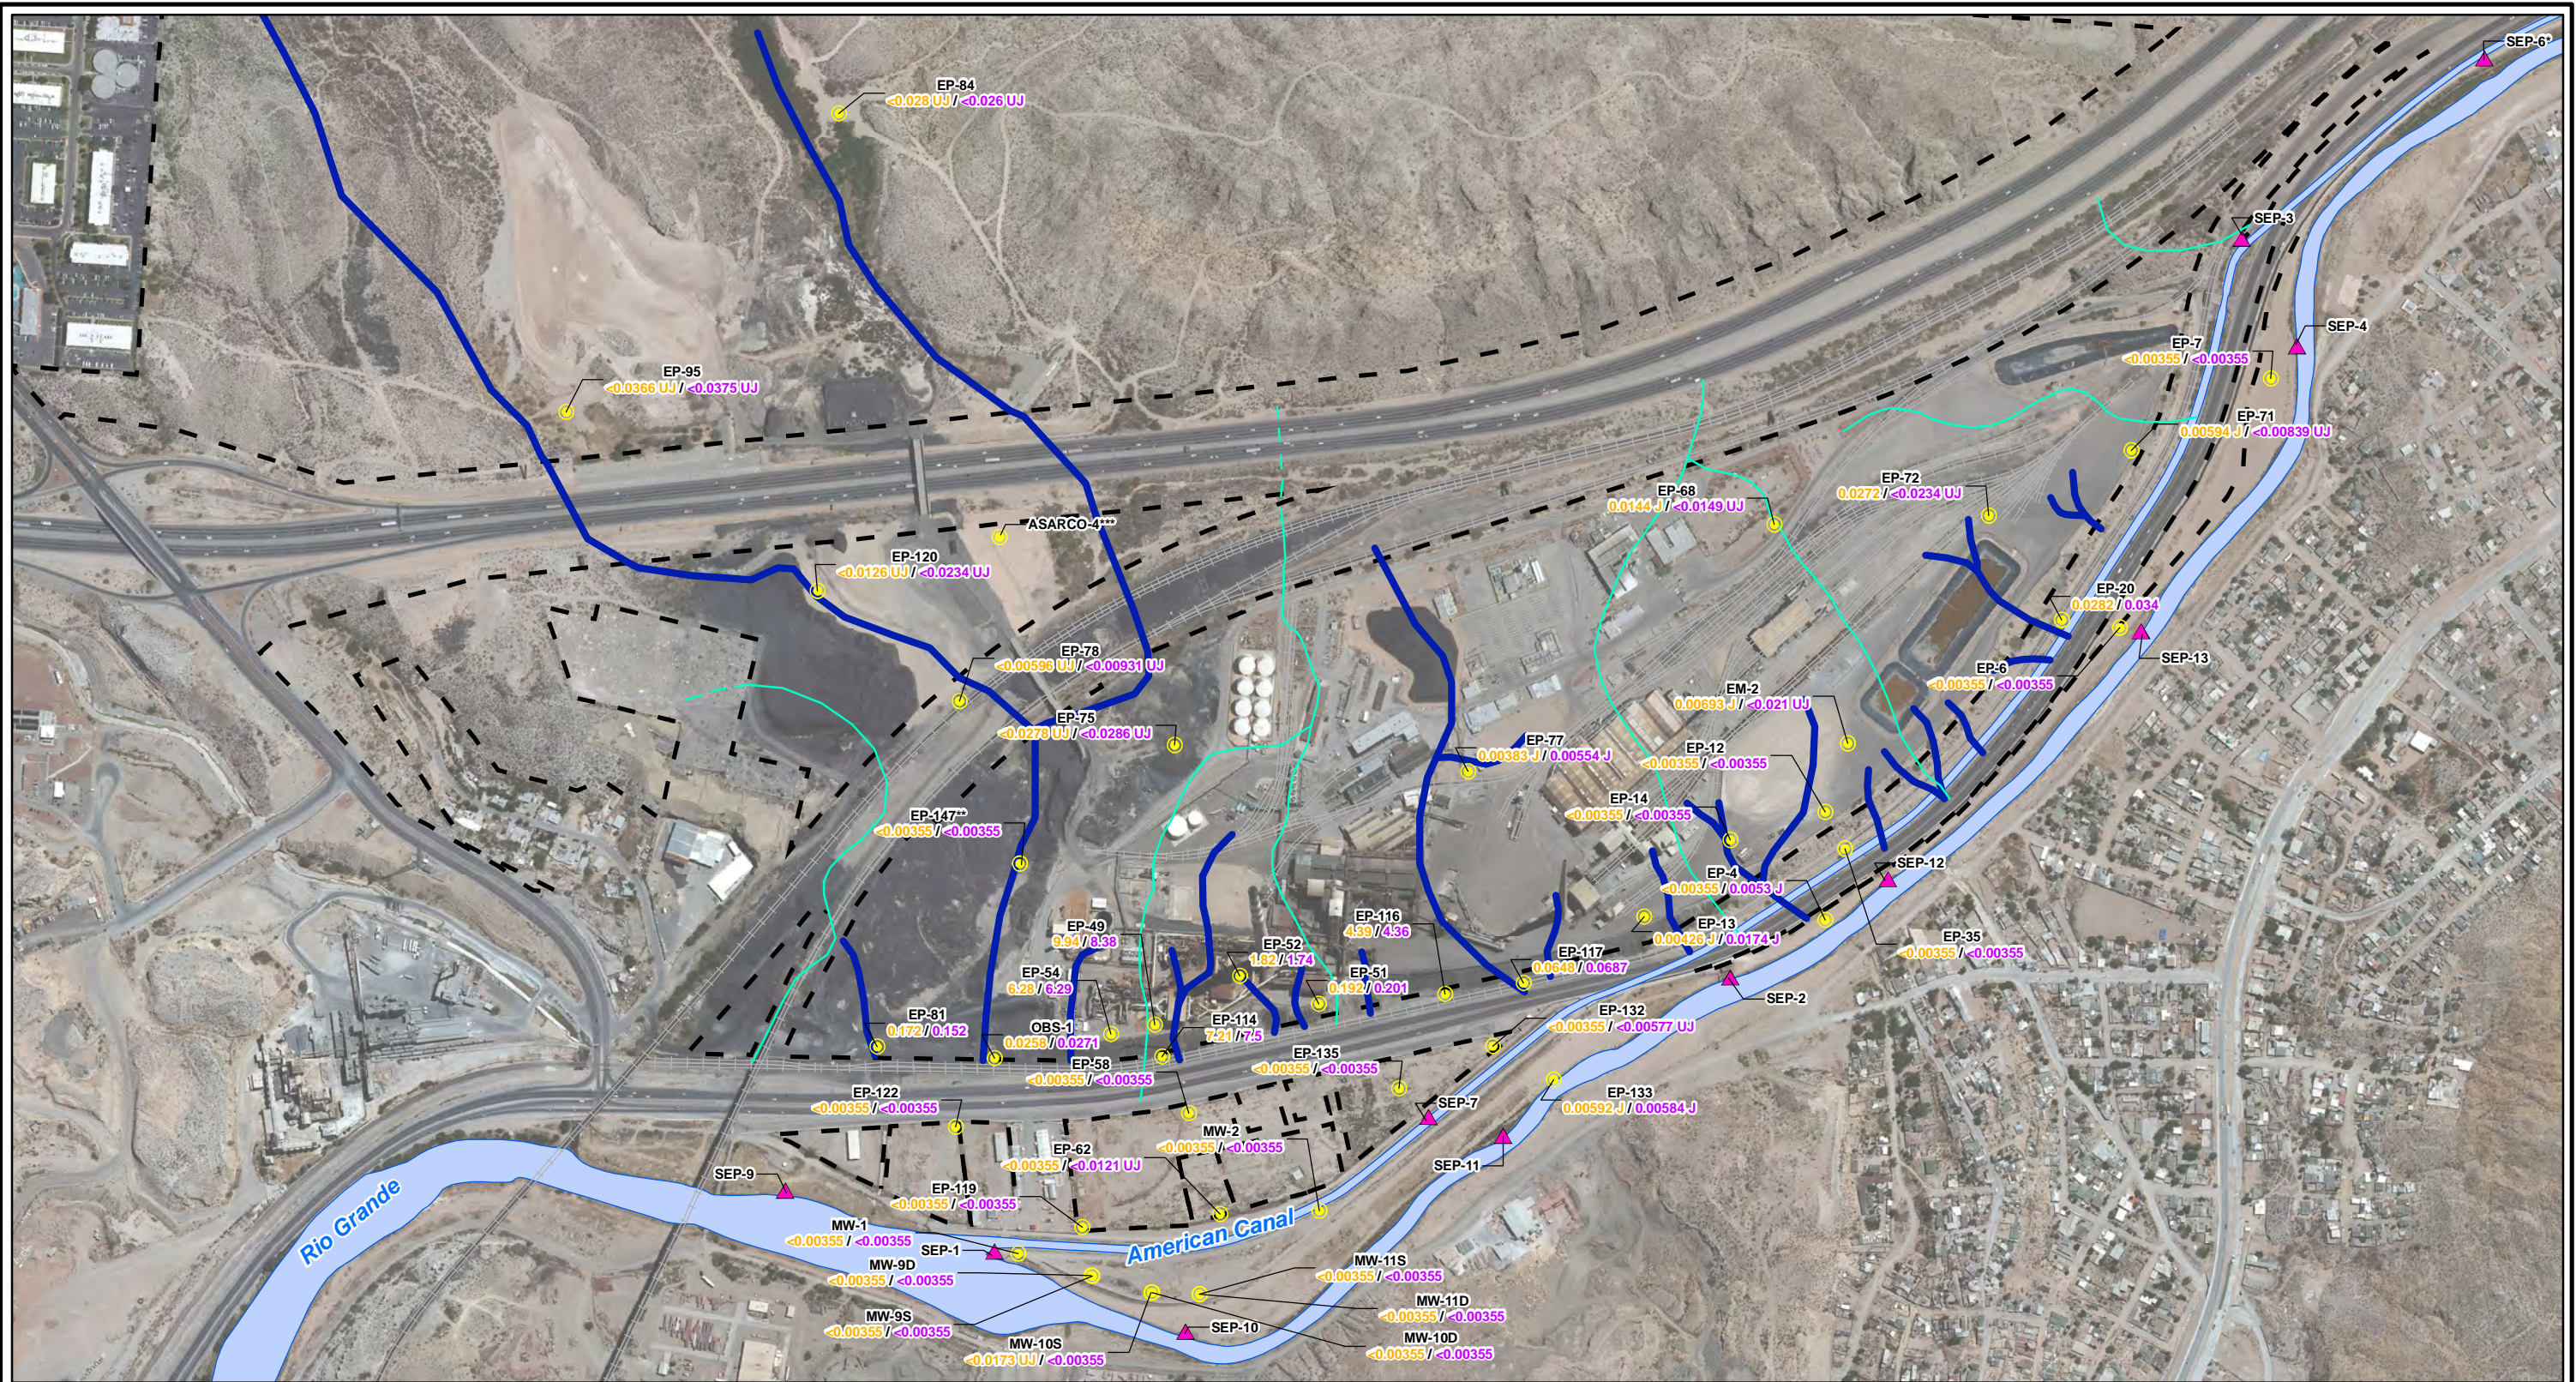
EP-81 Well ID
0.172 / 0.152 Dissolved Zinc/Total Zinc (mg/L)

Note:
 Zinc Screening Level = 31 mg/L (RRR Groundwater Industrial)
 J = The reported value was obtained from a reading that was less than reporting limit but greater than or equal to the method detection limit.
 UJ = Estimated Reporting Limit
 mg/L = milligrams per liter
 RRR = Risk Reduction Rules
 < = Non detect at the reporting limit shown
 *Actual location of SEP-6 is approximately one mile further downstream on the American Canal.
 **Data collected in October 2012
 ***TxDOT monitoring well not sampled
